AIRCRAFT ACCIDENT REPORT AND EXECUTIVE SUMMARY

Reference:	CA18/2/3/9138
Aircraft Registration	ZU-VXU	Date of Accident	29 January 2013	Time of Accident	1530Z
Type of Aircraft	PA22-160 Veteran		Type of Operation	Private	
Pilot-in-command Licence Type	Private	Age	48	Licence Valid	No
Pilot-in-command Flying Experience	Total Flying Hours	173.85	Hours on Type	58	
Last point of departure	Petit Aerodrome, Gauteng province				
Next point of intended landing	Petit Aerodrome, Gauteng province				
Location of the accident site with reference to easily defined geographical points (GPS readings if possible)					
In a maize field before the threshold of Runway 03 at Petit Aerodrome , Gauteng Province					
Meteorological Information	Fine weather conditions with wind NW at 10 Kts, Temperature 28°C and 3/8 clouds				
Number of people on board	1+0	No. of people injured	0	No. of people killed	0
Synopsis	<p>On 29 January 2013 at approximately 1530Z the pilot was flying a circuit at Petit aerodrome.</p> <p>During the approach for landing on runway 21 the pilot, overshot the extended centre line of the runway. He attempted to take corrective action but the aircraft entered into an aerodynamic stall and

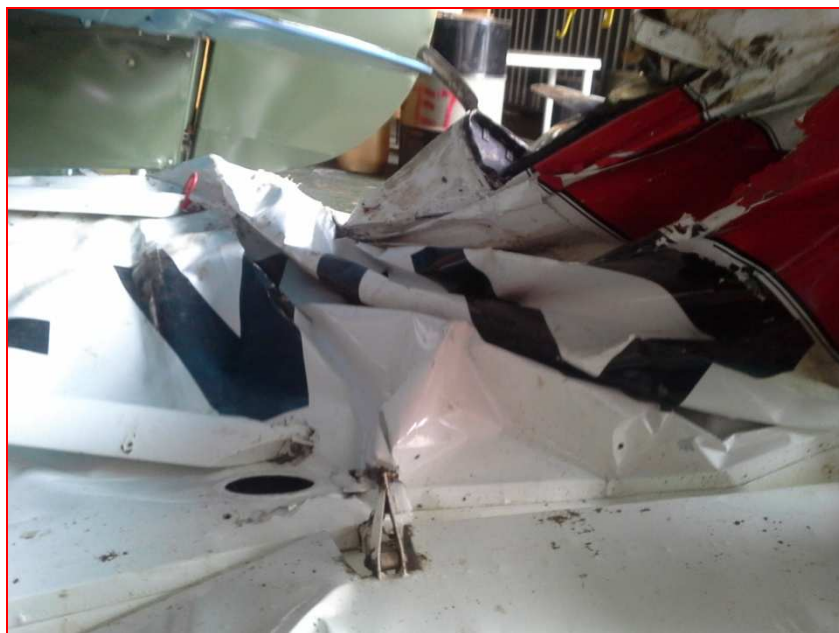
1.3.1 The aircraft sustained substantial damage to both the wings, the nose landing gear and the empennage area.

Figure 1: The left hand wing

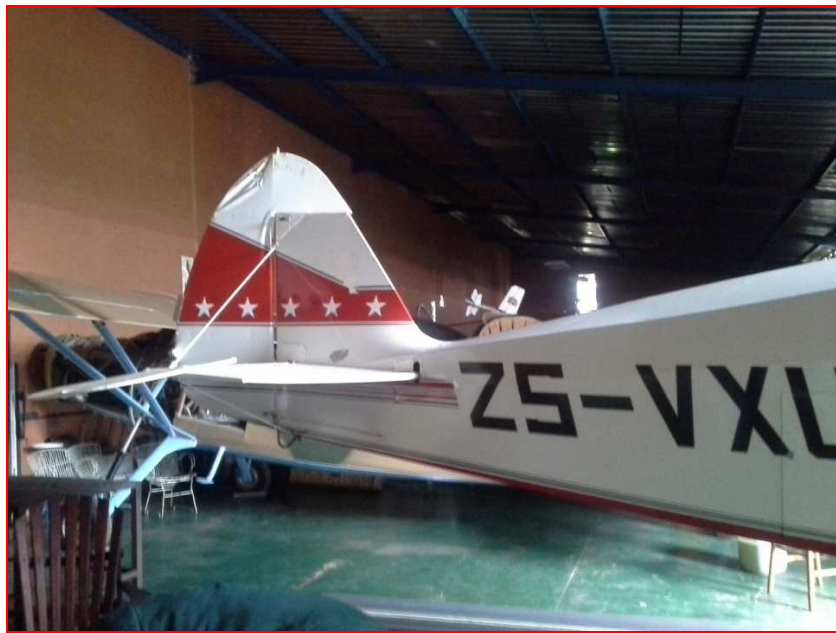
Figure 2: The Rudder

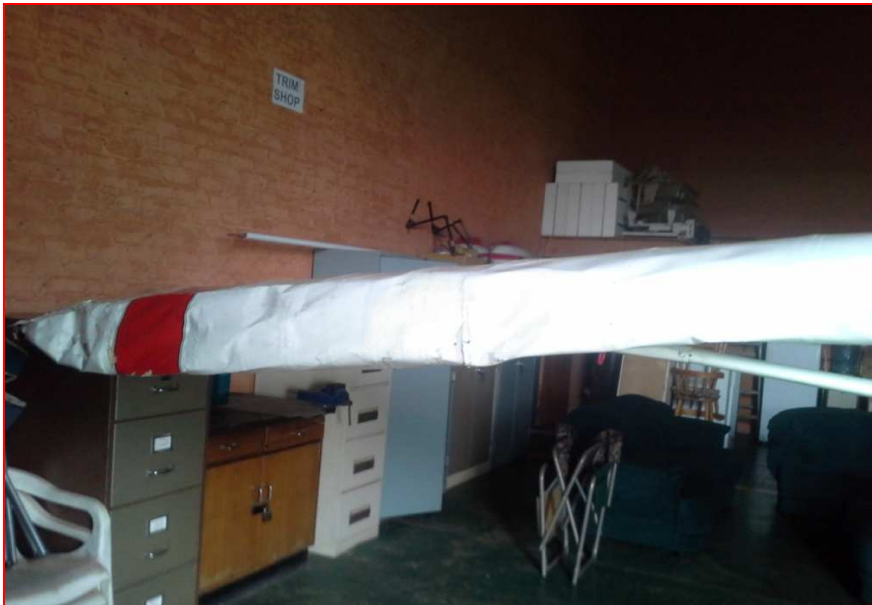
Figure 3: the right hand Wing

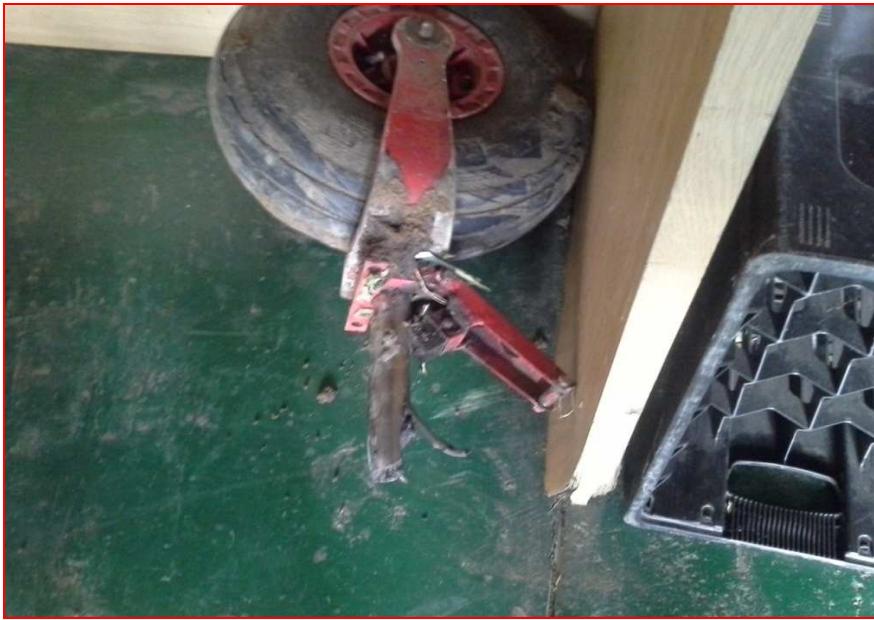
Figure 4: The nose landing gear
