AIRCRAFT ACCIDENT REPORT AND EXECUTIVE SUMMARY

Reference:	CA18/2/3/9137	
Aircraft Registration	ZU-CRV	Date of Accident	02 February 2013		Time of Accident	1645Z
Type of Aircraft	Jabiru SPT Aeroplane		Type of Operation	Private		
Pilot-in-command Licence Type		Private Pilot	Age	49	Licence Valid	Yes
Pilot-in-command Flying Experience		Total Flying Hours	2297.0		Hours on Type	+/-385hrs
Last point of departure		FAWI (Witbank, Mpumalanga Province)				
Next point of intended landing		FAWI (Witbank, Mpumalanga Province)				
Location of the accident site with reference to easily defined geographical points (GPS readings if possible)						
GPS co-ordinates S25 52.45' E029 17.10' next to the N4 highway near Witbank						
Meteorological Information		Temperature: 21 °C Dewpoint:09 °C Visibility: >10km Cloud base: Sky Clear				
Number of people on board	1+0	No. of people injured	1	No. of people killed	0	
Synopsis						
<p>The pilot departed in his Jabiru aircraft from Witbank airfield (FAWI) on a scenic flight to Witbank Dam, located to the East of the town.</p> <p>The aircraft was seen performing manoeuvres over the dam before routing back to FAWI airfield in a Westerly direction. En-route, the

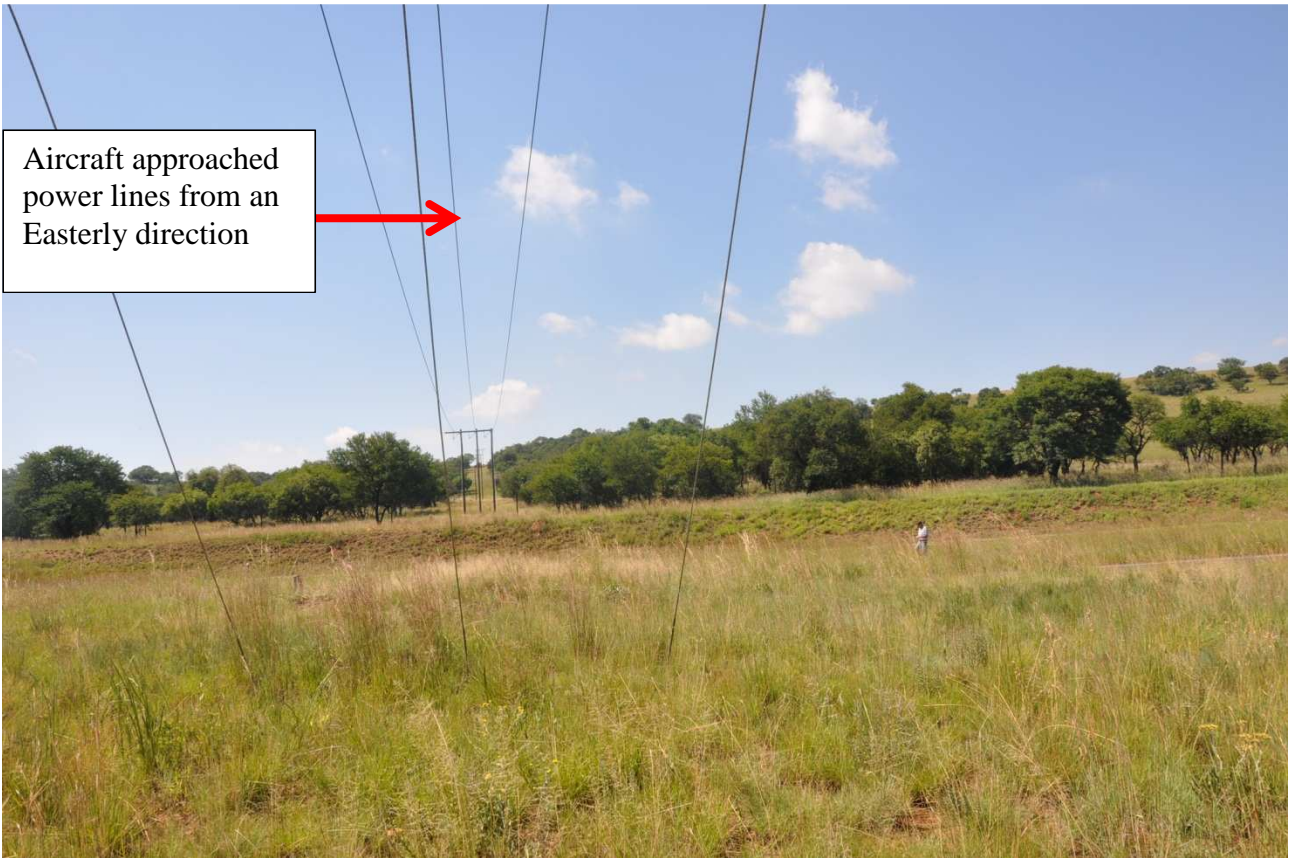
- 1.1.1 The pilot departed FAWI airfield on 2 February 2013 at approximately 1600Z on a local scenic flight to Witbank Dam. Eyewitnesses reported seeing the aircraft performing several manoeuvres over the dam before returning to FAWI airfield in a Westerly direction.
- 1.1.2 The aircraft struck Eskom power lines next to the N4 highway approximately 12km from Witbank airfield. This caused the aircraft's right wing to separate from the fuselage and the pilot to lose control of the aircraft. The aircraft impacted the ground (elevation 4931ft Above Mean Sea Level (AMSL)) at a high speed and came to rest 44 meters from the initial impact point in an inverted attitude.
- 1.1.3 The pilot sustained serious injuries and was transported to the local hospital. The aircraft was extensively damaged.

Figure 1: The power lines height above ground level are approximately 11 metres

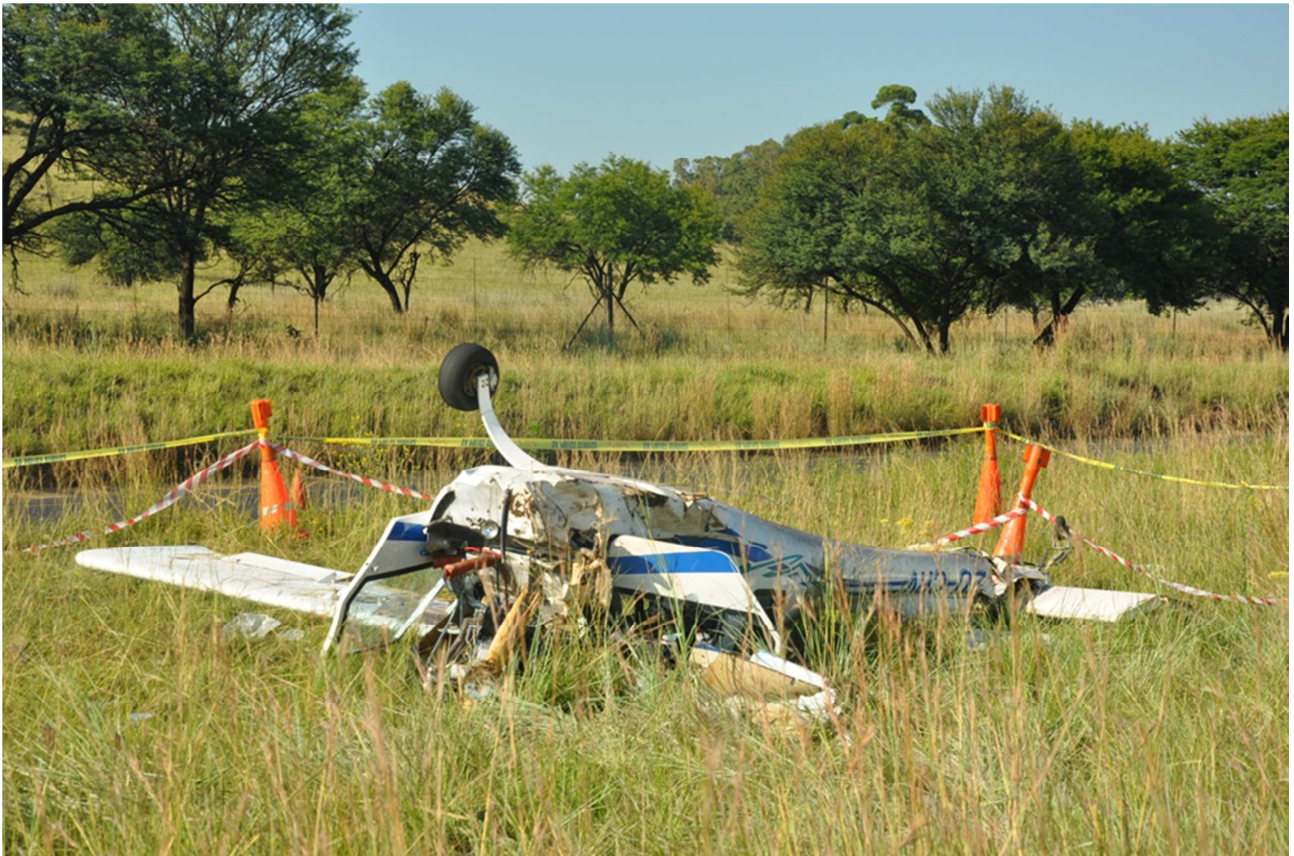
1.3.1 The aircraft sustained extensive damage.

Figure 3: Damage sustained to the fuselage, undercarriage, propeller, engine and wings.

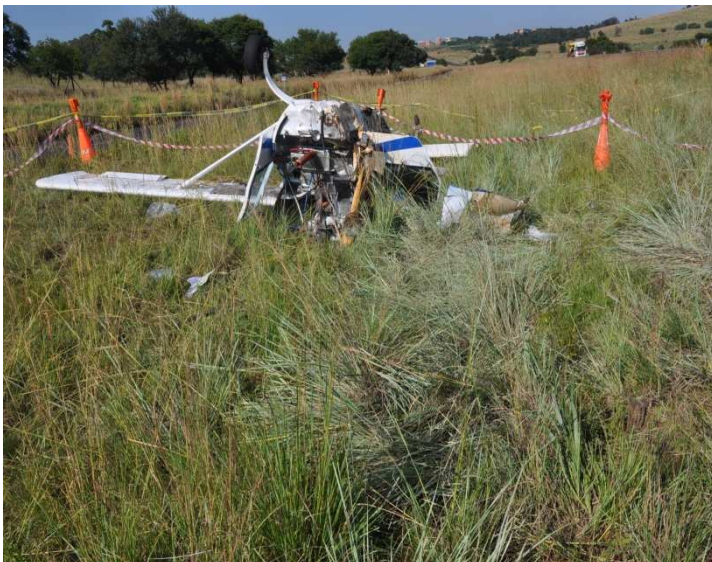
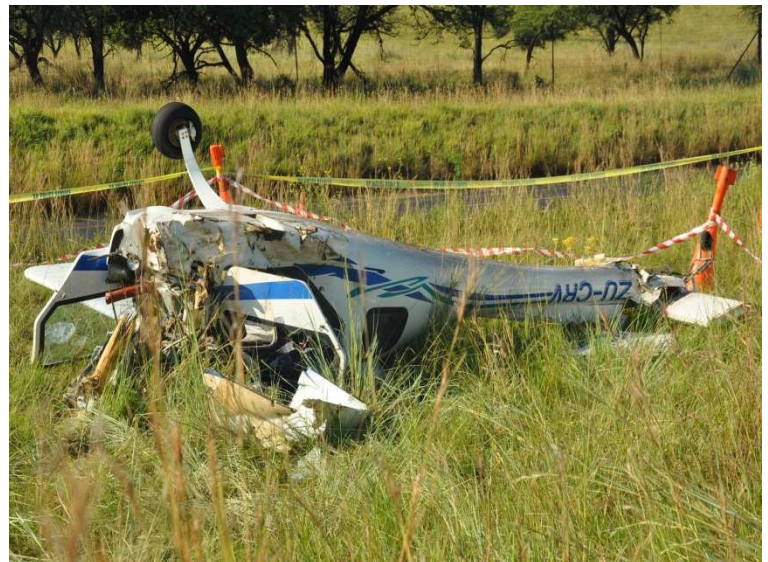
Figure 4 and 5: ZU-CRV's wreckage

1.12.1 The aircraft struck power lines before impacting the ground 15m from the power lines. The aircraft came to rest 44 metres from the initial impact point in an inverted position facing an Easterly direction.

1.12.4 The right wing and undercarriage separated from the aircraft during the accident sequence. The propeller and tail plane of the aircraft was damaged.

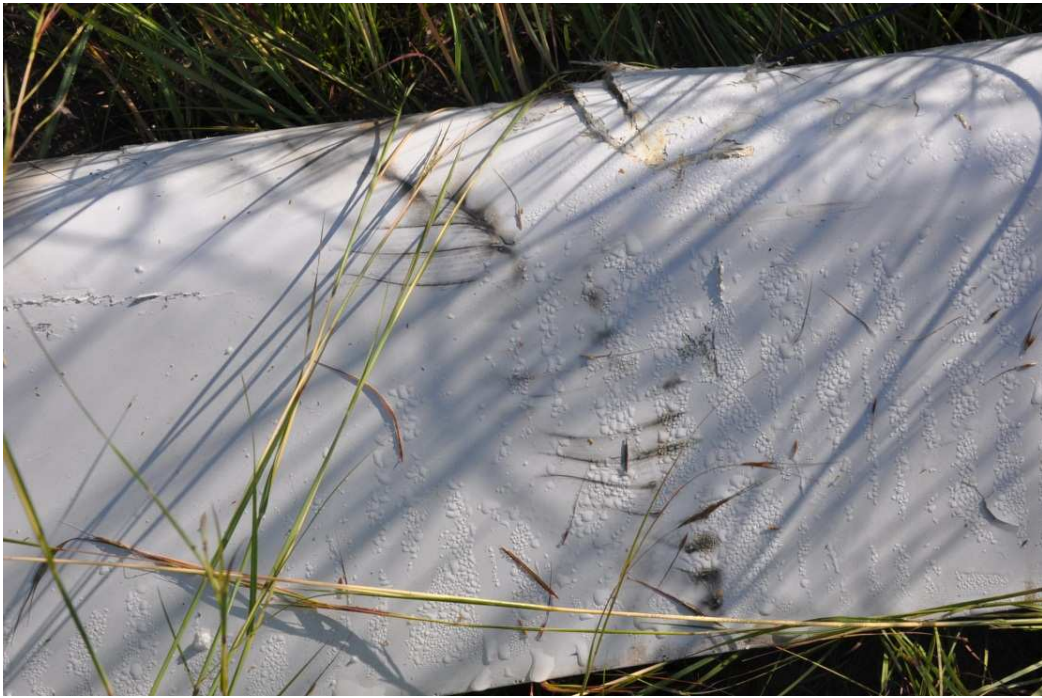
1.12.3 Arcing closer to the trailing edge on the right hand wing of the aircraft indicated the aircraft was banked to the right prior to impacting the power lines.

Figure 6: Evidence of arcing close to the trailing edge of the aircraft's right hand wing

Arcing closer to the trailing edge on the right wing indicated that the aircraft was in a turn to the right when it collided with the power lines.

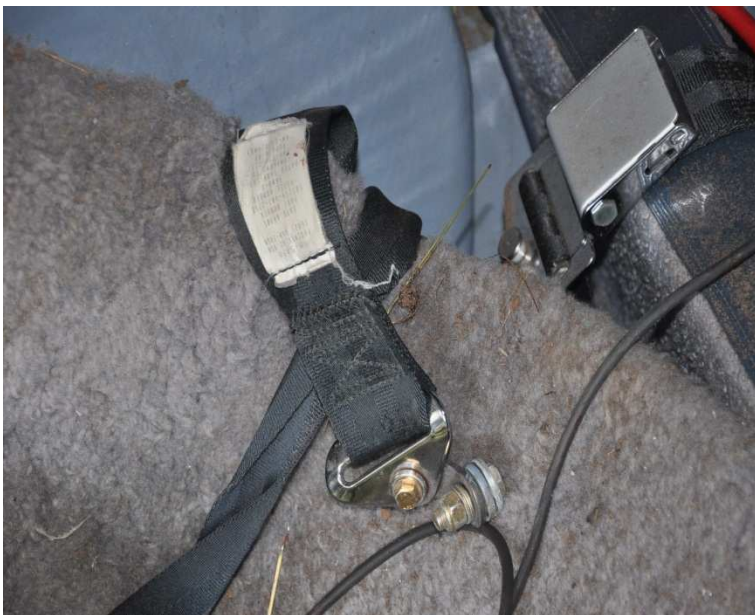
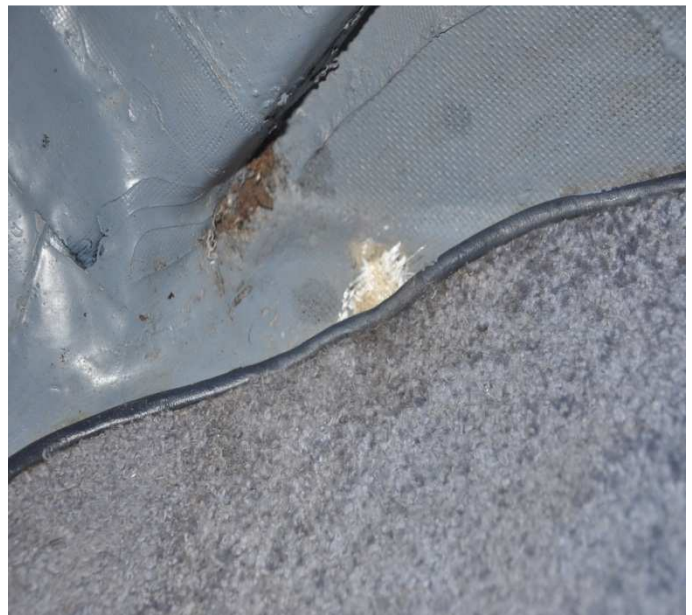
1.15.1 The aircraft impacted the ground at a high impact speed before coming to rest. Information obtained from the paramedic indicated the pilot did not use the aircraft's shoulder harness at the time of the accident. This caused his seat belt to become dislodged from the aircraft during the impact sequence. This resulted in the pilot sustaining severe head injuries when he impacted the instrument panel. The accident was considered survivable however associated with severe trauma.

Figure 7 & 8: The pilot's seat belt that became dislodged from the aircraft on impact

The severe head injuries sustained by the pilot might have been prevented had he worn the shoulder harness in the aircraft.

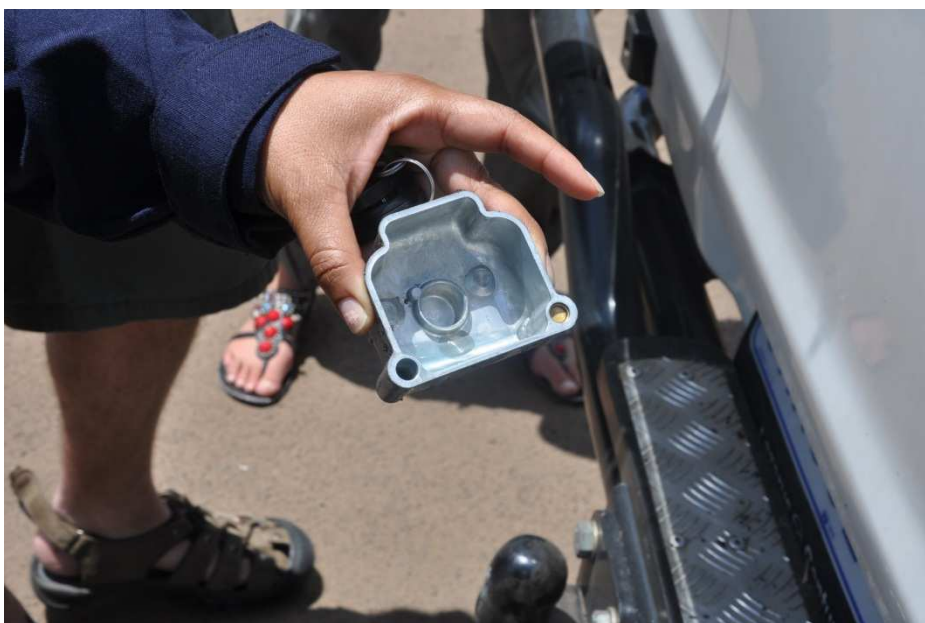
Figure 9: Carburettor at accident site did not contain any oil.

1.16.4 After cleaning the bowl a second start was performed and the engine started. The engine was warmed and ran smoothly at various power settings.
