<b>AIRCRAFT ACCIDENT REPORT AND EXECUTIVE SUMMARY</b>
---

Reference:	CA18/2/9144	
<b>Aircraft Registration</b>	ZS-OLR	<b>Date of Accident</b>	12 February 2013		<b>Time of Accident</b>	1050Z
<b>Type of Aircraft</b>	Extra EA-300/L		<b>Type of Operation</b>	Private		
<b>Pilot-in-command Licence Type</b>		Commercial Pilot	<b>Age</b>	62	<b>Licence Valid</b>	Yes
<b>Pilot-in-command Flying Experience</b>		Total Flying Hours	3203.29		Hours on Type	34.34
<b>Last point of departure</b>		FACT - Cape Town International Airport, General Aviation Area				
<b>Next point of intended landing</b>		FAKF-- Fistantekraal Airfield near Stellenbosch				
<b>Location of the accident site with reference to easily defined geographical points (GPS readings if possible),</b>						
In a field with small open areas and several trees, next to the Klipheuwel Rd, R304. (GPS Co-ordinates: S 33°47'46.11" E 18°45'16.86)						
<b>Meteorological Information</b>		Wind: Westerly/4 kts Visibility: CAVOK Temperature: 29°C

**Name of Owner/Operator** :Rusty Starfish Aerobatix CC  
**Manufacturer** :Extra Flugzeugbau GMBH  
**Model** :Extra EA-300/L  
**Nationality** :South African  
**Registration Marks** :ZS-OLR  
**Place*

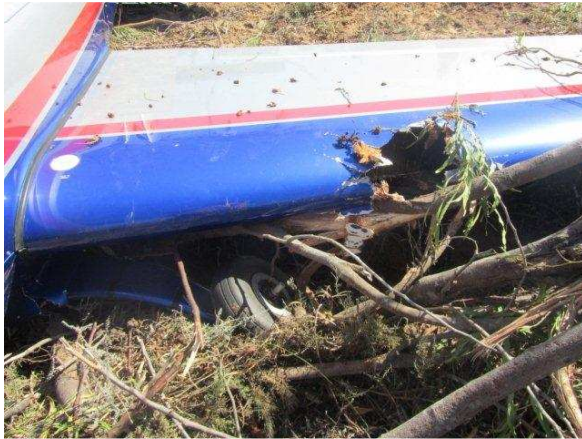
- 1.3.1 The wings sustained substantial damage when the aircraft collided with the trees.
- 1.3.2 The propeller and engine mount were also damaged.

1.3.3 The undercarriage also sustained substantial damage.

Fig 1: Damage to wing and undercarriage

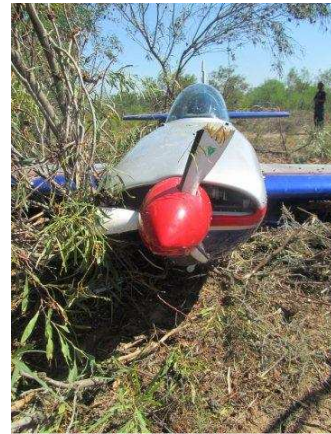
Fig 2: Damage to the propeller

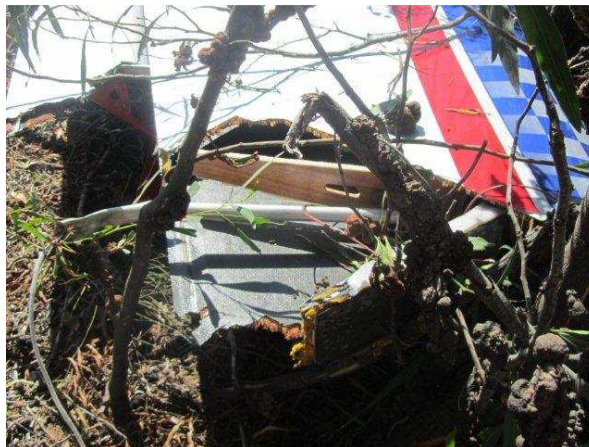
Fig 3: Damage to the wing

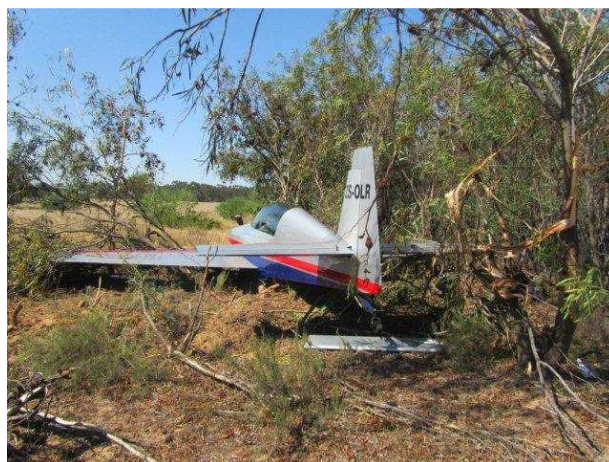
1.4.1 Several trees were damaged when the aircraft collided with them.

Fig 4: Damaged trees

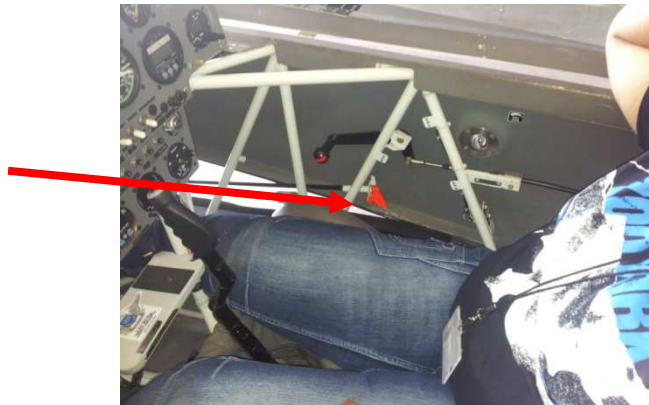
1.16.1 Although the fuel selector system was inspected and found to be serviceable after the accident, additional investigation went into the location and use of the fuel selector. It was found that the selector is not situated in the most accessible area.

Fig. 5 Location of the fuel selector from the pilot seat

1.16.4 The fuel selector is situated on the right hand side of the aircraft. The pilot uses his right hand to steer and left to control the throttles. Should the need arise to switch fuel tanks, the pilot is then required to steer with his left hand and not right.

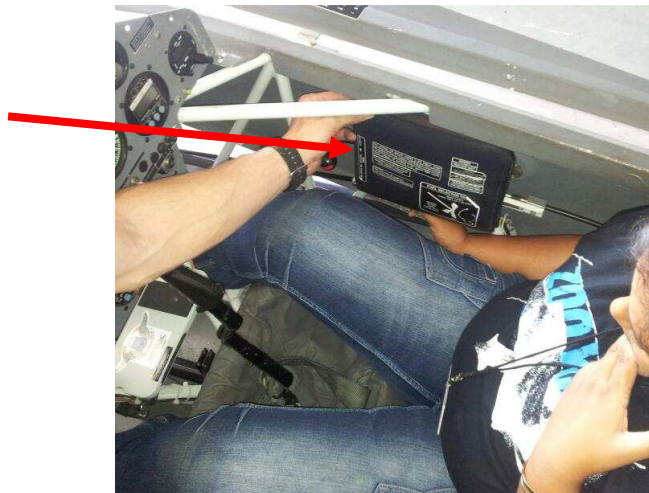
1.16.2 It is also obstructed by a document holder.

Fig. 6 Document folder in place

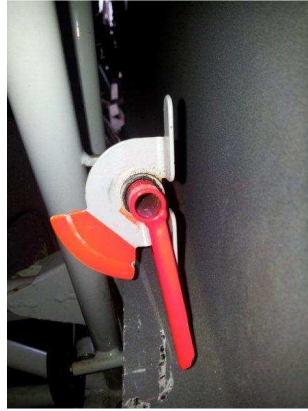
2.2 The pilot completed 3 successful touch and goes at Fisantekraal airfield before continuing on to Stellenbosch Airfield. On departure from the 3rd touch and go, the pilot commenced a left climbing turn towards Stellenbosch. During the climb at about 800 feet, the pilot moved the fuel selector through 180° to rectify his mistake and turned on the electrical boost pump. The pilot realised that he had actually moved the selector to the OFF position. He attempted to unlock the selector several times, but without success.

Fig. 7 Fuel selector in the OFF position

- 2.6.1 Upon further investigation, it was found that the fuel selector is not in a very accessible location. It is also extremely difficult to turn the selector out of the OFF position as the spring load is extremely tight.
