AIRCRAFT ACCIDENT REPORT AND EXECUTIVE SUMMARY

Reference:	CA18/2/3/9151	
Aircraft Registration	ZS-UHI	Date of Accident	5 March 2013		Time of Accident	1500Z
Type of Aircraft	Taylor monoplane (aeroplane)		Type of Operation	Private		
Pilot-in-command Licence Type		Airline Transport Pilot	Age	32	Licence Valid	Yes
Pilot-in-command Flying Experience		Total Flying Hours	4 794,7		Hours on Type	1,2
Last point of departure		Wonderboom aerodrome (FAWB), Gauteng				
Next point of intended landing		Panorama aerodrome, Gauteng				
Location of the accident site with reference to easily defined geographical points (GPS readings if possible)						
At Panorama cemetery at GPS coordinates S26°20,320' E028°04,110' at an elevation of 4 965 feet above mean sea level (AMSL).						
Meteorological Information		Wind direction: 320°; Wind speed: 6 knots; Clouds: Clear skies; Visibility: 10 kilometres; Temperature: 22 °C; Dew point 12 °C.				
Number of people on board	1 + 0	No. of people injured	1	No. of people killed	0

Name of Owner/Operator : B R Wardle
Manufacturer : D L Hocking
Model : Taylor Monoplane
Nationality : South Africa
Registration Marks : ZS-UHI
Place : At the local cemetery near Panorama aer

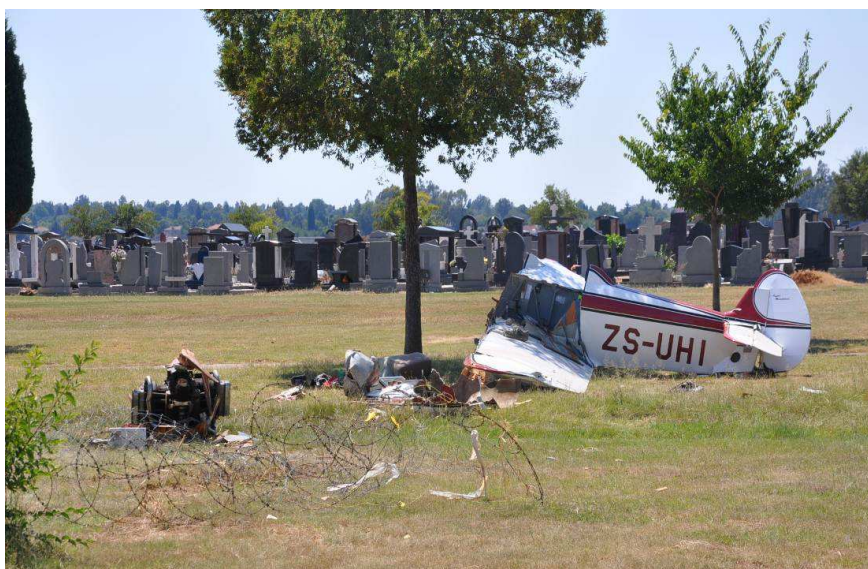
- 1.3.1 The aircraft was destroyed during the accident sequence.

Figure 1: View of the aircraft as found at the accident site

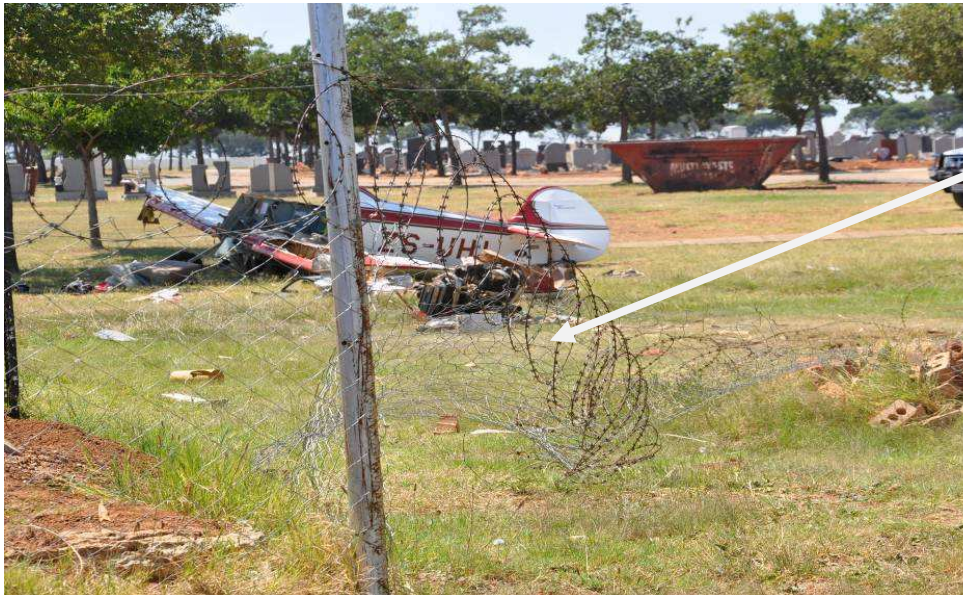
1.4.1 Damage was limited to the barbed wire fence enclosing the cemetery.

Damaged barbed wire fence enclosing the cemetery.

Figure 2: Damaged barbed wire fence

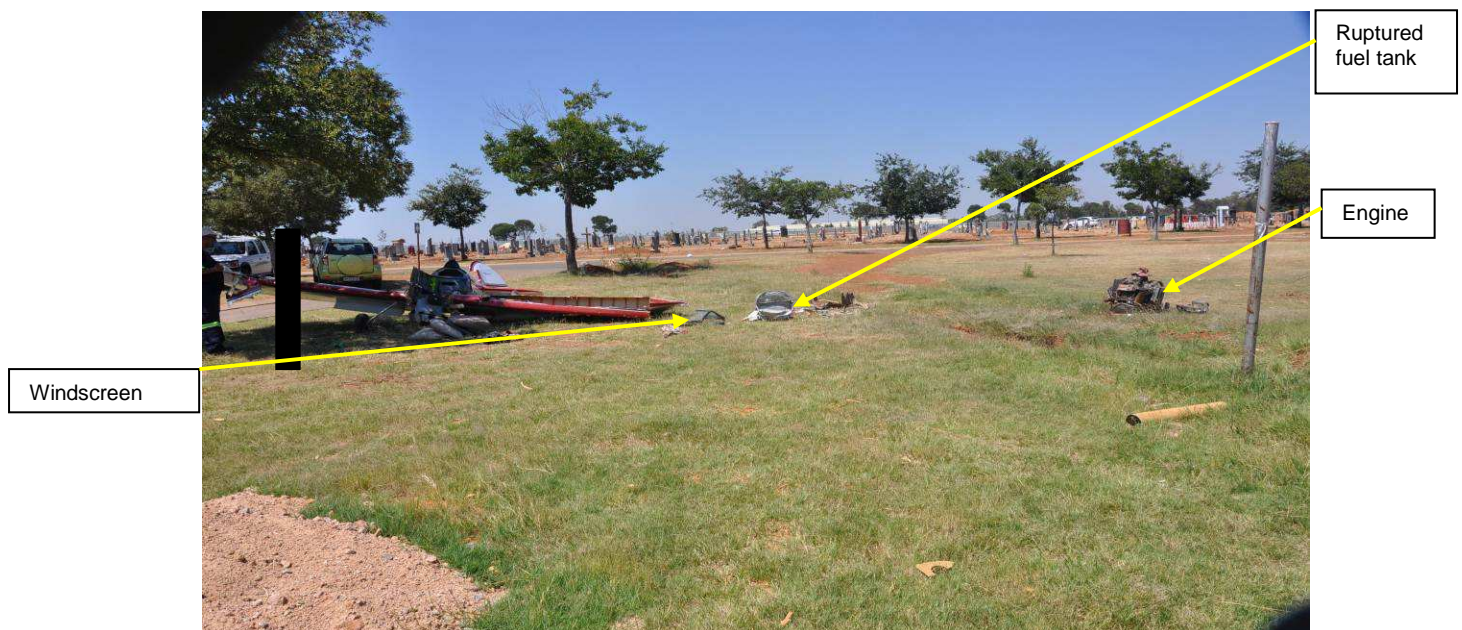
1.12.1 The aircraft collided with a barbed wire fence enclosing the cemetery and subsequently struck the ground in a nose-down attitude before coming to a halt.

- The aircraft wings and the landing gear were extensively damaged.
- Flight control surfaces were accounted for and flight control cable continuity and pre-impact control integrity could be established at the accident site.
- There was no evidence of any flight control problem or jamming. The cabin area was substantially damaged.
- The instrument panel was found three metres west of the main wreckage.
- The engine broke away during the impact sequence and came to rest seven metres west of the main wreckage.
- The fuel tank ruptured during the impact sequence, and there was a strong smell of aviation fuel at the accident site. The tank was found three metres west of the main wreckage. See Figure 4.

Figure 4: View of the wreckage distribution

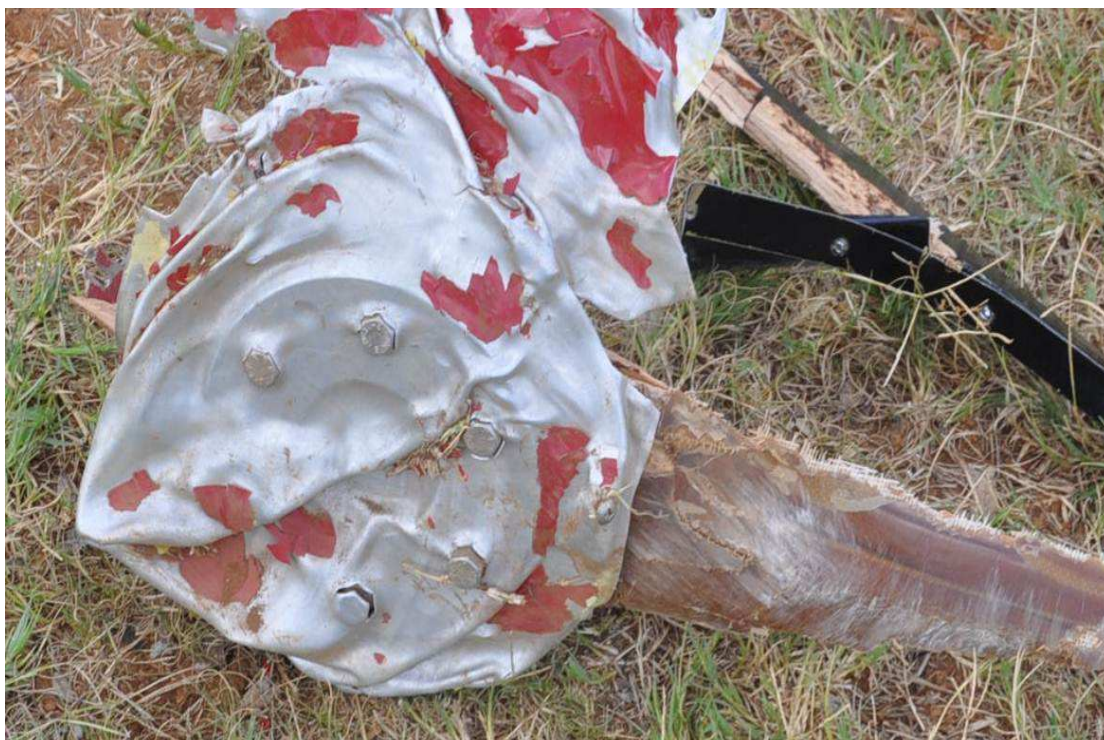
Examination of the propeller did not reveal any pre-impact mechanical anomalies. In addition, the propeller exhibited chord-wise scratching marks and torsional damage indicative of the engine producing power at impact. See Figure 5.

Figure 5: View of the propeller and witness marks on it

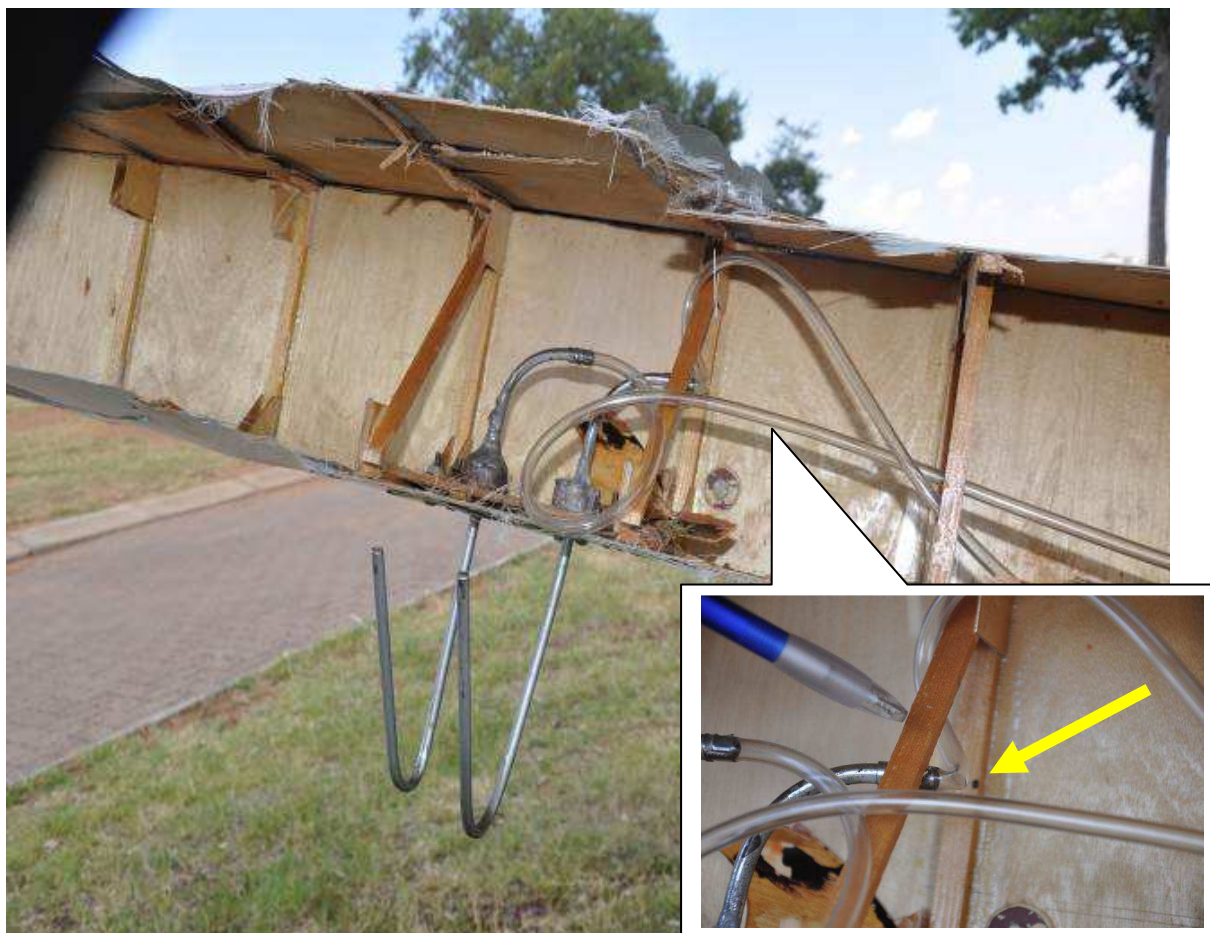
- 1.16.2 Investigation of the pitot tubes revealed no anomalies. They were well secured to the airframe and were free from foreign object dirt (FOD). The aircraft's flexible static hose, which connects the static tube to the airspeed indicator, was found to have been kinked, thus trapping the static pressure within the system and contributing to the faulty airspeed indicator reading.

Figure 6: View of the incorrectly installed static line

- 2.4 Investigation of the static line showed poor routing of the flexible hoses with a kink, and no clamps securing them, which can be attributed to poor maintenance practices.
- 2.5 Fine weather conditions prevailed in the area at the time of the flight and were therefore not considered to have any bearing on the accident.

- (i) Incorrect airspeed indicator reading misled the pilot.
- (ii) Incorrect installation of the static line.
