<b>AIRCRAFT ACCIDENT REPORT AND EXECUTIVE SUMMARY</b>
---

Reference:	<b>CA18/2/3/9165</b>	
<b>Aircraft Registration</b>	<b>ZS-OSS</b>	<b>Date of Accident</b>	16 April 2013		<b>Time of Accident</b>	1557Z
<b>Type of Aircraft</b>	DH-82 Tiger Moth		<b>Type of Operation</b>	Private		
<b>Pilot-in-command Licence Type</b>		CPL	<b>Age</b>	54	<b>Licence Valid</b>	YES
<b>Pilot-in-command Flying Experience</b>		Total Flying Hours	870.6		Hours on Type	252
<b>Last point of departure</b>		Mahikeng airport . (FAMM), Mahikeng, North West				
<b>Next point of intended landing</b>		Mahikeng airport . (FAMM), Mahikeng, North West				
<b>Location of the accident site with reference to easily defined geographical points (GPS readings if possible)</b>						
In the Modimola dam, under water. Located 3.4nm bearing 194° from FAMM airport (GPS S25° 51q55+ E025° 31q31+)						
<b>Meteorological Information</b>		Surface wind light and variable, Visibility >10km Temp. 28° Celsius dew point 04° Celsius. Few clouds at 4000 feet. No significant weather reported.

**Name of Owner/Operator** : Pearl Coral 1323 CC  
**Manufacturer** : De Havilland  
**Model** : DH 82  
**Nationality** : South African  
**Registratio

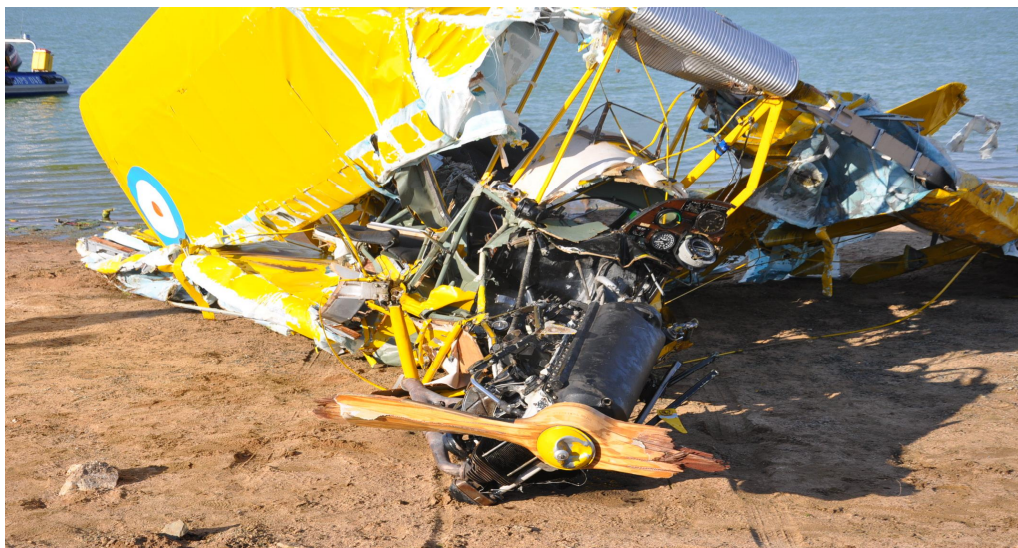
**Figure 2:** Aircraft wreckage recovered by SAPS divers

- 1.3.2 The propeller blades shattered as they contacted the water and the pieces that

broke from it were no longer attached.

- 2.7 There is evidence indicating that at the time of impact the engine had power. The propeller blade tips that broke off would have been still attached if the aircraft entered the water with blades wind milling. The aircraft had power and hence the tips that broke off could not be found due to the forces involved as the blades struck the water. The broken area had very sharp splinters indicating that the propeller broke into several pieces.

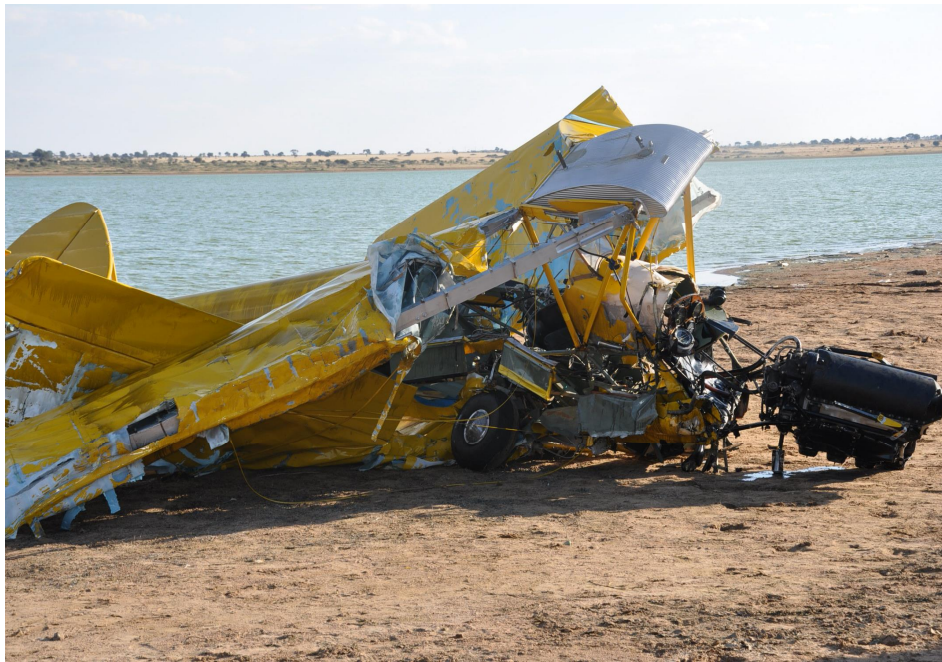
**Figure 3:** Wreckage salvaged from the water

- 2.6 The wreckage, when analysed, indicated that impact was at a high angle. Both bi-planes were bent backwards in a symmetrical fashion. The undercarriage was also broken, which indicated that there was no delay between the two wings hitting the water. If the angle was low or the point of first contact was the undercarriage the aircraft would have overturned and the wings would have sustained minimal damage.

- 3.1.3 There was no evidence of airframe failure or system malfunction prior to the accident. The damage to all control surfaces and joining high tension cables was attributed to the severe impact forces.
