Islamic Republic of IRAN
Civil Aviation Organization

Incident Final Report

State File Number: I139201299MXAC
Type of Occurrence: Incident (RWY Excursion)
Date of Occurrence: April 18th 2013
Place of Occurrence: I.R.IRAN
Aircraft Type: A340-300
Registration: 9M-XAC
Operator: Air Asia

State File Number: I139201299MXAC
Type of occurrence: Incident (Runway Excursion)
Date of occurrence: April 18th 2013
Place of occurrence: on RWY 30L, Tabriz INTL Airport (OITT) Islamic republic of Iran
Aircraft Model: A340-300
Registration: 9M-XAC
Operator: Air Asia
Lessor: Saudi Arabian Airlines

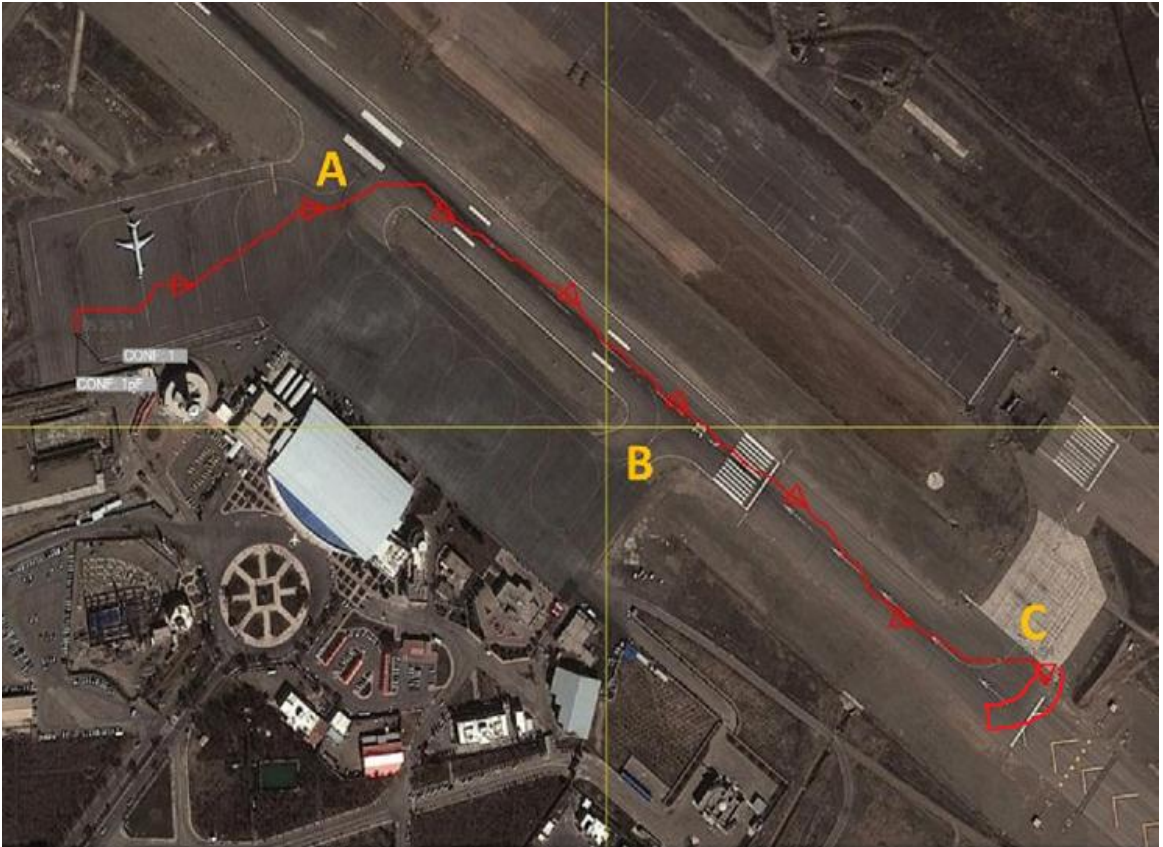
- e) DFDR approximate position plotting confirms accurate information from both pilots.

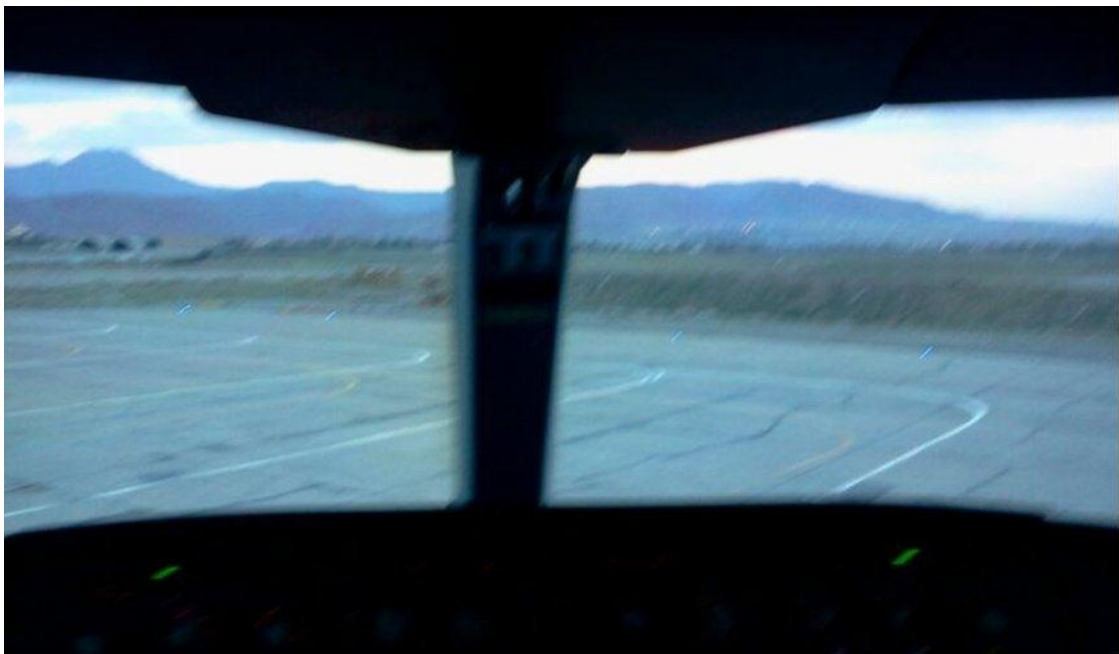
f) Captain did not make much use of the additional space of taxiway “C”.

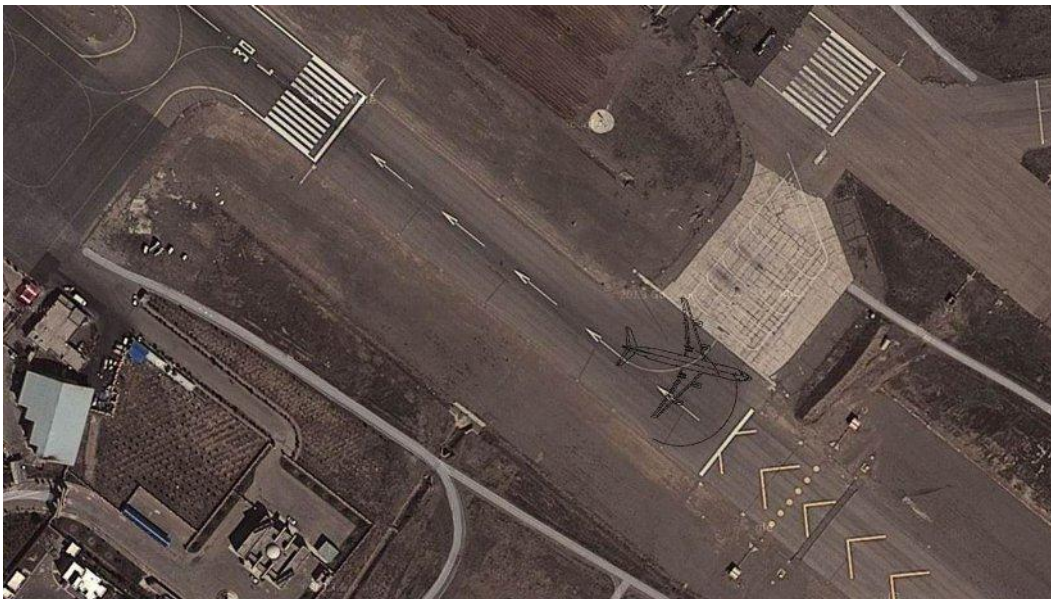
g) 180° turn maneuver on a 45 meters runway width - absolute minimum without margin with maximum NWS angle of 72°(FCOM PRO-NOR-SOP-10 P 9/14)

“A standard runway is 45 m wide. With the maximum nose wheel steering angle 45 m for (72 °), the actual turn width (without margin) is 41 m for an A340–200 and an A340-300”

- h) Aircraft skidded during clockwise turn on wet surface. DFDR shows that captain performed 180^o turn as using Differential Braking against SOP which is not recommended. Ground speed recorded was in the range of 3 knots with asymmetric thrust used. Thus the wet runway surface was the main contributing factor for the skidding.

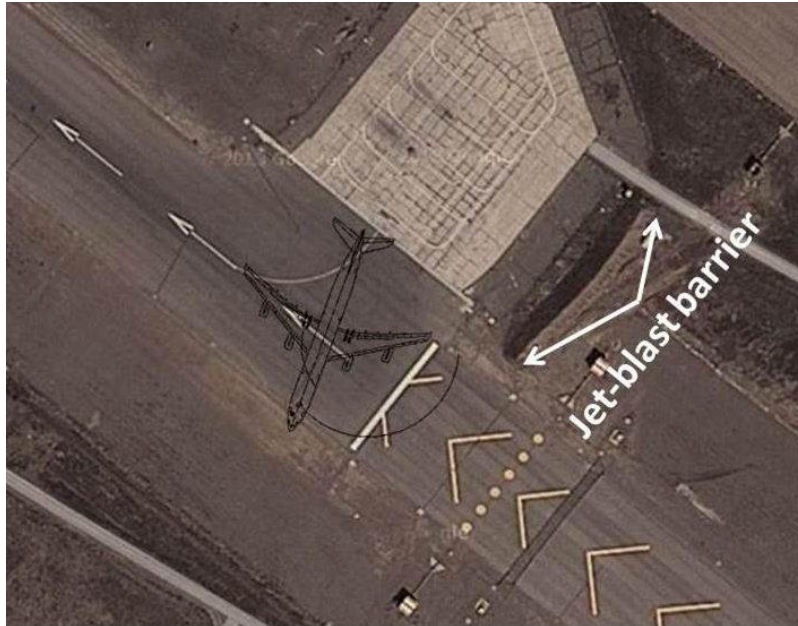
- i) Captain requested Marshaller aid to move Nose wheel of A/C to RWY margin to have enough width for the anti-clockwise turn
- j) During the anti-clockwise turn, the captain came to realize that the outer left engine (number 4) might not have sufficient clearance over the “Jet-blast barrier” at the south-east corner of the runway end.

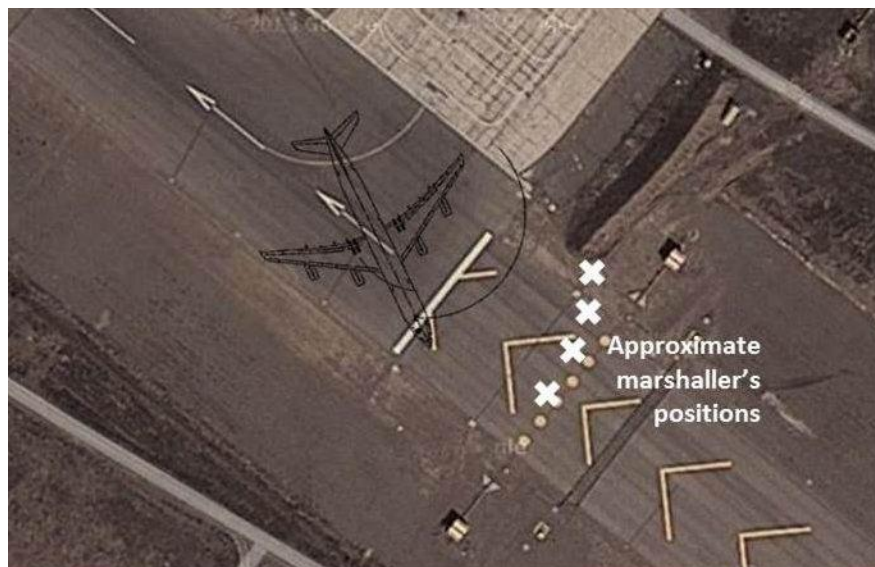
- k) Aircraft entered into “Pre-Threshold” Area (Chevron Marking).
- l) DFDR data divulges that the aircraft was skidding during the anti-clockwise turn. Substantial Left brake pedal input with high engine power settings (up to 55% N1) recorded at the speed of less than 3 knots.
- m) The captain had to make a slow turn to allow the Marshaller to “run along” so that they could keep visual contact with each other.
