| AIRCRAFT ACCIDENT REPORT AND EXECUTIVE SUMMARY |

| | | | | Reference: | CA18/2/3/9170 | |
| Aircraft Registration | ZS-KLL | Date of Accident | 11 May 2013 | | Time of Accident | 1300Z |
| Type of Aircraft | Beech 58 | | Type of Operation | Private flight | | |

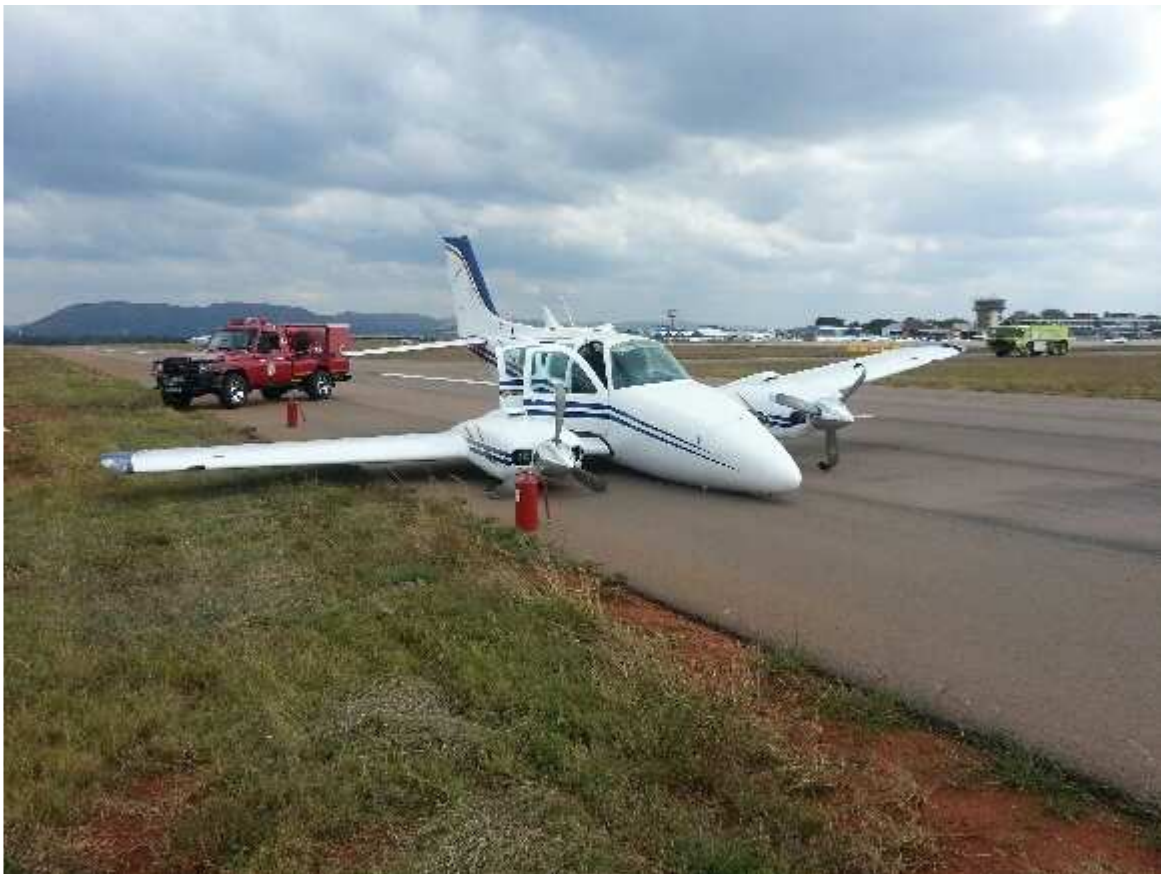
1.3.1 The aircraft sustained damage to the propeller, nose cone and the undercarriage.

Figure 1: Wreckage of the aircraft.

- Nose wheel not extended
- Both propellers bent
- Nose cone chafed at the base
- Main landing gear only extended approximately $\frac{1}{4}$ of the way and not locked minor chafing on the right-hand wingtip light lens
- Left-hand and right-hand inboard main landing gear doors severely chafed on the

- bottom edges due to their still being extended during landing
- Skid marks from the main landing gear tyres along the runway, but no nose tyre marks

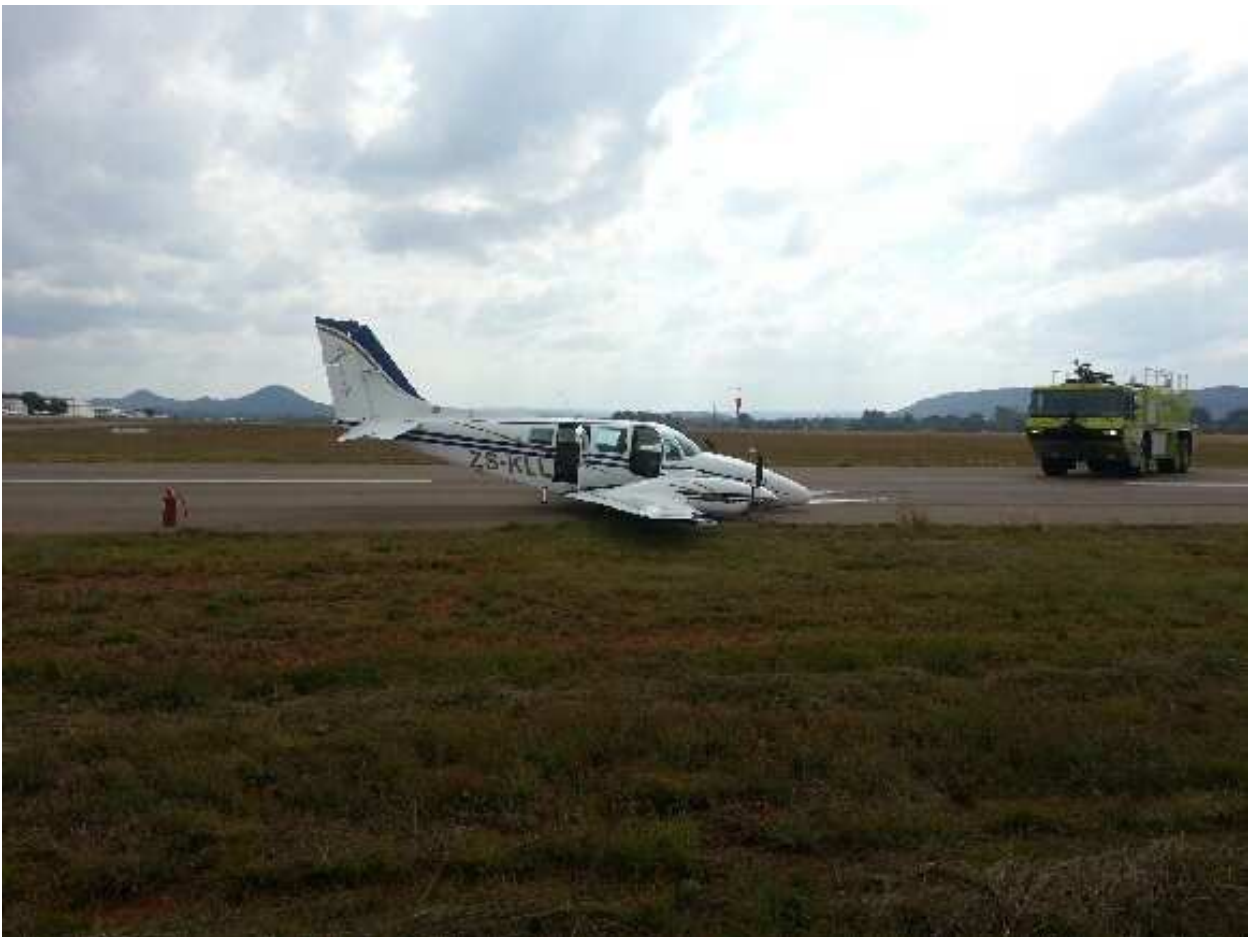
1.12.1 The aircraft touched down with the main undercarriage as normal. The propeller struck the ground and the gear doors jammed preventing the nose wheel from extending before the aircraft came to a halt.

Figure 2 View of the aircraft from the site

Inspection of the nose gear area after lifting the nose revealed that the doors were in the closed position and that the face sides of the gear doors were chafed, not the edges. The chafing was so extensive the right-hand nose gear drag brace attachment bracket was chafed through approximately a third of the way.

To extend the nose gear the doors had to be pried open with considerable effort. Once the doors were open, the nose gear assembly dropped easily to the down position. The nose gear extension bellcrank on the landing gear actuator was found to be bent and cracked, and the aft nose gear extension rod was broken at the rod end. The chafing on the drag brace, the attachment bracket and the attachment bolt lined up with the drag in the up position. No further damage was found at that stage.

- The chafing marks on the nose landing gear doors as well as the drag brace and attachment bracket indicate that the nose gear doors were closed during landing. If the doors had been open, they would have been chafed on the edges. The nose gear is only held up by tension on the nose gear retract mechanism. No physical uplock hooks assist in holding the gear up. With the aft retract rod broken, the nose gear should have extended but not locked by gravity. This shows that the nose gear doors jammed, preventing the nose gear from extending.

- 3.2.1 The nose gear doors jammed, preventing the nose gear from extending.
