<b>AIRCRAFT ACCIDENT REPORT AND EXECUTIVE SUMMARY</b>
---

Reference:	CA18/2/3/9174	
<b>Aircraft Registration</b>	<b>ZS-CBW</b>	<b>Date of Accident</b>	24 May 2013		<b>Time of Accident</b>	1100Z
<b>Type of Aircraft</b>	Mooney M20E (Aeroplane)		<b>Type of Operation</b>	Private Flight		
<b>Pilot-in-command Licence Type</b>		Private Pilot	<b>Age</b>	41	<b>Licence Valid</b>	Yes
<b>Pilot-in-command Flying Experience</b>		Total Flying Hours	102.8		Hours on Type	74.1
<b>Last point of departure</b>		Springs aerodrome ( FASI): Gauteng Province				
<b>Next point of intended landing</b>		Heidelberg aerodrome (FAHG): Gauteng Province				
<b>Location of the accident site with reference to easily defined geographical points (GPS readings if possible)</b>						
300m from the threshold of Runway 24 at FAHG (GPS position: 26°30' 05" South 28°23' 41" East)						
<b>Meteorological Information</b>		Temperature:23°C , Dew point:1°C , Surface wind:120°01kts,Gusting 12kts

<b>AIRCRAFT ACCIDENT REPORT</b>
---------------------------------

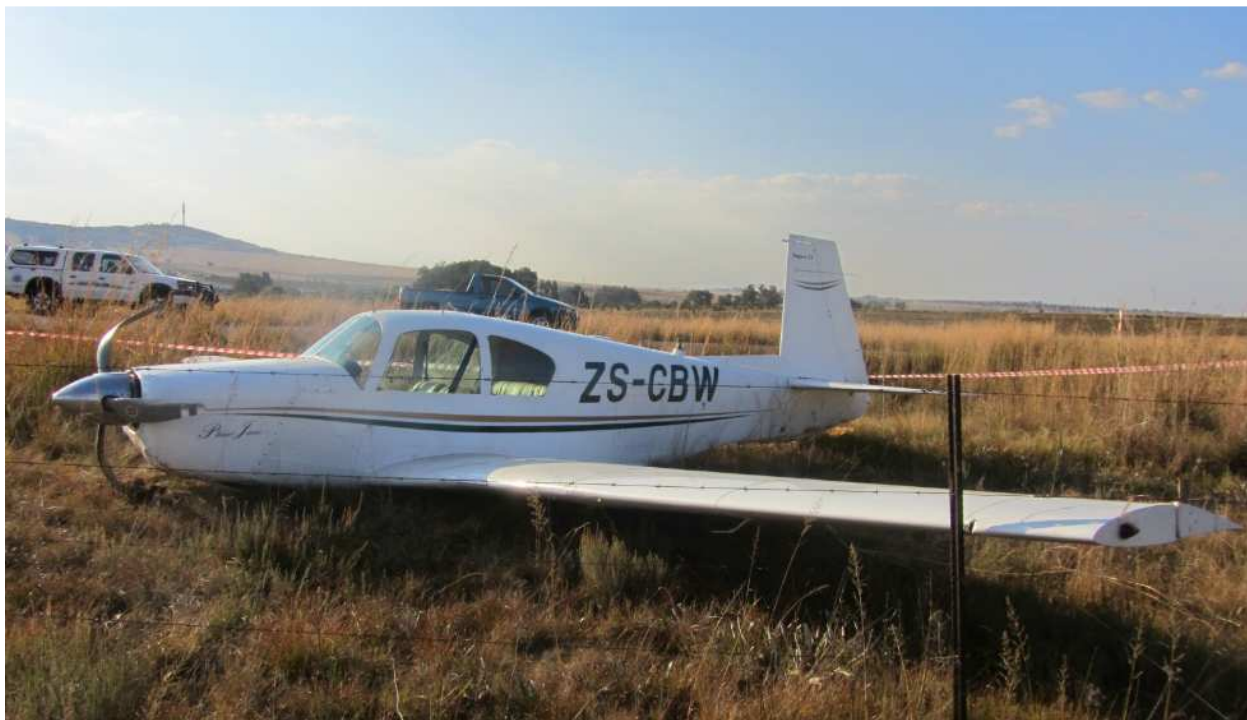
**Figure 2:** A view of the aircraft as it came to rest

1.12.1 The aircraft impacted an embankment which resulted in the right hand undercarriage separating from the aircraft. The aircraft continued to travel for 22m across a public road before coming to rest 300m from the threshold of Runway 24 on a magnetic heading of 315°.

1.12.3 The aircraft sustained substantial damage to the fuselage, propeller, undercarriage and wings.

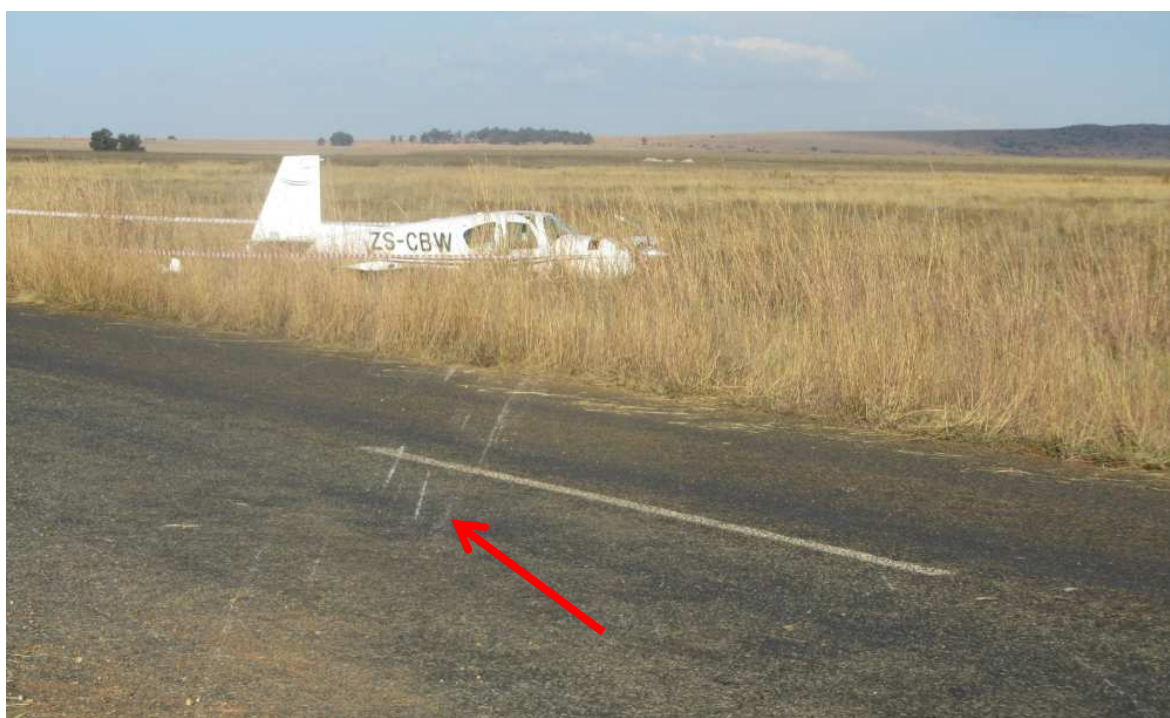
**Figure 3:** Indicates the skid marks across the road made by the aircraft prior to coming to rest.

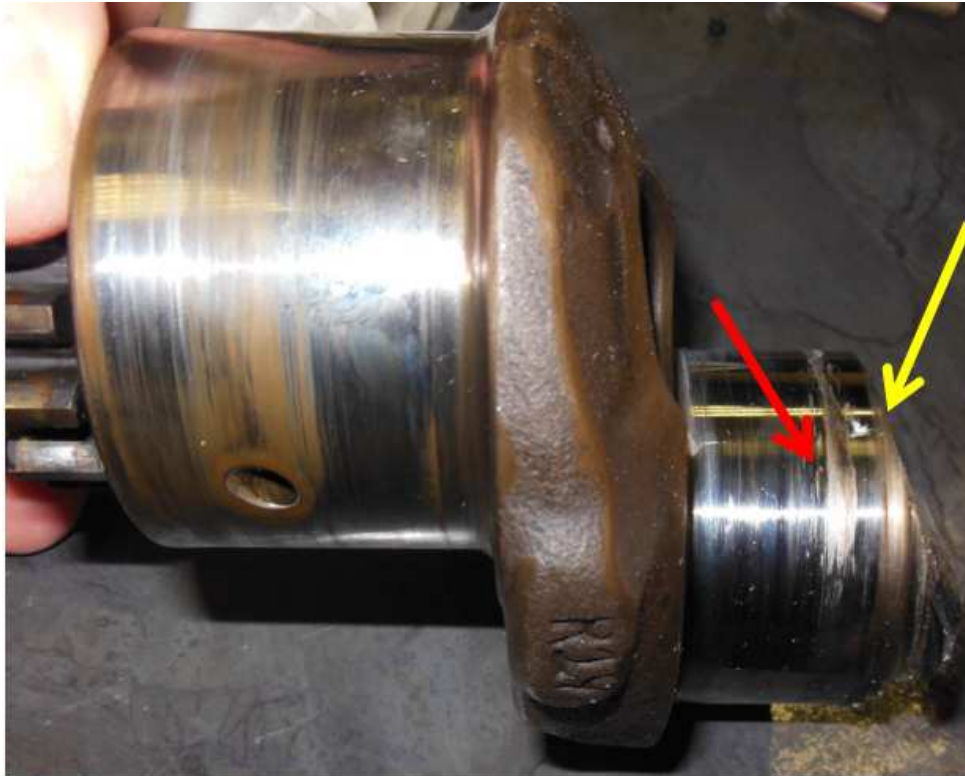
- *There was no visible damage to the exterior of the engine.*
- *Manual rotation of the crankshaft was not possible.*
- *The cylinders exhibited scoring however this was more prevalent on the number 4 cylinder and the piston pin was seized in the small end bush.*
- *The number 4 bearing journal of the crankshaft was fractured. The big end bearing was damaged by the fracture but showed no sign of lack of oil lubrication.*
- *There was no evidence of lack of lubrication oil anywhere in the engine.*

- A fracture corresponding with a fatigue mode failure under conditions of high frequency and low load.
- The position of the point initiation proved to be in the radius area of the number 4 connecting rod big end bearing journal.
- The fatigue failure progressed over an undetermined period of operational time.

**Figure 5:** Fracture and scoring damage of the number 4 connecting rod big end bearing journal.

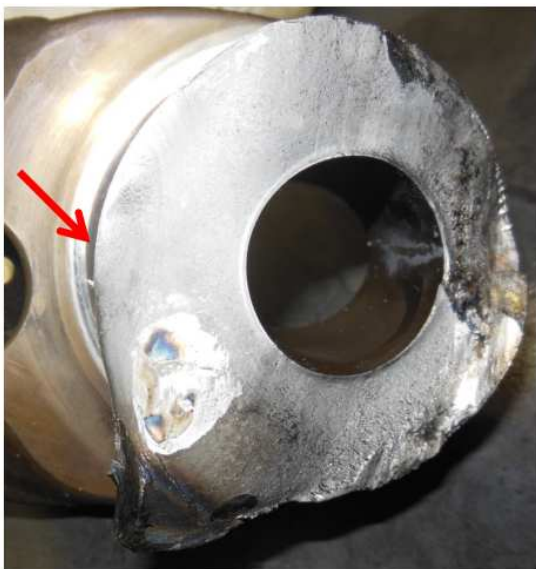
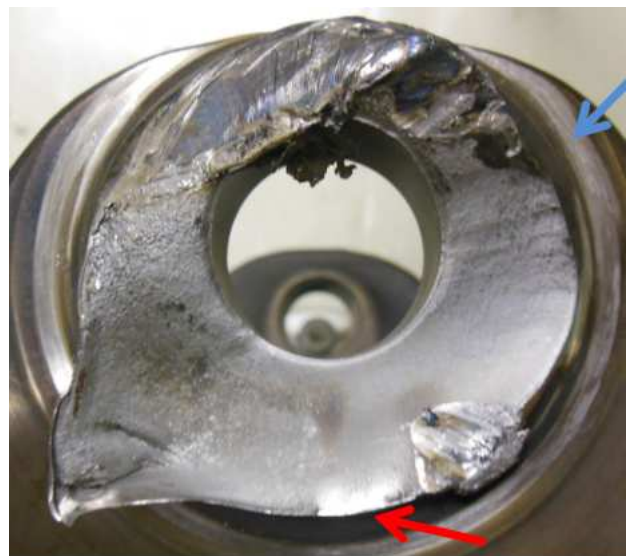
**Figure 6 & 7:** Fracture showing initiation point and scoring damage aft and forward

1.16.3.1 According to the metallurgical report the following could have contributed towards the fatigue failure:

- **Vibration:**
  - *Incorrect balancing of the propeller may induce sufficient strain to initiate a fatigue fracture under normal operating conditions.*

- **Bearing:**
  - *Incorrect seating and/or type of the relevant connecting rod big end bearing may have induced the noted scouring marks at the interface. The excessive wear may introduce higher temperatures at the relevant positions with subsequent lubrication breakdown that may in turn lead to fatigue inducing surface stress raiser in vicinity of the initiation point. Furthermore pre- or post- detonation or even over boost of the relevant piston could cause damage to the big end bearing resulting in 'nipping' the journal surface that may lead to the same type of failure*

- **Overhaul procedure:**
  - *Some indications of machining induced scoring were noted in close proximity of the initiation point that may act as detrimental surface stress raisers. It is not clear from this investigation if the marks were introduced post-failure and/or if any prior reworking of the relevant crankshaft completed.*

2.2.5 The metallurgist investigation of the crankshaft revealed a fracture corresponding with a fatigue mode failure. The exact cause of the failure could not be established however the Metallurgist report indicated that possible causes of the failure could be as a result of imbalance of the propeller, incorrect seating of the bearing or machine induced scoring during the overhaul procedure.
