AIRCRAFT ACCIDENT REPORT AND EXECUTIVE SUMMARY

Reference:	CA18/2/3/9177	
Aircraft Registration	ZU-DTD	Date of Accident	25 May 2013		Time of Accident	1100Z
Type of Aircraft	RAF 2000 GTX SE F1 Gyrocopter		Type of Operation	Private		
Pilot-in-command Licence Type		National Pilot License	Age	54	Licence Valid	Yes
Pilot-in-command Flying Experience		Total Flying Hours	176.7		Hours on Type	49.9
Last point of departure		Clanwilliam (Western Cape province)				
Next point of intended landing		Town of Loeriesfontein (Northern Cape province)				
Location of the accident site with reference to easily defined geographical points (GPS readings if possible)						
On the farm Papkuilsfontein at GPS position S 31°33'37.9" E 019°10'59.9"						
Meteorological Information		Wind: 220°08 kts Visibility:10000m Temperature:18°C Dew point:0°C Cloud cover: Nil: Cloud base: N/A				
Number of people on board	1	No. of people injured	0	No. of people killed	1	
Synopsis

AIRCRAFT ACCIDENT REPORT

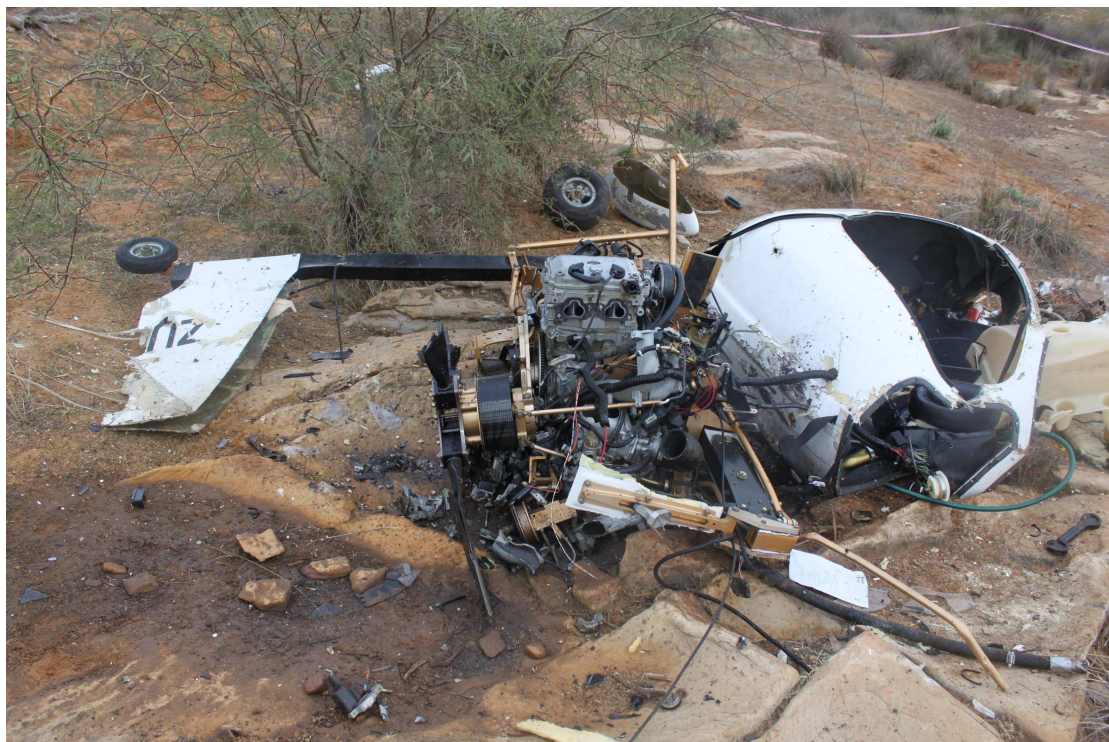
The gyrocopter was destroyed during the impact sequence of the accident.

Figure 1 The wreckage after the accident.

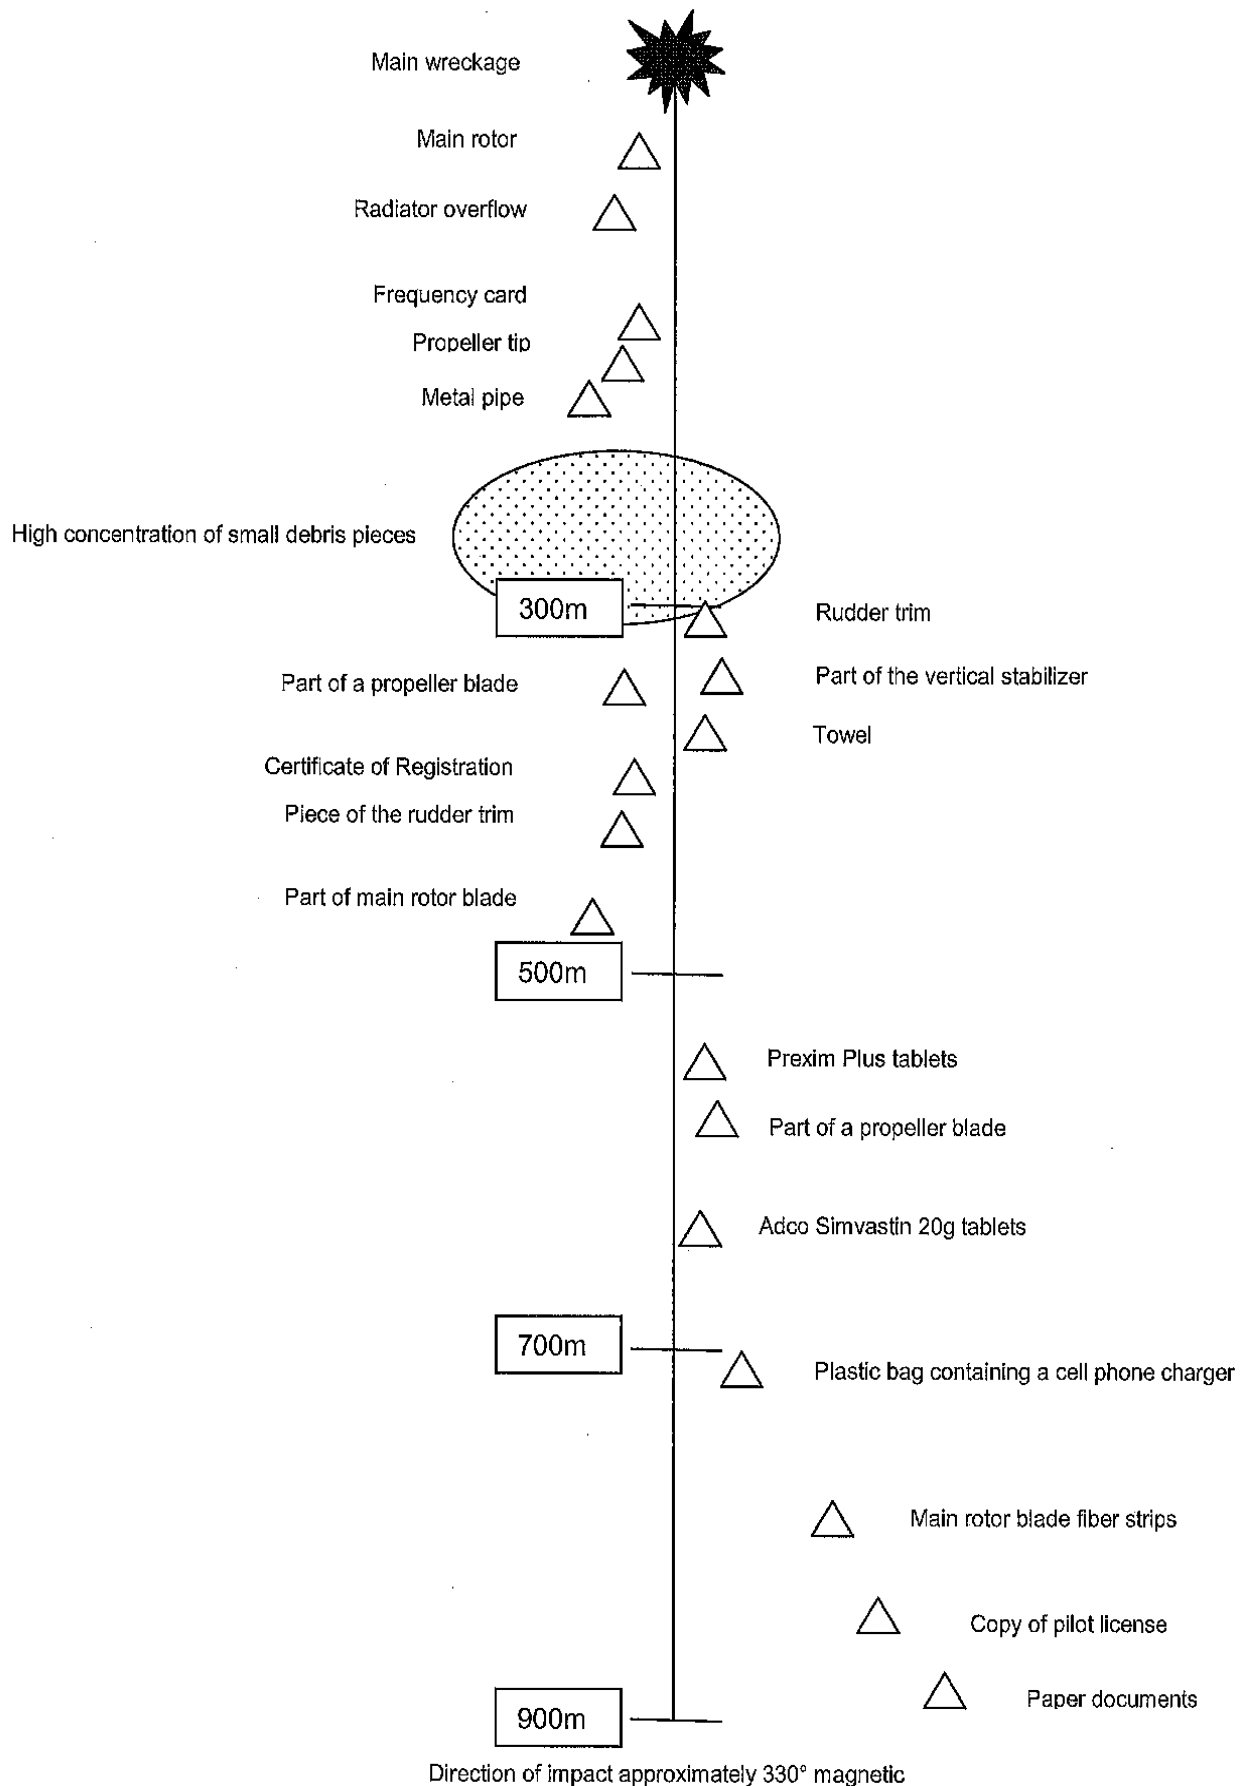
Figure 2 Wreckage diagram (Not to scale).

The gyrocopter was flying in a direction of approximately 330 degrees magnetic and collided with the ground in a direction of approximately 057 degrees magnetic at GPS position S31°33'37.9" E 019°10'59.9".

Evidence at the scene indicate the rotor blades made contact with the vertical stabilizer and rudder while in flight at a GPS position of S 31°33'46.2" E 019°11'05.6". The gyrocopter then continued to fly for another 300 meters before impacting the ground.
