AIRCRAFT ACCIDENT REPORT AND EXECUTIVE SUMMARY

Reference:	CA18/2/3/9182	
Aircraft Registration	V5-SMA	Date of Accident	04 June 2013		Time of Accident	1335Z
Type of Aircraft	Beechcraft King Air E90		Type of Operation	Training		
Pilot-in-command Licence Type	Airline Transport	Age	70	Licence Valid	Yes	
Pilot-in-command Flying Experience	Total Flying Hours	21107		Hours on Type	51	
Student pilot Licence Type	Commercial	Age	33	Licence Valid	Yes	
Student Pilot Flying Experience	Total Flying Hours	585		Hours on Type	6.1	
Last point of departure	Lanseria international airport (FALA): Gauteng province.					
Next point of intended landing	Rustenburg aerodrome (FARG):North West province.					
Location of the accident site with reference to easily defined geographical points (GPS readings if possible)						
On Runway 34 at Rustenburg aerodrome GPS coordinates determined to be S25°38' 40.67 E027°16'24.82 at an elevation of 3 671 feet above mean sea level (AMSL).

AIRCRAFT ACCIDENT REPORT

Name of Owner/Operator : Wings Over Africa CC
Manufacturer : Beech Aircraft Corporation
Model : Beechcraft King Air E90
Nationality : Namibian
Registration Marks : V5-SMA
Place : Rustenburg Aerodrome
Date : 04

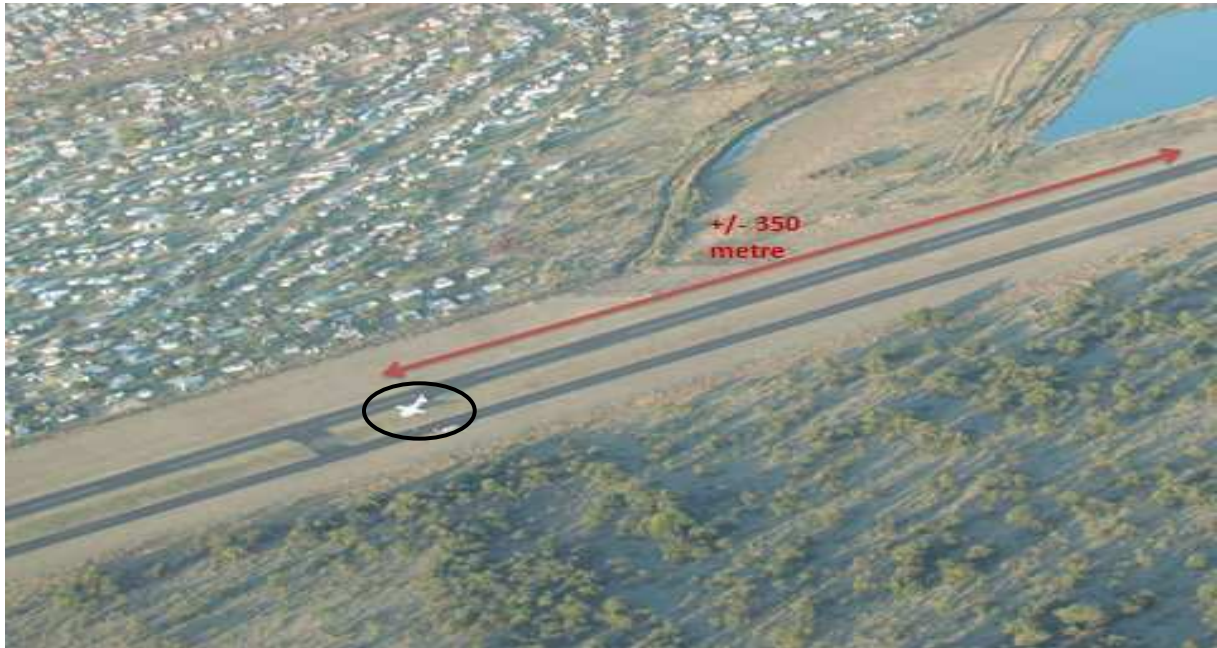
Figure 1, shows aerial view of FARG, Runway 34 and wreckage.

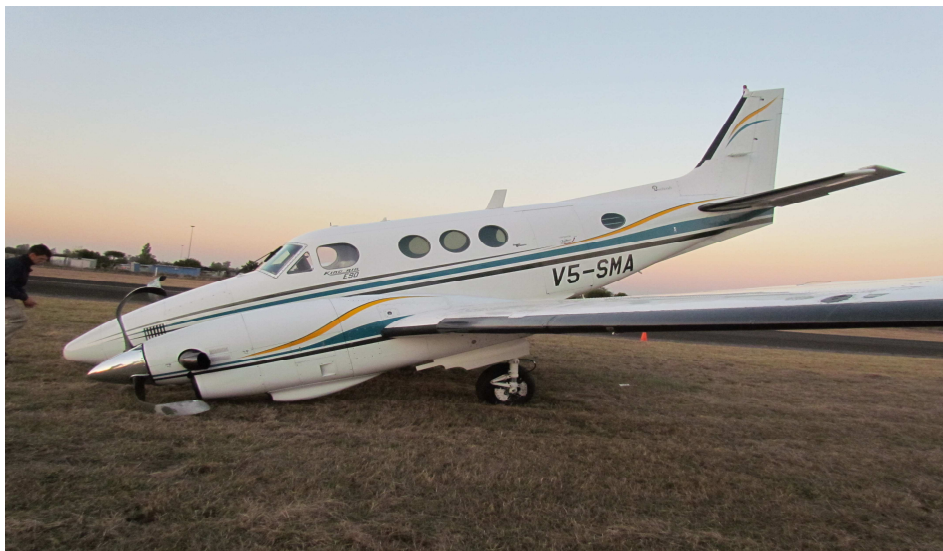
Figure 2, shows damage caused to propellers of the aircraft.

- (i) The propellers, radar dome, nose gear doors and the pitot tubes.
- (ii) The landing light bracket detached from its mounting point and was destroyed.

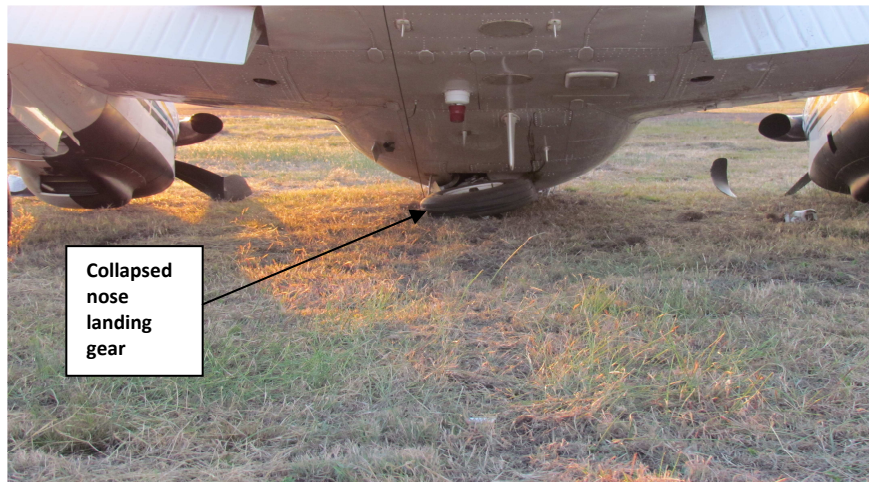
Figure 3, shows damage to nose landing gear of the aircraft.

- 1.6.1.3 The aircraft was examined during the investigation process. The evidence found shows that the aircraft suffered a landing gear failure during landing. The landing gear failure was caused as a result of the nose landing gear drag brace bracket that failed.

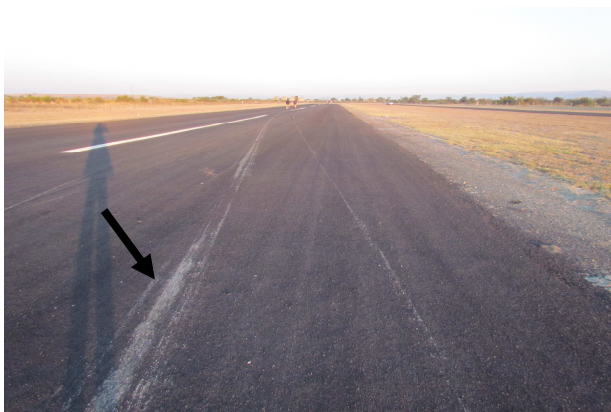
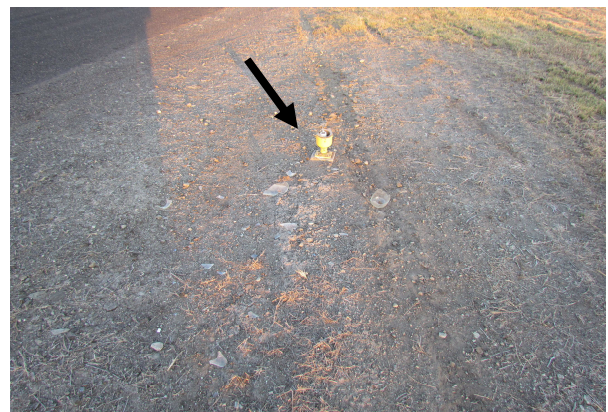
1.4.1 Other damage was limited to the runway surface and to a runway light.

Figure 4 and 5, shows damage caused to the runway surface and light.

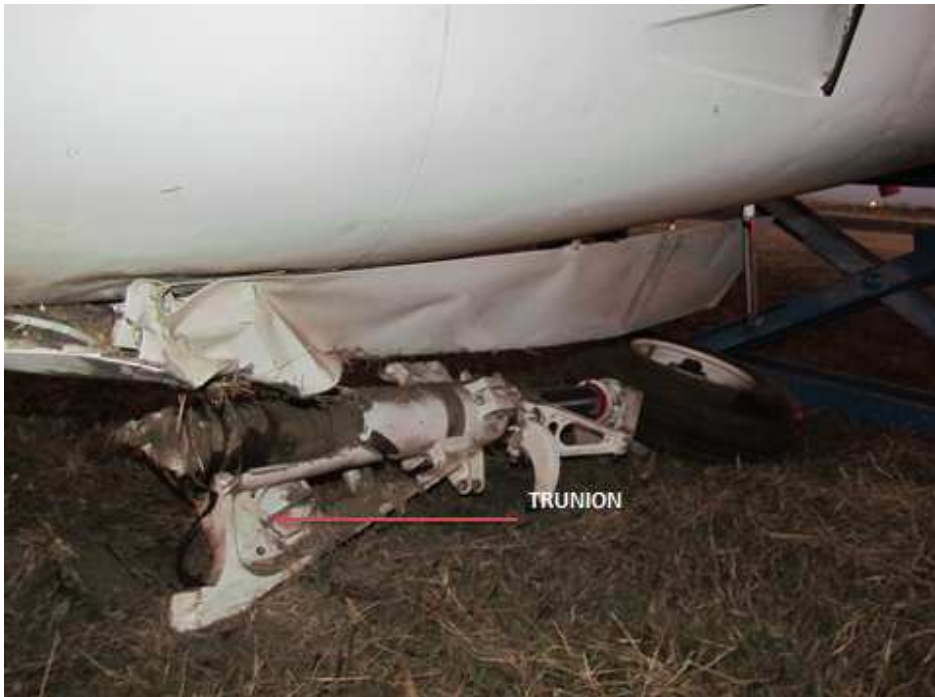
1.12.2 During the wreckage examination, the evidence found show that the aircraft nose landing gear trunnion detached from the keel during the accident. The damage was caused to the following items:

Figure 6, shows the broken nose landing gear trunion

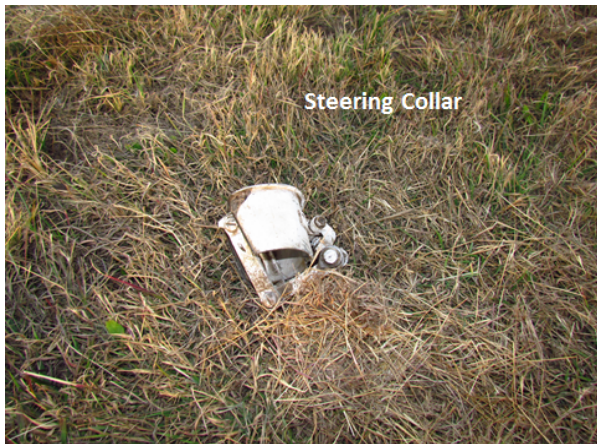
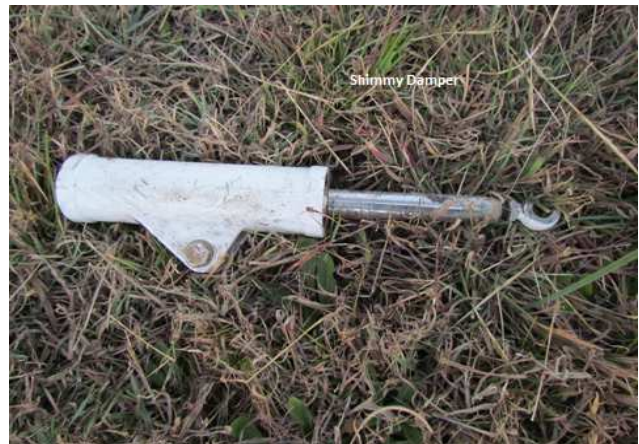
- (iii) The nose landing gear shimmy damper and the nose gear steering collar detached from the nose gear.

Figure 7 and 8, shows the nose landing gear debris (steering collar and the shimmy damper).

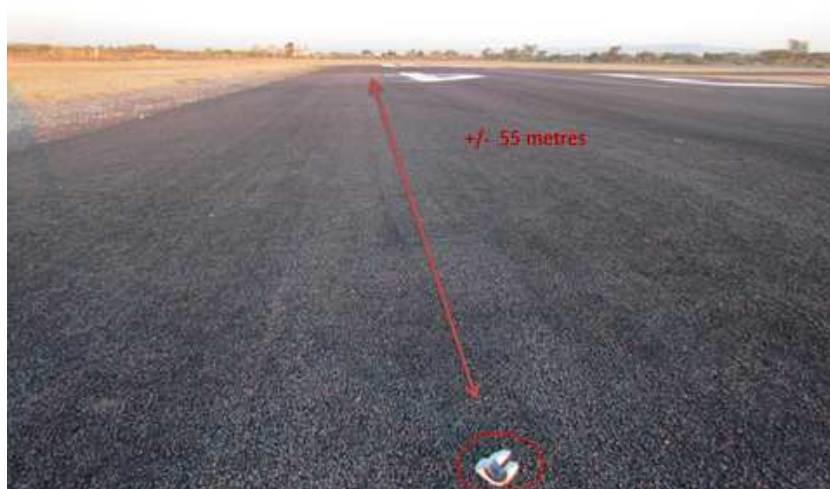
1.16.1 The on-site investigation process revealed that the nose landing gear drag brace bracket failed during landing roll on Runway 34 at FARG. The identified failure of the drag brace bracket resulted in the nose landing gear becoming loose and collapsed from the landing overload.

Figure 9, shows the nose landing gear drag brace bracket which was found approximately 55 metres from Runway 34 threshold.

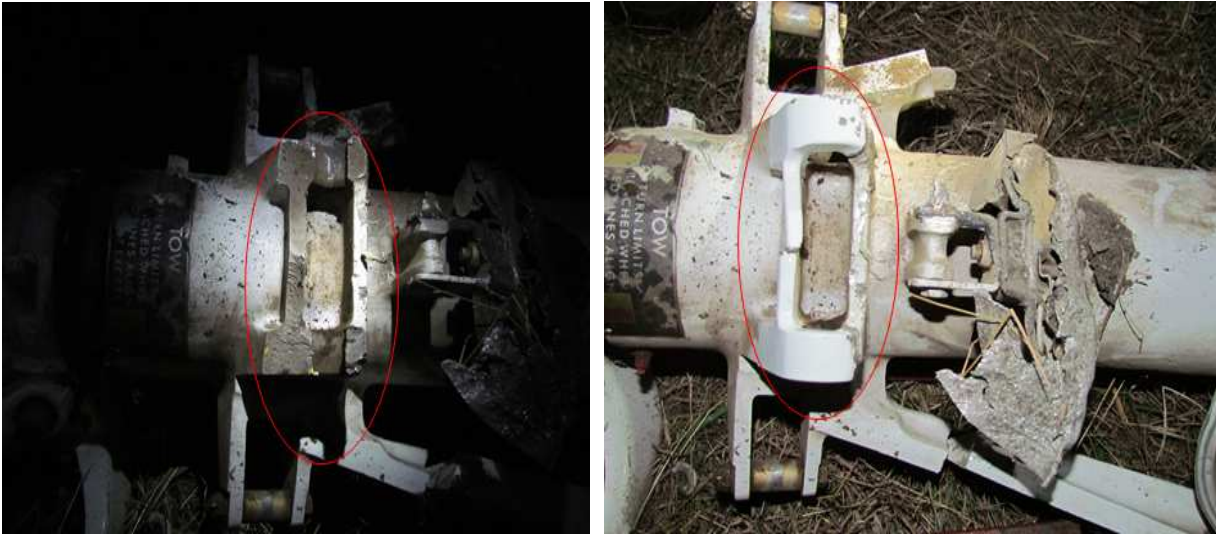
Figure 10 and 11, shows broken nose landing gear drag brace bracket attachment.

2.7 The metallurgical testing and analysis revealed that neither fracture surfaces found on the drag brace bracket debris showed any sign of pre-existing defects. The drag brace bracket showed surface characteristics of the part failing quite rapidly. The fracture surfaces indicated that the failure occurred as a result of a severe, transient overload. There was no evidence of fatigue or material imperfection that was visually apparent on any of the fractures examined. However the conclusion was that the aircraft could have been exposed to a hard landing or subsequent bouncing which caused the drag brace bracket to fail.

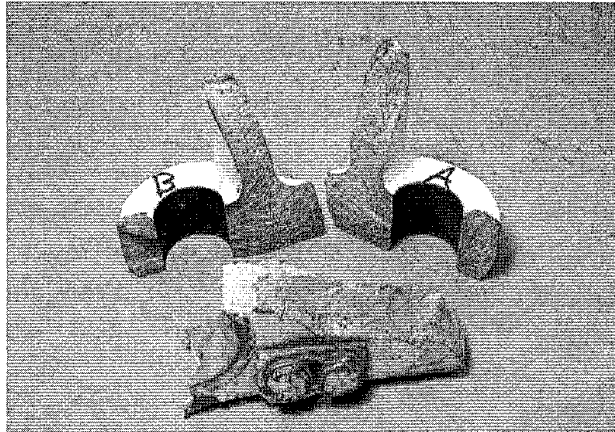
Figure 1. The three parts as received.

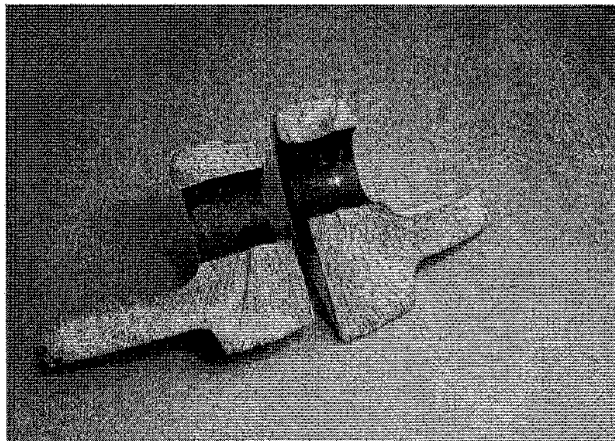
Figure 2. Fracture surfaces "A" and "B" as received. Note that they are not from the same fracture.

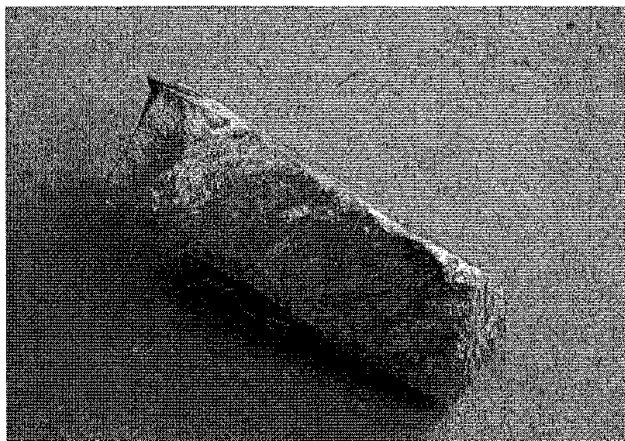
Figure 3. The third part received, showing severe battering.

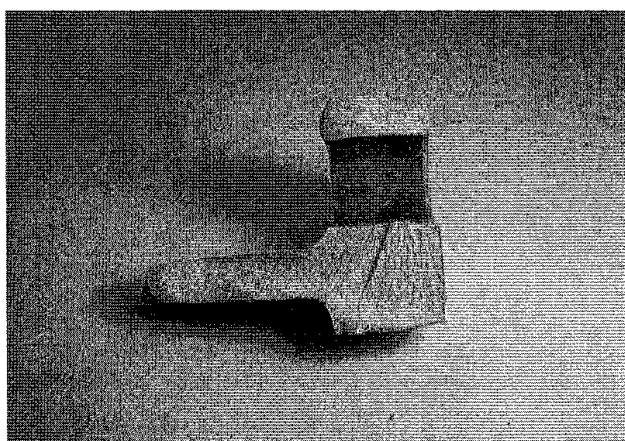
Examination of the fracture surfaces of the two supplied showed that they were not matching surfaces and had originated in different areas of the torque link, figures 4 & 5.

Neither fracture surface showed any sign of any pre-existing defect. Both showed surface characteristics indicating a very rapid failure, although one did show marking which could be interpreted as very coarse beach marks, figure 6, indicating that, whilst the loading may have been cyclic, very few cycles were encountered.

Figure 4. Fracture surface "A" as received.

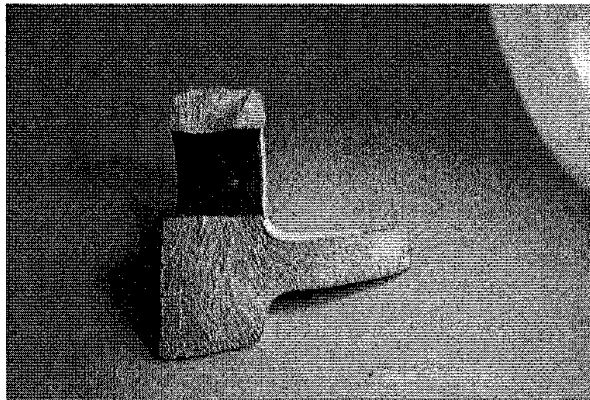
Figure 5. Fracture surface "B" as received.

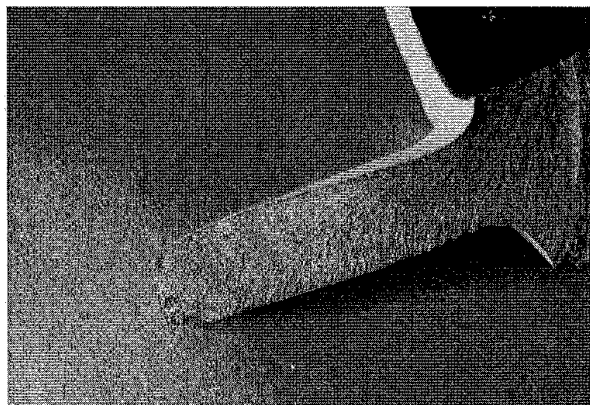
Figure 6. Possible very coarse beach marks on fracture surface "A".

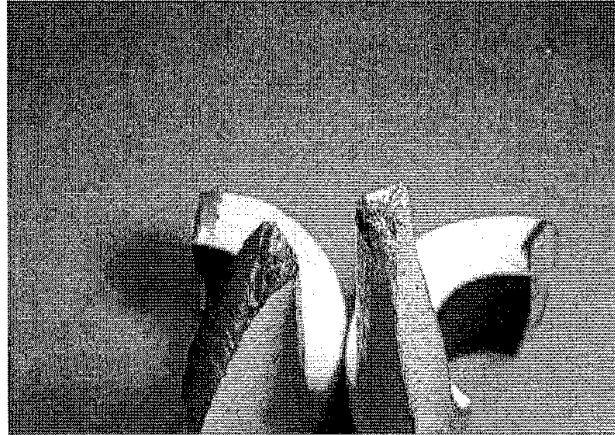
Both showed damage which may be attributed to post-failure impacts, figure 7.

Figure 7. Impact damage attributed to contact with the runway surface after failure.
