AIRCRAFT ACCIDENT REPORT AND EXECUTIVE SUMMARY

Reference:	CA18/2/3/9196	
Aircraft registration	ZU-FVY	Date of accident	16 July 2013		Time of accident	0945Z
Type of aircraft	Van's RV-7A (Aeroplane)		Type of operation	Private		
Pilot-in-command licence type	Private pilot		Age	64	Licence valid	Yes
Pilot-in-command flying experience	Total Flying Hours		661,0		Hours on type	55,0
Last point of departure	Baragwanath aerodrome (FASY), Gauteng province					
Next point of intended landing	Baragwanath aerodrome (FASY), Gauteng province					
Location of the accident site with reference to easily defined geographical points (GPS readings if possible)						
1,5 km from the threshold of runway 31 at FASY (GPS position: 26°21.297' South 027°47.905' East)						
Meteorological information	Surface wind: 230%5 knots, Temperature: 20°C, Visibility: + 10 km					
Number of people on board	1 + 0	No. of people injured	1	No. of people killed	0	
Synopsis	<p>The pilot, being the sole occupant onboard the aircraft was engaged in a private flight from Tedderfield aerodrome to Baragwanath aerodrome where he executed one touch-and-go, making use of runway 31. While positioning the aircraft for a second touch-and

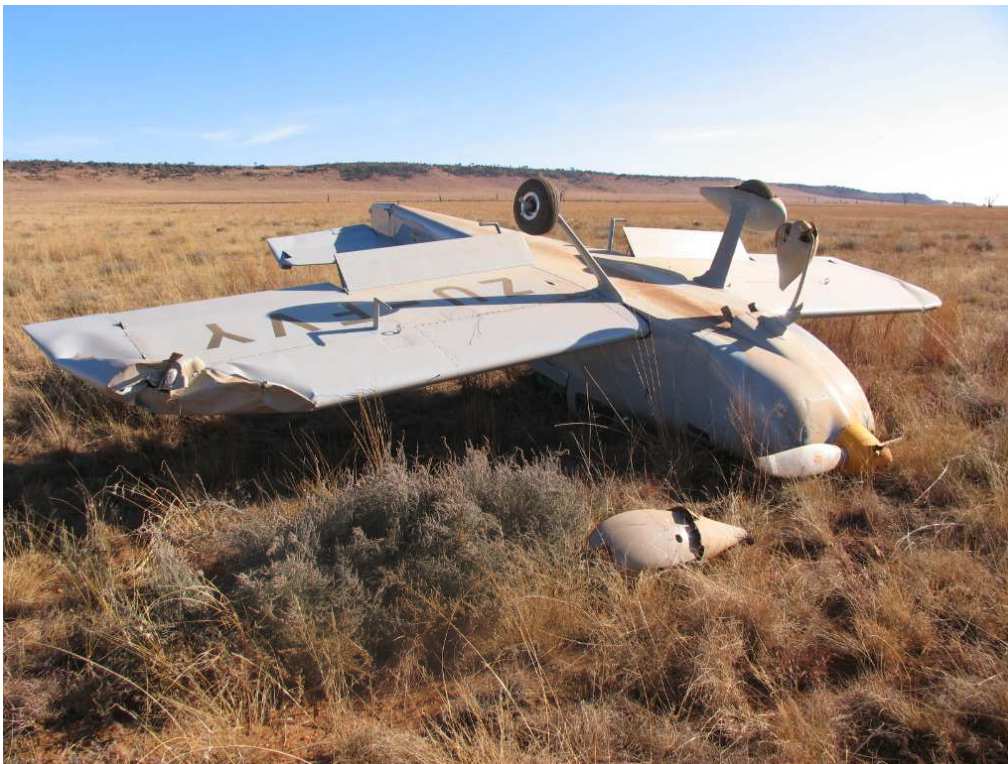
1.3.1 The aircraft was substantially damaged when it nosed over coming to rest in an inverted attitude during a forced landing in an open grass field.

Figure 1. A view of the aircraft as it came to rest in an inverted attitude.

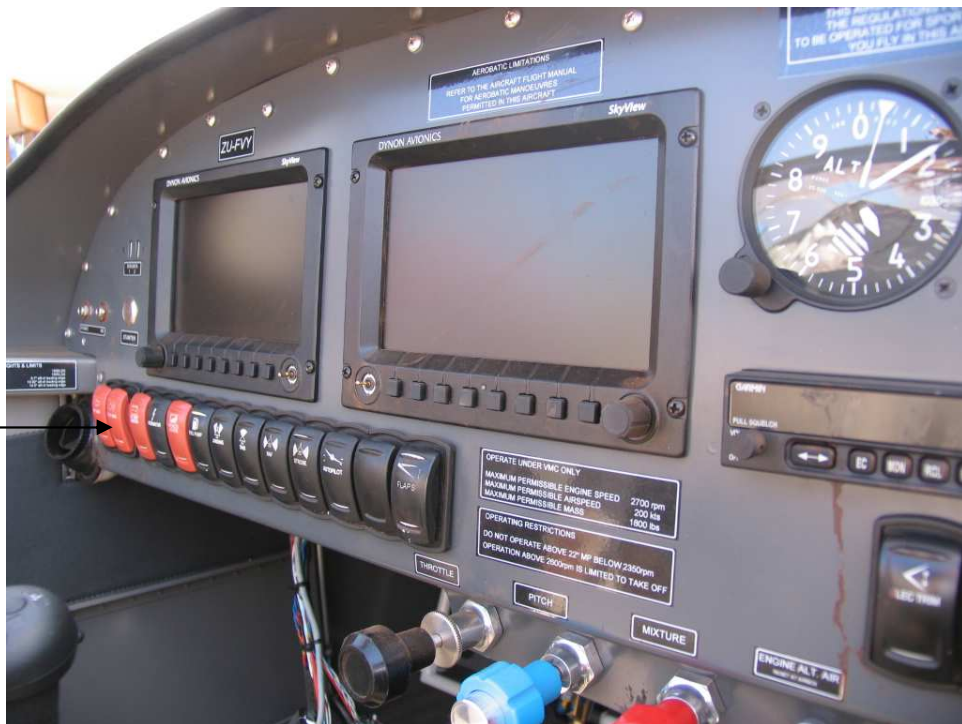
Figure 3. A view of the layout of the switches that was opted for by the owner/pilot of ZU-FVY.

The aircraft owner, who was also the pilot at the time of the accident flight, had opted to install Dynon Skyview EFIS instrumentation and further to that he opted for an array of 'non standard' switches (meaning switches that did not form part of the aircraft kit as made available by the manufacturer). The switches he opted for excluded the installation of the key type ignition switch, which comes standard with the aircraft kit. The switch layout he opted for instead allowed for a separate 'Battery Masters' switch as well as a two separate magneto switches (left and right) as can be seen in figure 4, page 9 of this report.

From an esthetical point of view the switches as opted for by the owner looked very neat, but from a safety perspective the switches could easily (without effort) be switched from the ON position to the OFF without any warning system being in placed (i.e., either a warning light or an audio warning or both). Further to that, essential switches, which include the two magneto switches was not of the guarded type, which made it even more prone to an accidental disturbance (being switch off in-flight) without any warning to the pilot.

4.1 It is recommended in the interest of aviation safety that the switches that were installed in the accident aircraft should not be allowed on aircraft if the magneto switches are:

- 4.2 It is recommended that the key switch mechanism, which is an approved and tested mechanism worldwide, not be substituted by the installation of separate magneto switches, which could jeopardise flight safety.
- 4.3 It is recommended that the headset sockets be installed on the aircraft in such a location that once a headset is plugged in, its control mechanism does not interfere with any of the controls/critical parts of the aircraft at any stage during the flight.

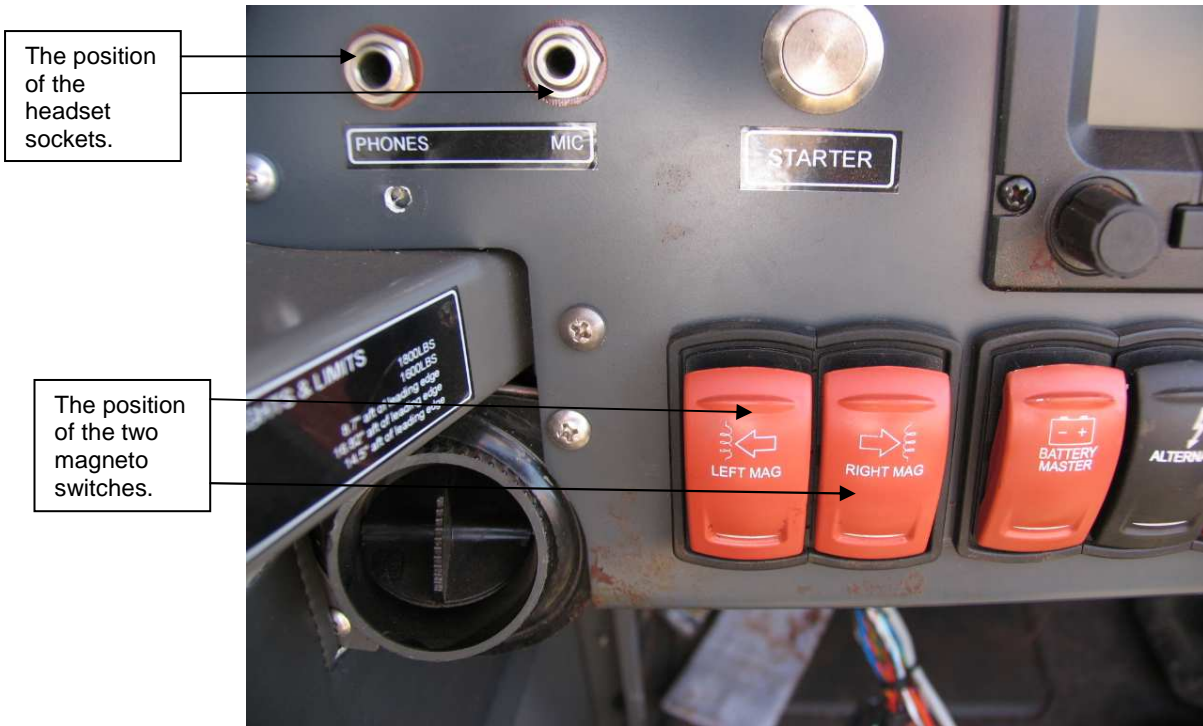
Figure 4. A close-up view of the two magneto switches as well as the battery master switch on ZU-FVY.

- 3.1.11 The aircraft was not equipped with a key type switch mechanism, but instead the owner opted for an array of separate switches, which include a switch for each magneto, these switches were not of the guarded type.

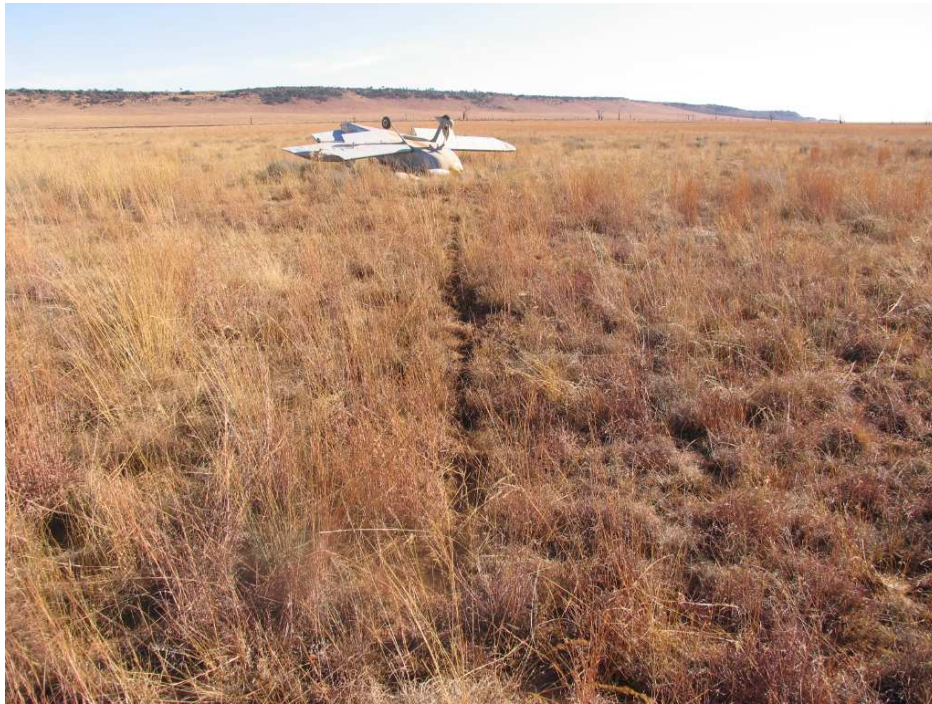
Figure 6. The ground mark in the centre of the photo was caused by the nose landing gear.

The flight was conducted within the perimeter of an aerodrome. Fine weather conditions prevailed at the time with the wind being from a south-westerly direction at 5 knots, which could have resulted in some moderate turbulence being around midday. The pilot managed to land the aircraft on the open field he had identified but due to the rough ground surface the nose wheel collapsed and the aircraft nosed over.

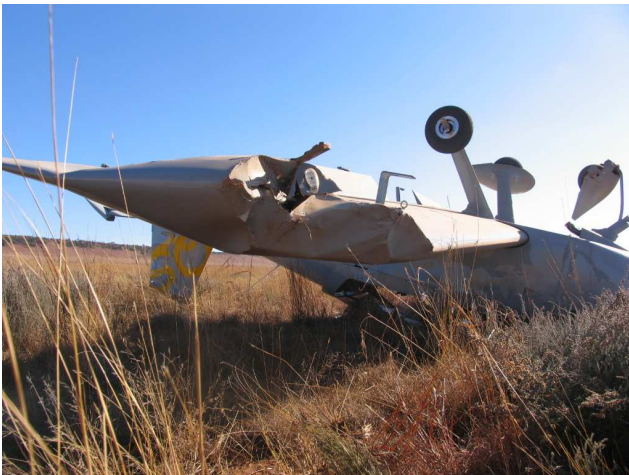
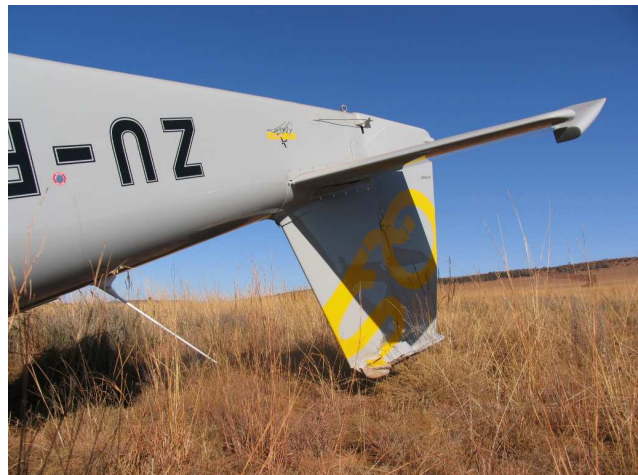
Figure 7. A view of the damage caused to the left wing (a), also visible the deformation to the vertical stabilizer (b).

1.12.2 The fuselage displayed evidence of deformation especially in the area aft of the wings. The spinner was fractured and one of the propeller blades displayed a bending moment backwards. Both fuel caps were found to be secured, with the wing tanks still intact. Evidence of fuel spillage was evident from both the fuel vents, which was located just aft of the forward bulkhead. This observation was confirmed by the aerodrome manager that dispatched to the scene following the notification of the accident to him. He stated that he observed a substantial amount of fuel being drained from the aircraft fuel tanks via both the fuel tank vent lines (left and right).

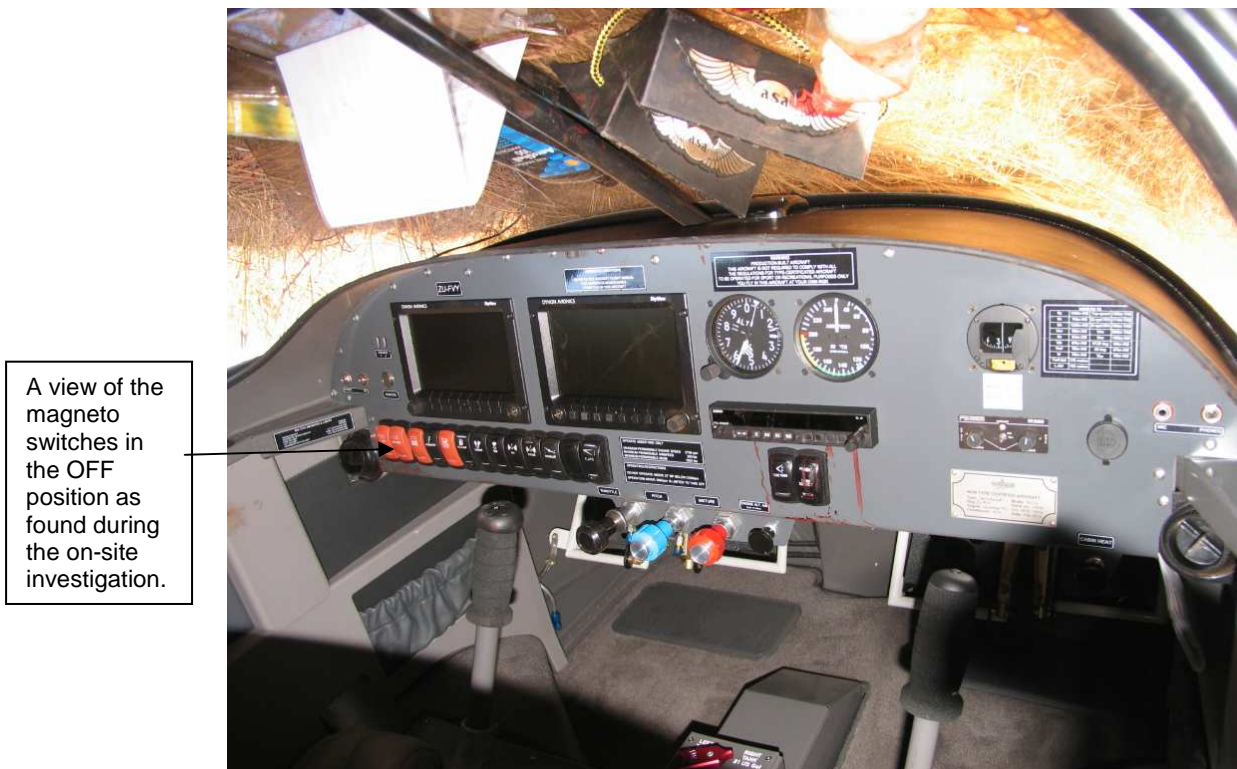
1.12.3 Both the magneto switches were found to be in the off position during the on-site

Figure 8. A photo of the cockpit, which was taken during the on-site investigation, aircraft in an inverted attitude.

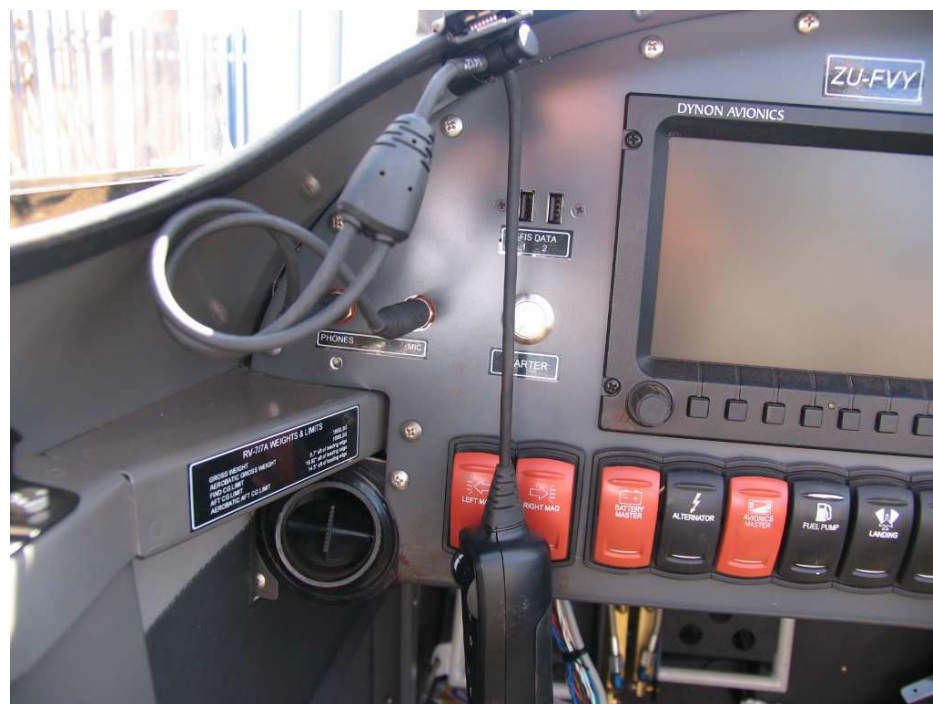
The two point headset socket was positioned above the two magneto switches and slightly to the left of it on the instrument panel. A test was conducted where the pilot brought his headset to the aircraft and he plugged it into the sockets and attached the wire clip to the glare-shield as illustrated in figures 9, 10 and 11, this was as the headset was installed in the aircraft on the day of the accident flight. It was noted that the headset control mechanism, which include two AA batteries, weighing 0.1350 kg (0.298 lbs) was hanging directly in front of the two magneto switches in very close tolerance to it.

Figure 9. The photo displays the headset as it was plugged in at the time of the accident flight.

The airframe headset sockets (two points) for the pilot's headset was found to be located slightly above the two magneto switches on the left-hand side of the instrument panel. Depending on the way the pilot route his headset wiring once plugged in it did allow for the headset control mechanism to be positioned in close (very) proximity to the two magneto switches, hanging directly in front of them. The routing of the headset wiring as displayed in figure 9, 10 and 11 of this report was as the pilot recalls it to be on the day of the accident with the control mechanism hanging in front of the two magneto switches. With the information that was obtained from the download of the data from the non volatile memory of the Dynon instrumentation it was possible to determine that the two magnetos were grounded (switched off) simultaneously, which caused the engine to stop and the propeller to windmill.

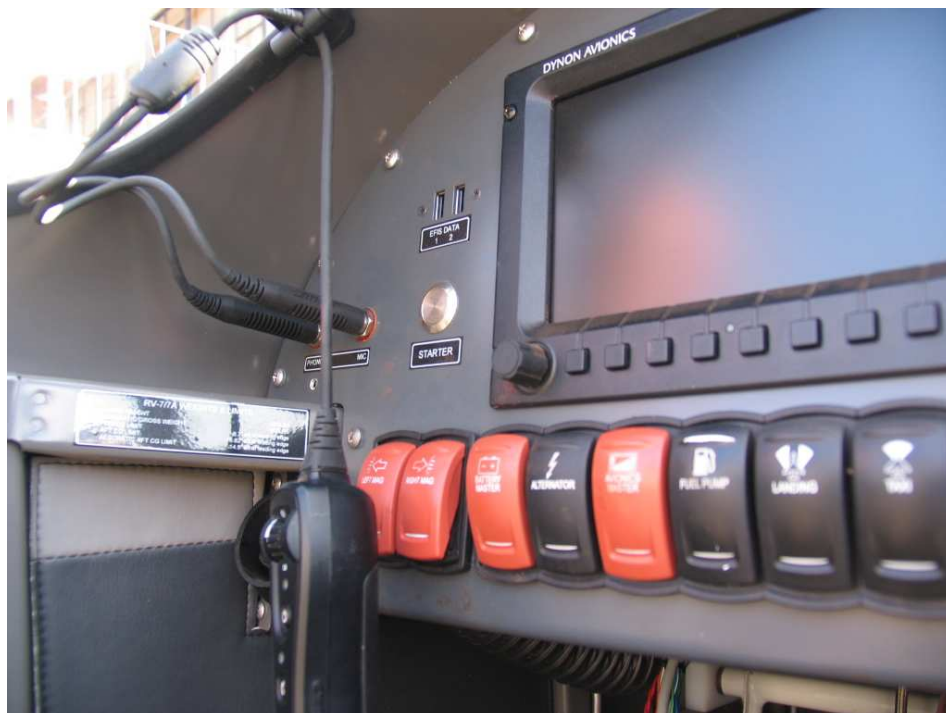
Figure 10. The photo displays the headset control mechanism with the magneto switches in the ON position.

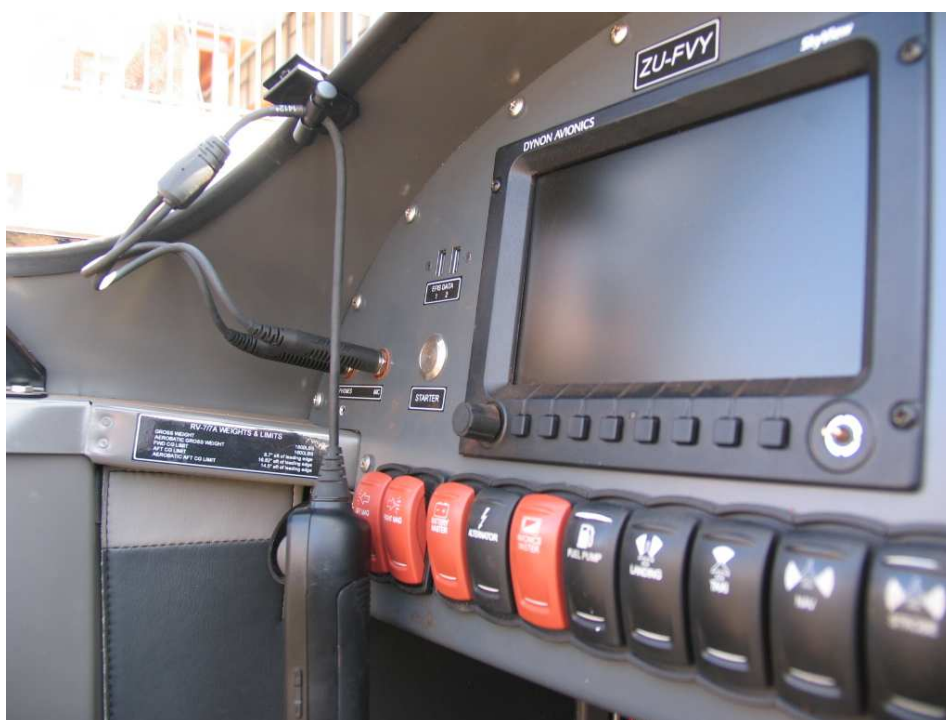
Figure 11. The photo displays the headset control mechanism with the magneto switches in the OFF position.

3.3.1 The engine stoppage was determined to have been caused by the simultaneous grounding of both the magnetos during flight. (The probability that the pilot's headset control mechanism have made contact with both the magneto switches while in-flight, switching them off could not be ruled out).

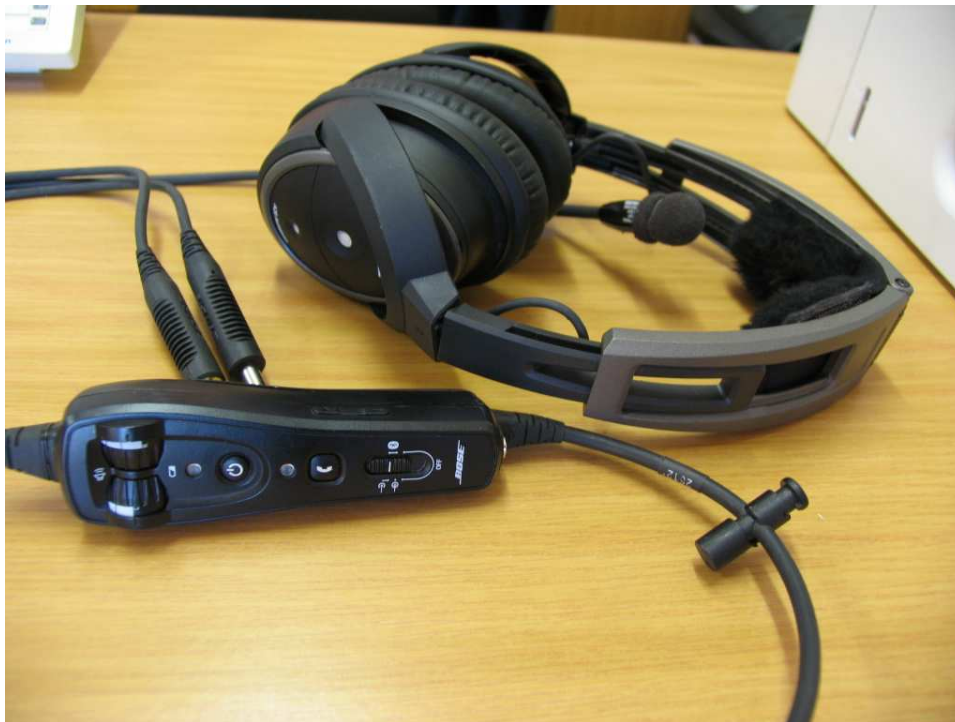
Figure 12. The photo displays the headset with its control mechanism that was used by the pilot.

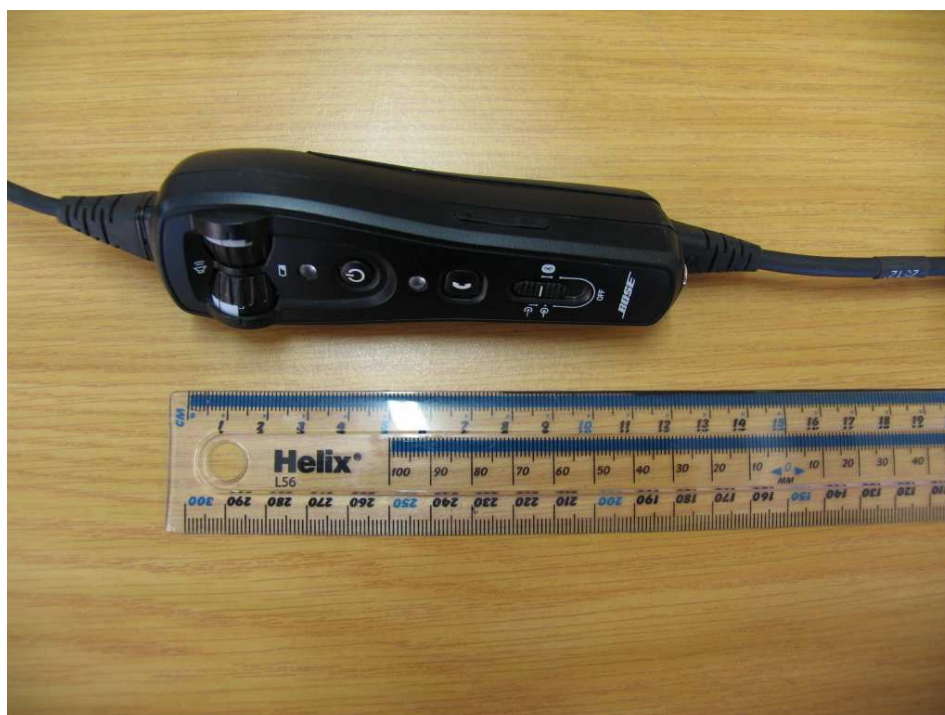
Figure 13. The photo displays the headset control mechanism which was 12 cm in length.

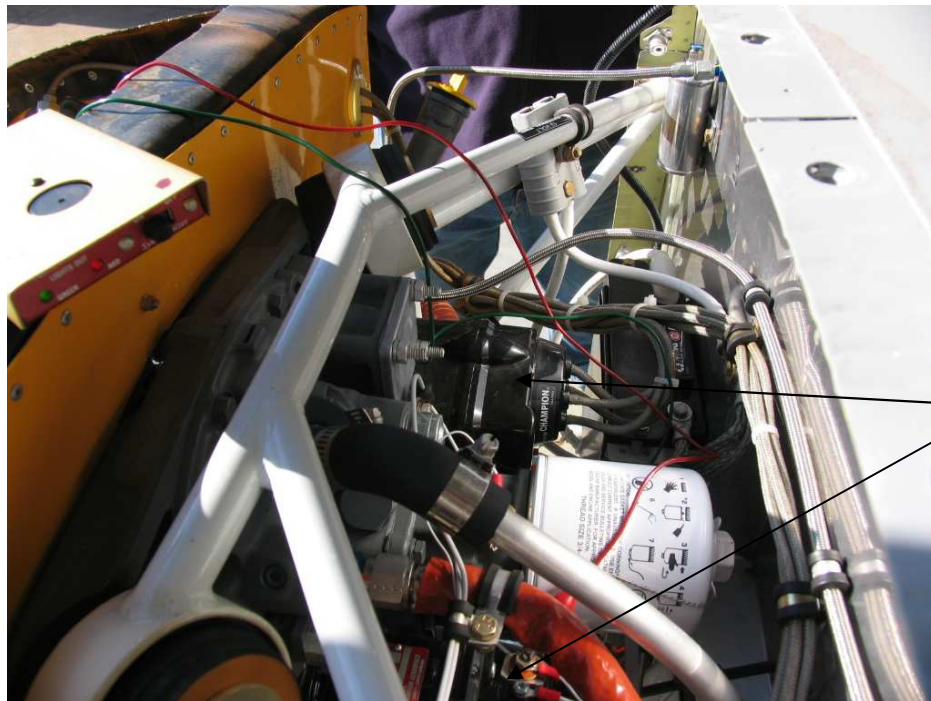
Both the magnetos, serial number's 12071531 and 12070359 were found to be undamaged during the accident sequence, they were removed from the engine and were subjected to a bench tests functional check at an approved engine maintenance facility, no anomalies were found during the test procedure. Further to that the engine gear drive train with reference to the magneto drives were inspected

and was found to be consistent with normal operation. It was further determined that there was no short circuit in the system and each magneto switch allowed power through to the magnetos when switched to the ON position.

Figure 14. A view of the two magnetos, still attached to the engine.

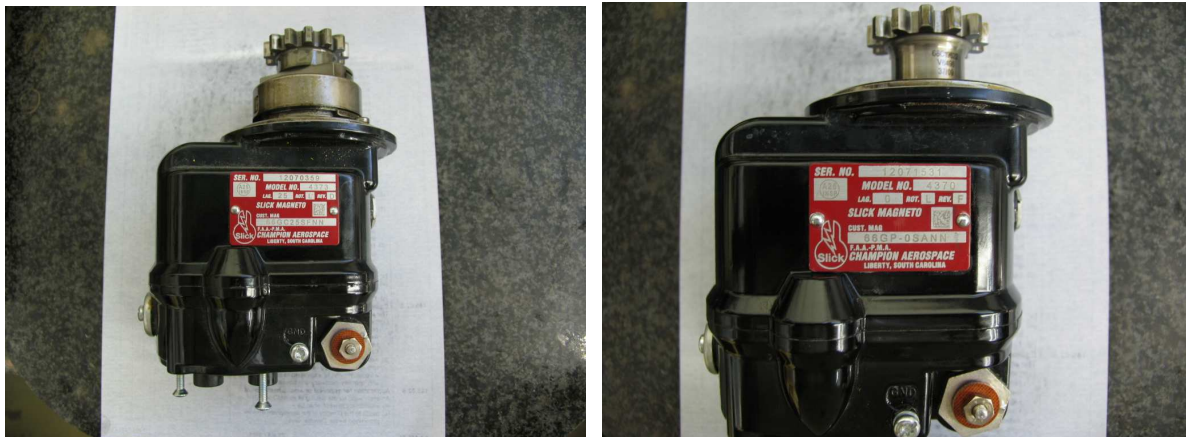
Figure 15. A view of the two magnetos after they were removed from the engine prior to bench testing.
