AIRCRAFT ACCIDENT REPORT AND EXECUTIVE SUMMARY
--

Reference:	CA18/2/3/9199	
<b>Aircraft Registration</b>	ZS-CAP	<b>Date of Accident</b>	18 July 2013		<b>Time of Accident</b>	0730Z
<b>Type of Aircraft</b>	Cirrus SR20		<b>Type of Operation</b>		Training (Check flight)	
<b>Pilot-in-command Licence Type</b>	Commercial Pilot		<b>Age</b>	24	<b>Licence Valid</b>	Yes
<b>Pilot-in-command Flying Experience</b>	<b>Total Flying Hours</b>		1 637,5		<b>Hours on Type</b>	777,3
<b>Private Licence Type</b>	Private Pilot		<b>Age</b>	19	<b>Licence Valid</b>	Yes
<b>Private Pilot Flying Experience</b>	<b>Total Flying Hours</b>		55,6		<b>Hours on Type</b>	50,8
<b>Last point of departure</b>	Lanseria International Airport (FALA), Gauteng Province					
<b>Next point of intended landing</b>	Lanseria International Airport (FALA), Gauteng Province					
<b>Location of the accident site with reference to easily defined geographical points (GPS readings if possible)</b>

## AIRCRAFT ACCIDENT REPORT

**Name of Owner/Operator** : CDC Aviation (PTY) LTD  
**Manufacturer** : Cirrus  
**Model** : SR20  
**Nationality** : South Africa  
**Registration Marks** : ZS-CAP  
**Place** : Farm Bultfontein, Muldersdrift

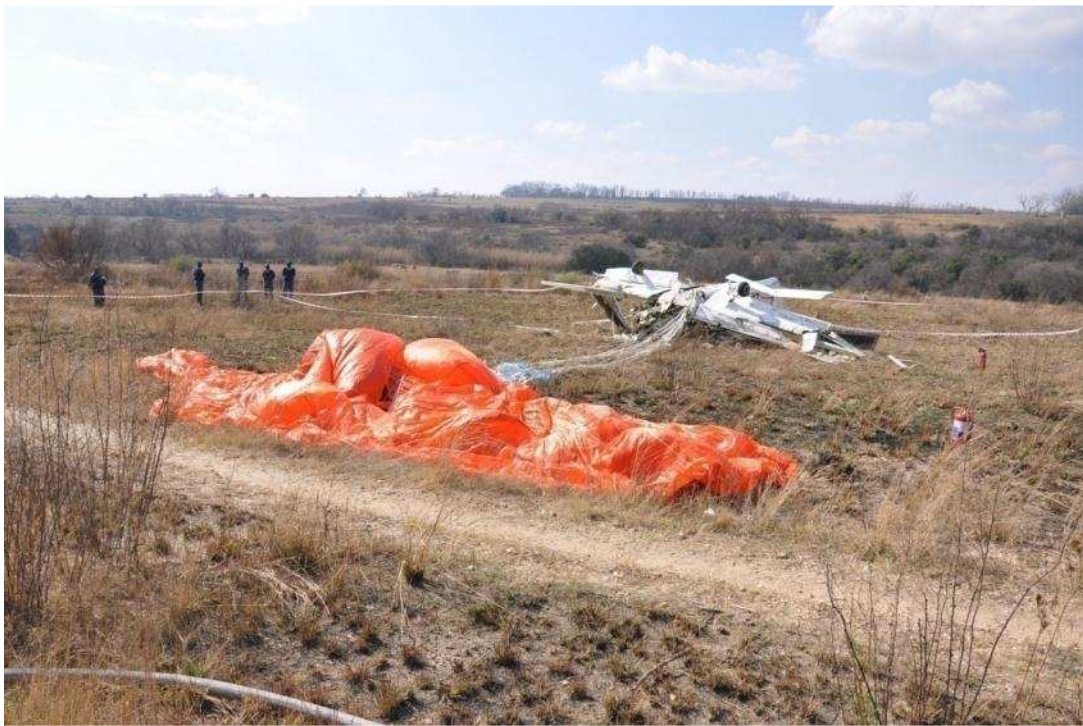
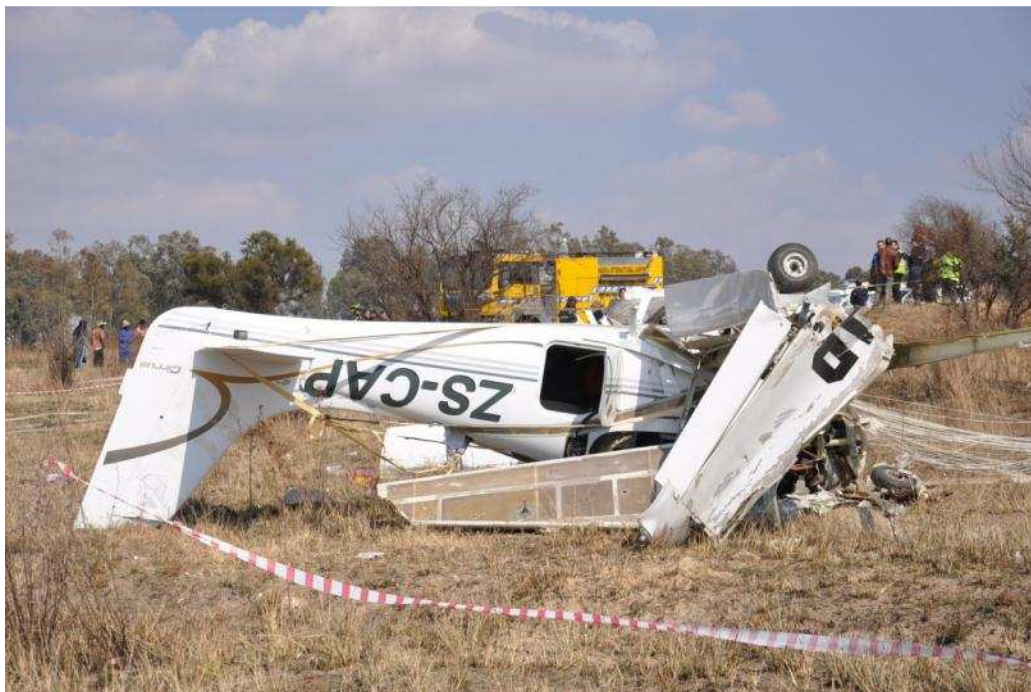
1.3.1 The aircraft was destroyed during the impact sequence.

**Figure 3:** View of aircraft wreckage

**Figure 4:** View of aircraft wreckage

1.12.2 The wreckage indicated that the aircraft impacted the ground in a nose-down and slight left wing low attitude. The propeller dug into the ground and the aircraft nosed-over with the fuselage breaking at the engine section. The aircraft wreckage pattern was confined to the impact point with the ballistic parachute deployed and still attached to the aircraft wreckage. The aircraft was destroyed during the impact sequence.

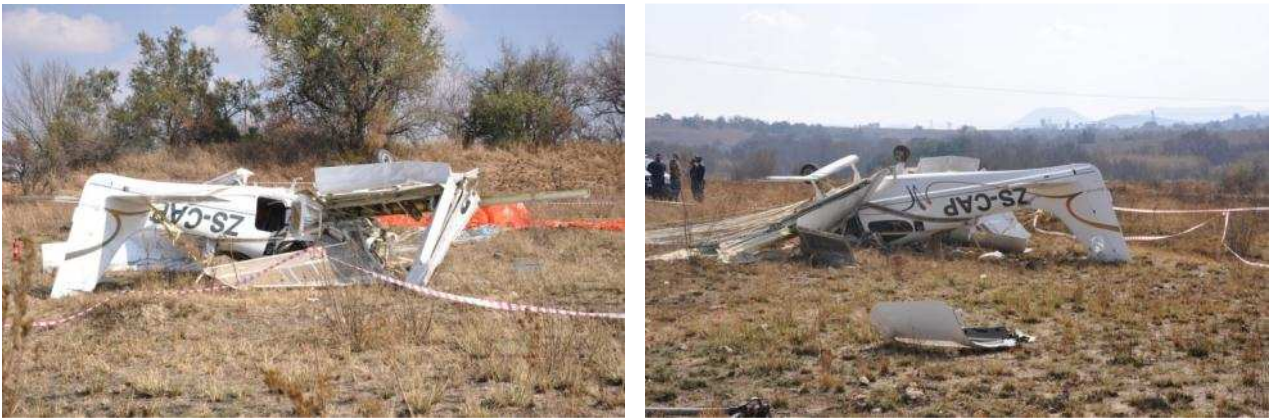
- The damage sustained to the propeller indicated that the engine was at a high power setting at the time of the impact sequence.
- Both wings of the aircraft were destroyed during the impact sequence.
- The left wing broke midway; however, the wing spar was still intact.
- Both wing tanks ruptured during the crash.
- The cockpit area and forward part of the cabin was completely destroyed.
- Both front seats broke from their attachments.
- The nose landing gear broke from the fuselage and the main landing gear was still intact.
- The right flap was found in the full down (100%) position with the right flap attachments broken on impact.
- The flap linear actuator was found in the full down (100%) position.
- The flap control switch and flap indicator lights mounted on the centre console that identify flap position was completely destroyed during the accident sequence.

The rudder, horizontal stabiliser, vertical stabiliser and elevators sustained no damage.

**Figure 8 & 9:** Damage to the aircraft

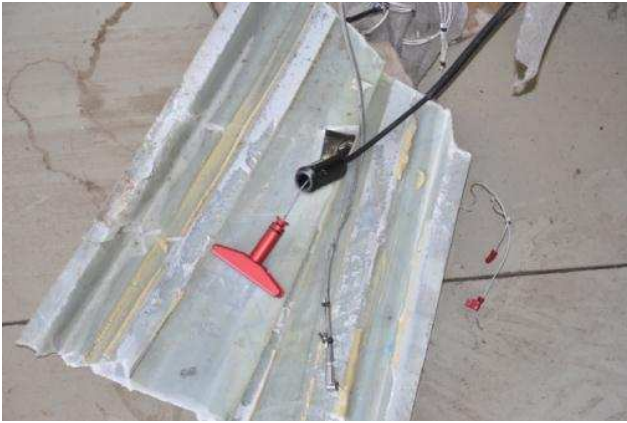
1.12.3 The ballistic parachute of ZS-CAP was found on the ground in the deployed position. The ballistic parachute T-handle was found in the slack position indicating that it was pulled by the crew and the ballistic parachute canopy was still attached with the canopy suspension lines and harness to the fuselage structure. The ballistic parachute rocket canister, fuselage parachute composite cover and deployment bag was found approximately 37m from the wreckage.

**Figure 10:** The activation T-handle in the slack position

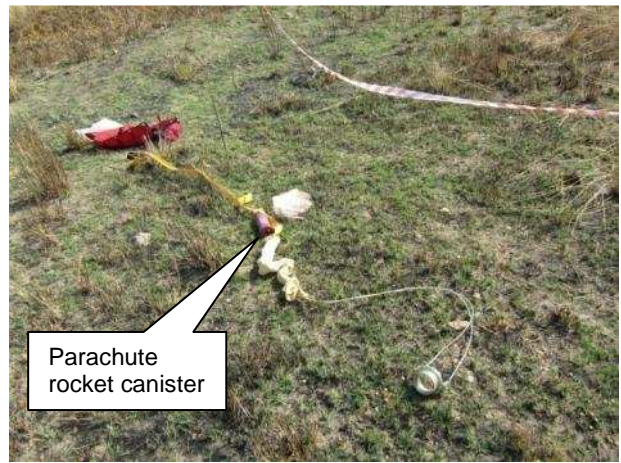
**Figure 11:** The rocket canister that was found 37m away

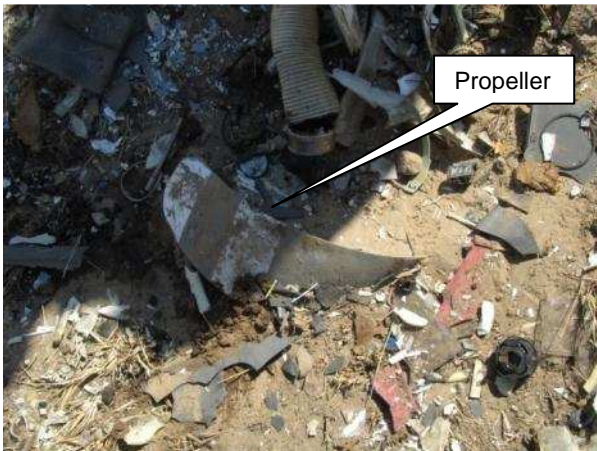
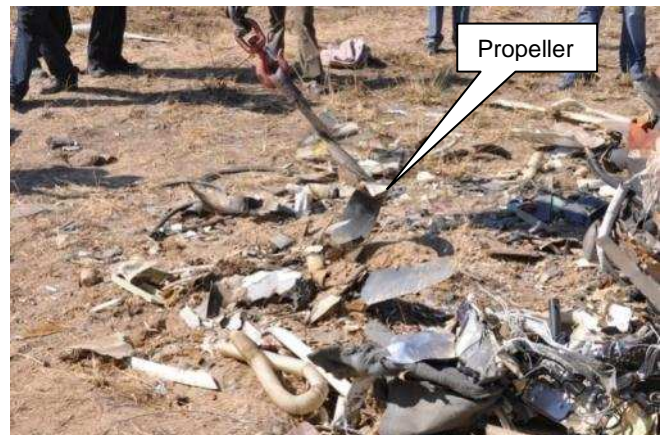
1.12.5 After the engine was lifted off the ground, the three-bladed propeller was found to have dug into the ground during the impact sequence. The propeller broke at the attachment to the crankshaft during the impact with the ground. Propeller blade damage and twist was consistent with the engine producing power at impact.

**Figure 12 & 13:** Recovery of the propeller

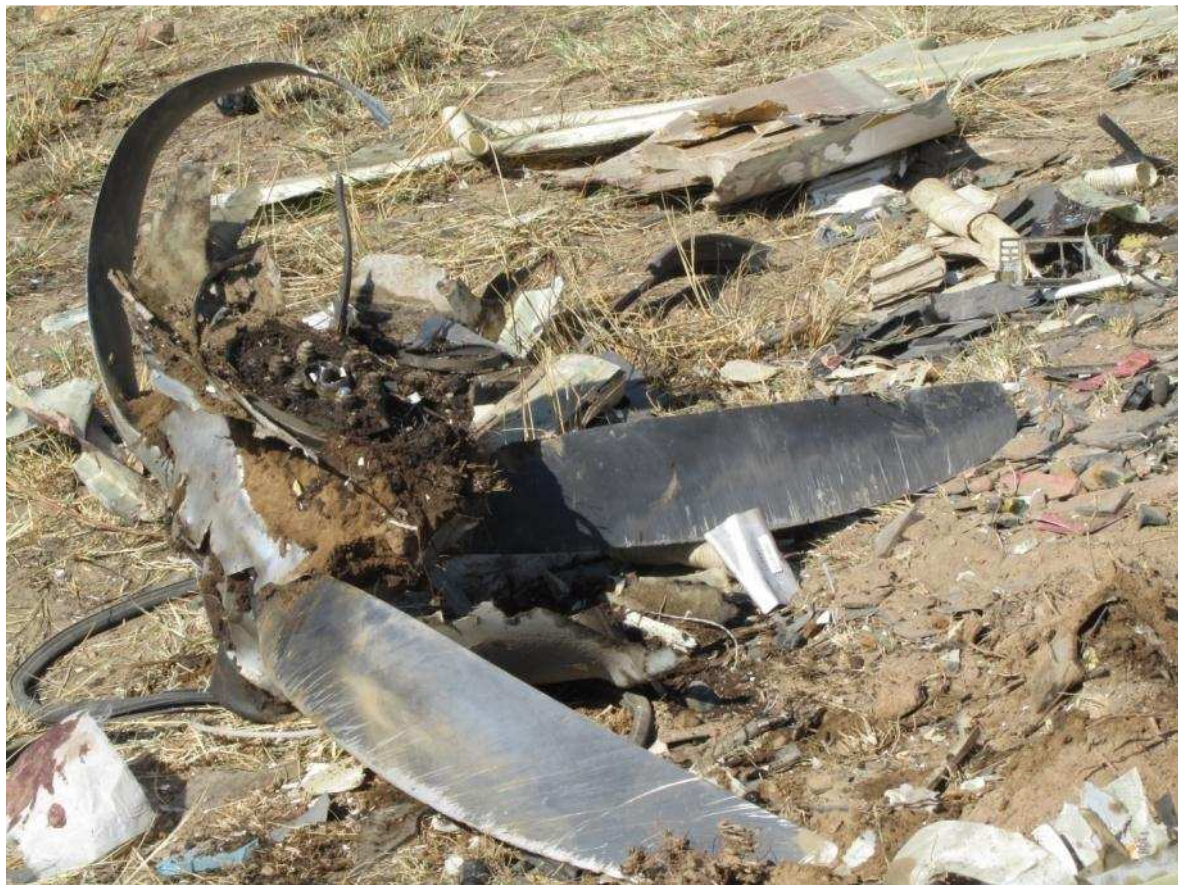
**Figure 14:** Propeller of ZS-CAP

- 3.1.10 Propeller blade damage and twist was consistent with the engine producing power at impact.
- 3.1.11 The second touch and go was performed with 100% (full) flaps configuration which was the incorrect configuration as prescribed by the POH. The approved take off settings are 0% or 50%.

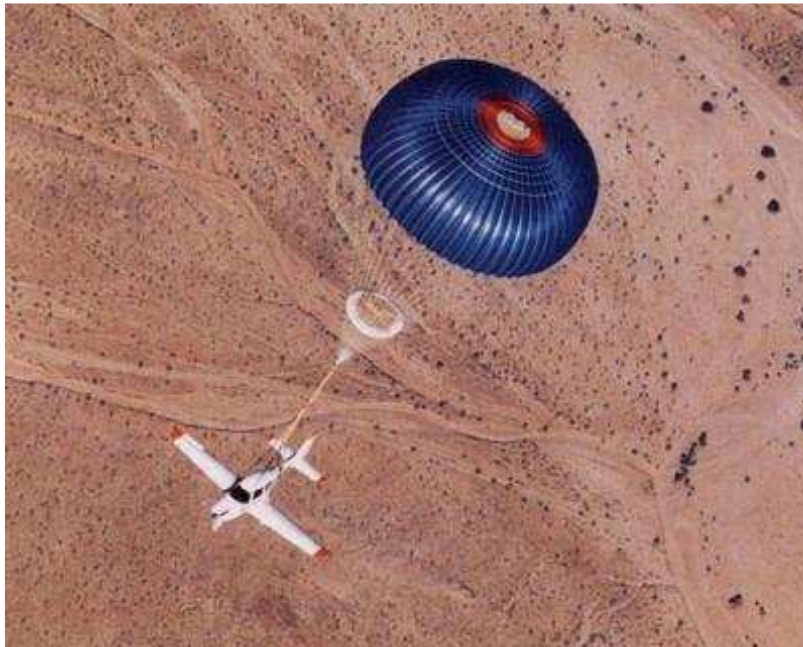
**Figure 17:** View of CAPS deployed

- 3.1.15 The aircraft ballistic parachute was deployed but did not have time to fully deploy before impact due to the low altitude.
- 3.1.16 Fine weather conditions prevailed, which were not considered to have had any bearing on the accident.
