AIR ACCIDENT INVESTIGATION

Factual Accident Report on

Cessna 206

Registration 5Y-BUG

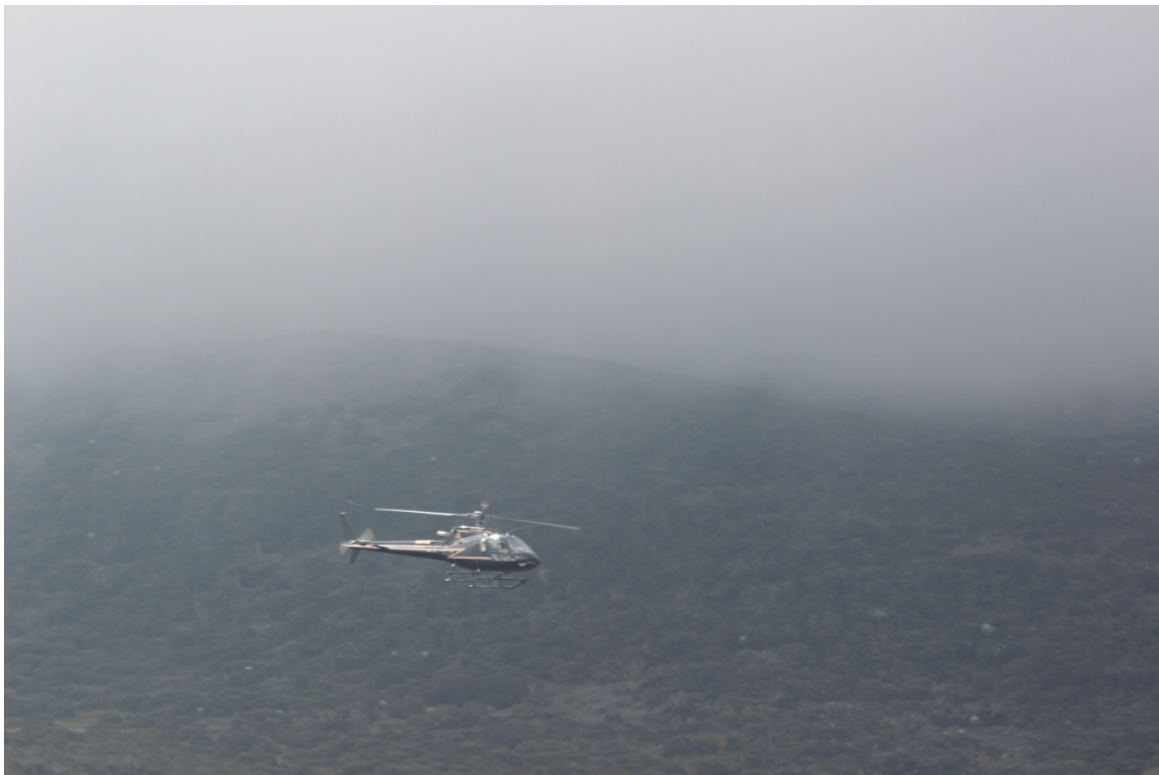
Figure 1: Typical foggy weather condition in the Abardare ranges in June/July season

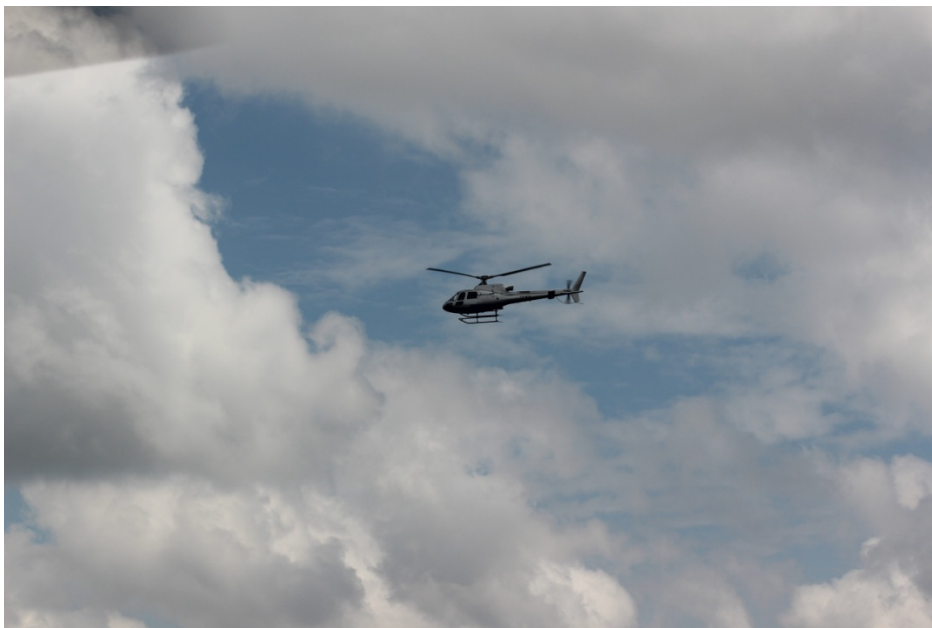
Figure 2: Typical low clouds at the Aberdares Mountains

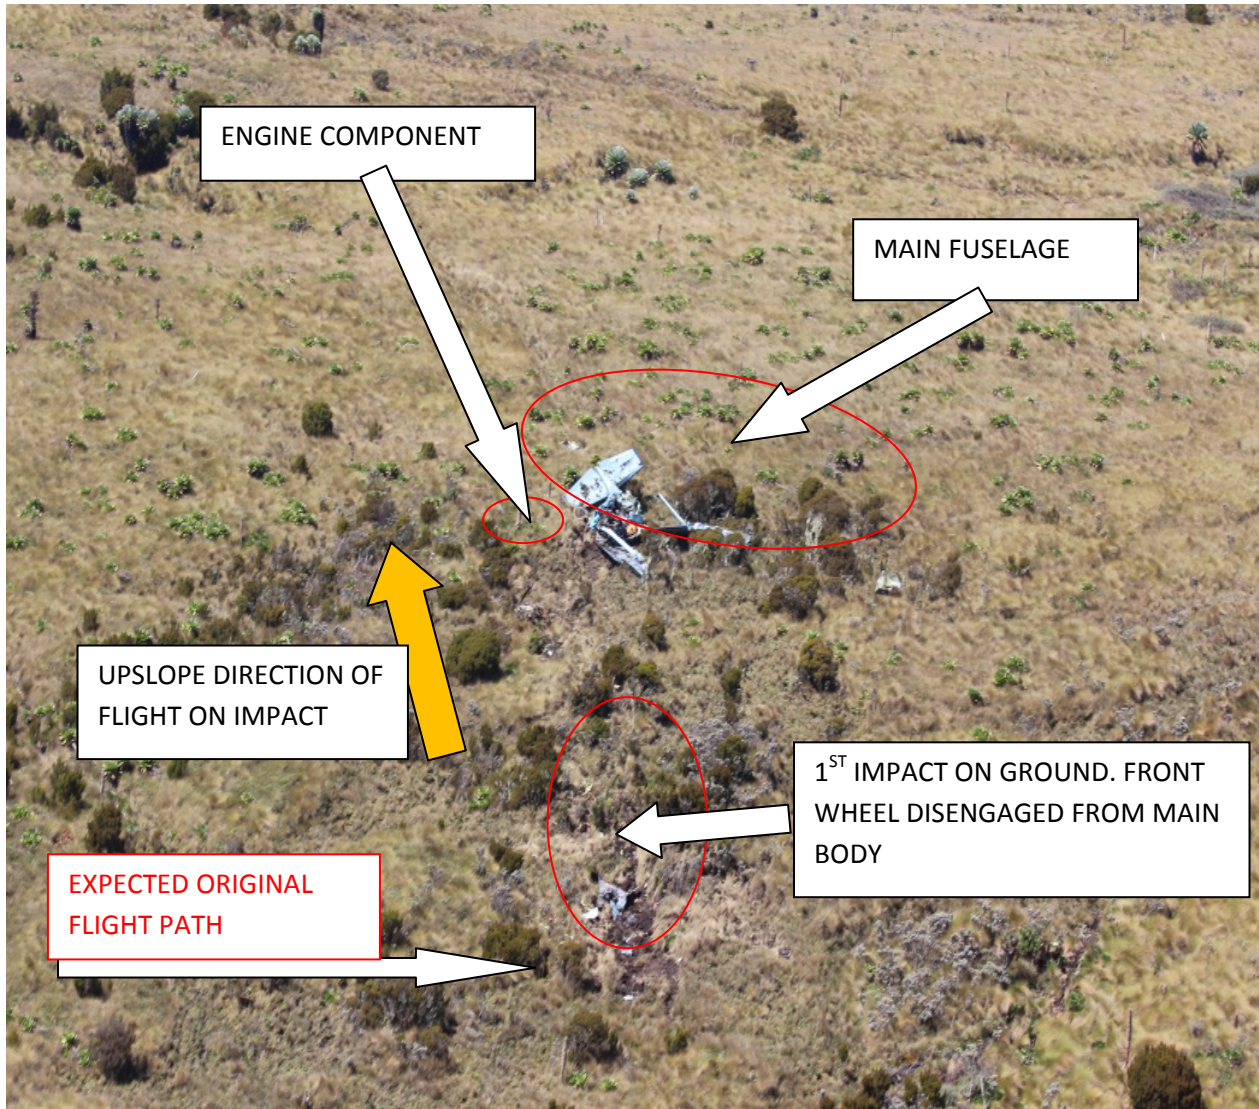
The aircraft had collided into the mountain in a forward flight impacting the ground in a level pitch attitude and in powered flight. Impression on the ground indicates that the aircraft impacted the ground and then ballooned up/leapt into the air. The second impact happened some ten meters up the hill where this time the engine plunged into the ground and the fuselage separated from the engine and was flung about fifteen meters to the right of the engine up hill. The wreckage was distributed about 50 meters in a linear direction and some parts were strewn about 20 meters from the main fuselage.

Figure 3: Wreckage Distribution

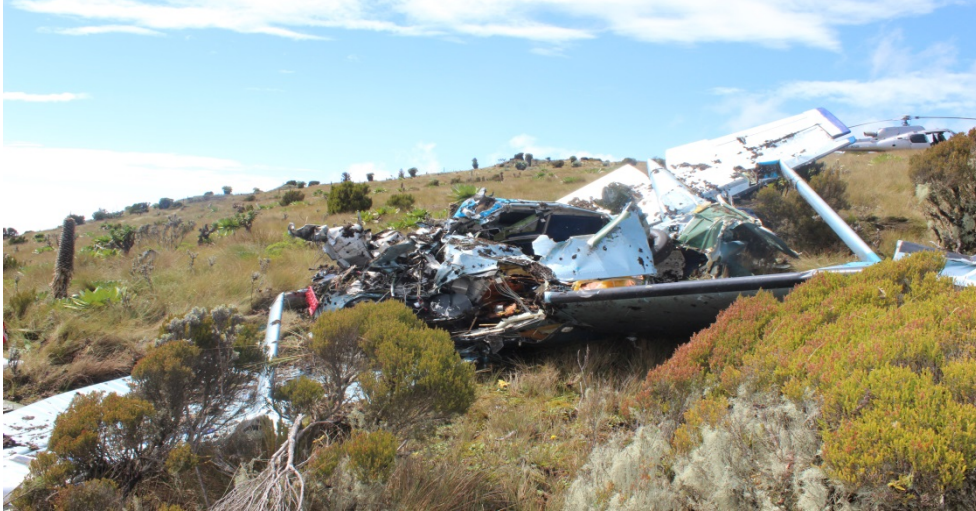
Figure 4: Main Fuselage on Mountain slopes

The aircraft impacted the ground on up slope direction with right wing low. The size of impact impression on ground indicated a powered flight. After the first impact the aircraft ballooned into the air, plunged into the ground with the engine first. The force of impact separated the fuselage from the engine and the fuselage was flung another ten meters upslope and to the right. The cabin and the fuselage weretotally destroyed/mangled. The tail fin (empennage) remained intact. The undercarriage was ruined on impact. The wings were severed from the main fuselage.

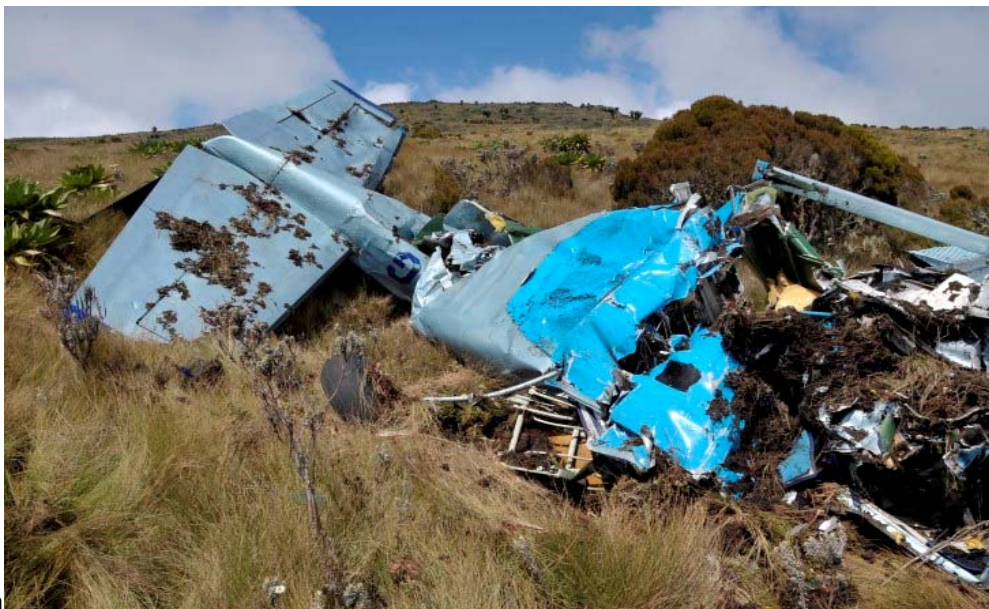
Figure 5: Main Fuselage and tail

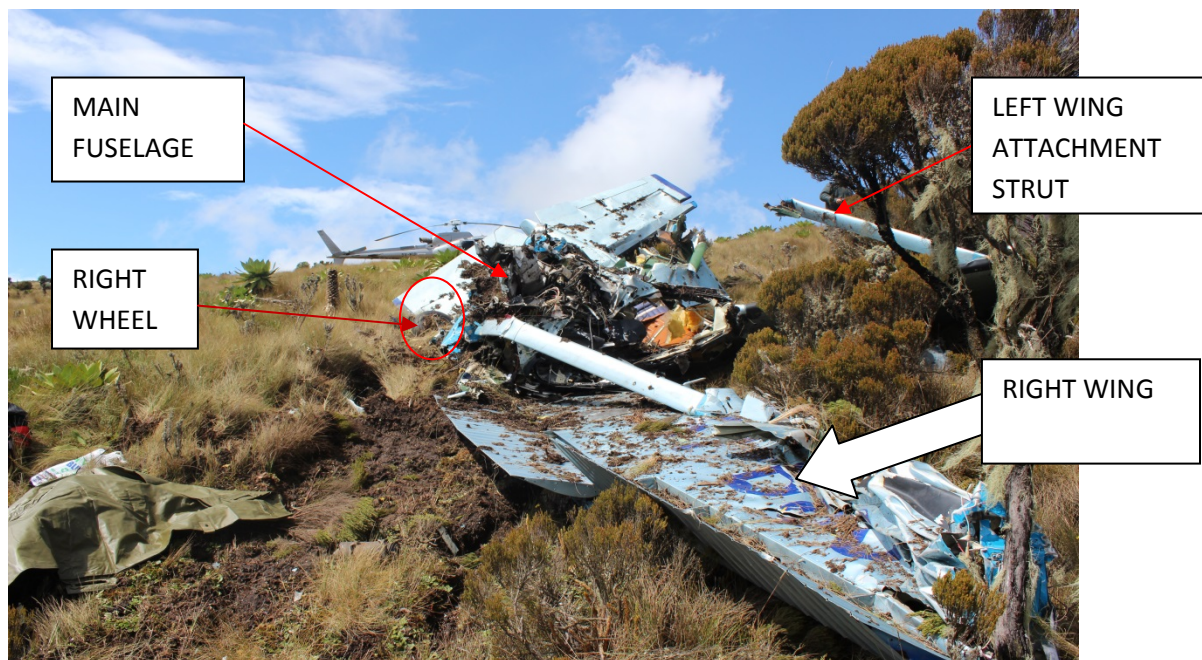
Figure 6: Main Fuselage and the wings

From available evidence the aircraft was structurally intact before the impact. It was under engine power and in pilot's control. The direction of impact is about 90° from the original track heading towards the top of the peak at the time of first impact
