AIRCRAFT ACCIDENT REPORT AND EXECUTIVE SUMMARY

Reference:	CA18/2/3/9209	
Aircraft Registration	ZS-NOF	Date of Accident	2 August 2013		Time of Accident	1310Z	
Type of Aircraft	PA-36-285 (Aeroplane)		Type of Operation		Agricultural crop spraying		
Pilot-in-command Licence Type		Private Pilot	Age	58	Licence Valid	Yes	
Pilot-in-command Flying Experience		Total Flying Hours	2259		Hours on Type	1764	
Last point of departure		Jakkalskloof Farm, West of Porterville (Western Cape Province)					
Next point of intended landing		Jakkalskloof Farm, West of Porterville (Western Cape Province)					
Location of the accident site with reference to easily defined geographical points (GPS readings if possible)							
Jakkalskloof Farm (GPS position: 33°01'47" South 18°54'40" East, elevation 276 ft. AMSL)							
Meteorological Information		Temperature: 24°C, Wind direction: 10° Wind speed: 3kts, Visibility: CAVOK					
Number of people on board	1 + 0	No. of people injured	1	No. of people killed	0

Name of Owner : Mr. W.J. Visagie
Name of Operator : Visagie Air CC
Manufacturer : Piper Aircraft Company
Model : PA-36-285
Nationality : South Africa
Registration Marks : ZS-NOF
Place : West of Porterville i

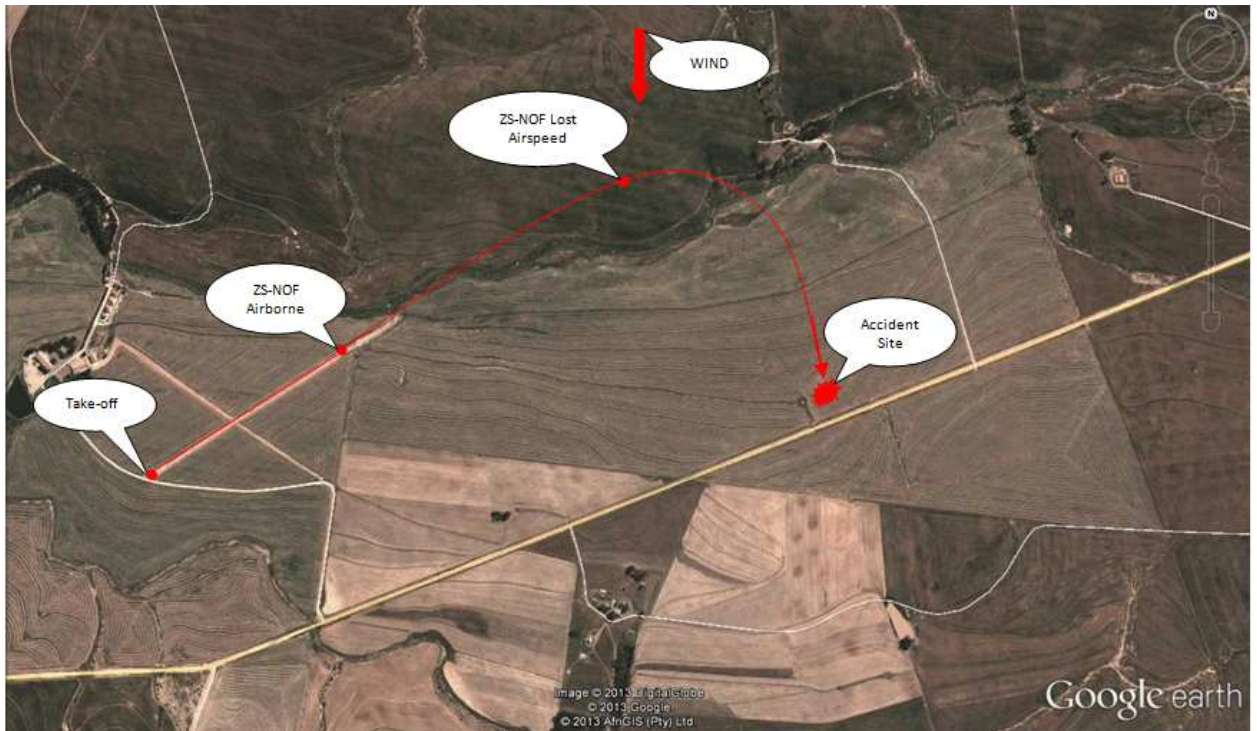
- 1.1.3 The aircraft was on the lee side of the hill when it experienced wind shear. The pilot attempted to recover by releasing the fertilizer that was intended for the crop spraying exercise in order to reduce his weight and increase the aircraft's lift. He was unsuccessful in regaining control of the aircraft. The aircraft descended and impacted the ground.

Figure 1: Depicts flight path of the aircraft

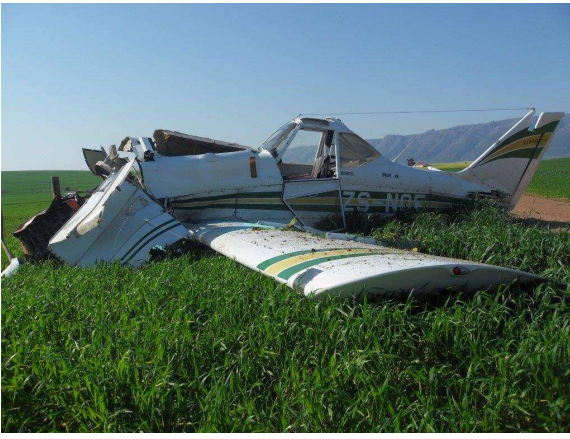
1.12.1 The aircraft impacted the ground in a nose down attitude and came to rest in a westerly direction in an open field surrounded by vegetation.

1.12.2 The aircraft sustained substantial damage to the forward engine section of the fuselage, propeller, wings, tail plane and undercarriage.

Figure 3: Side view of the aircraft

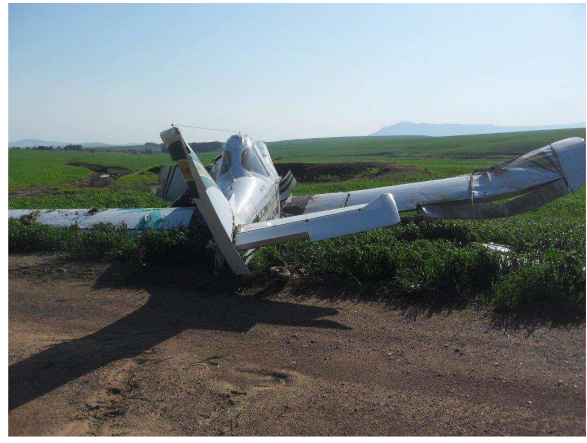
Figure 4: View from the back

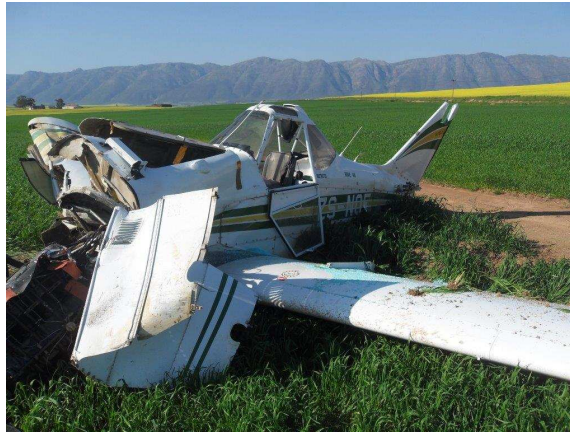
Figure 5: The destroyed forward section of the aircraft

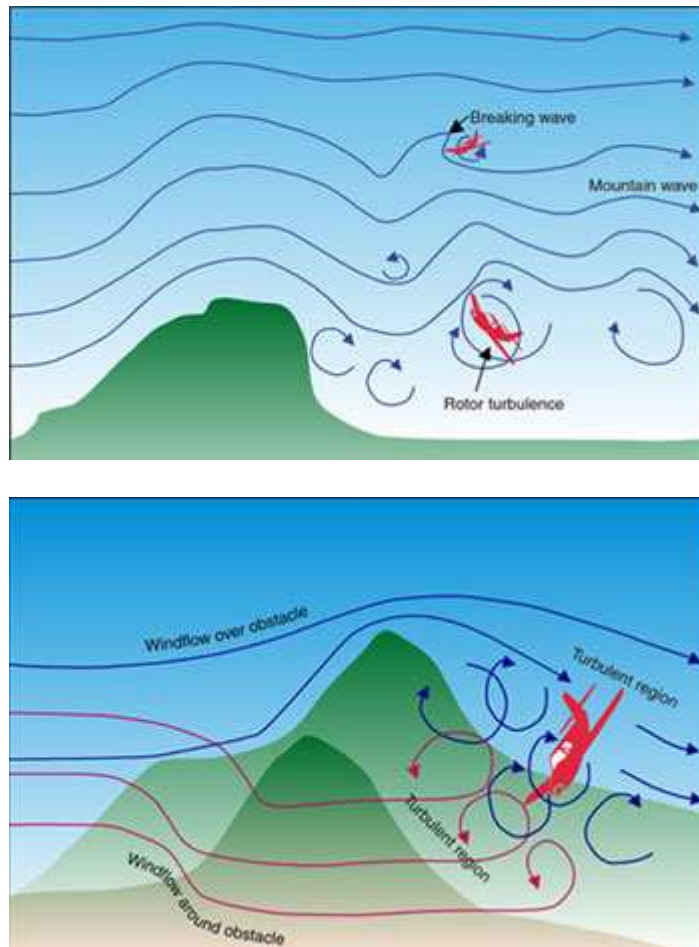
Figure 6 & 7: Illustration of mountain wave and associated turbulence
