| AIRCRAFT INCIDENT REPORT AND EXECUTIVE SUMMARY |

| | | | | Reference: | CA18/3/2/0999 | |
| Aircraft Registration | ZS-SMJ | Date of Accident | 10 September 2013 | | Time of Accident | 1848Z |
| Type of Aircraft | Boeing 737-300 | | Type of Operation | | Commercial – Cargo | |

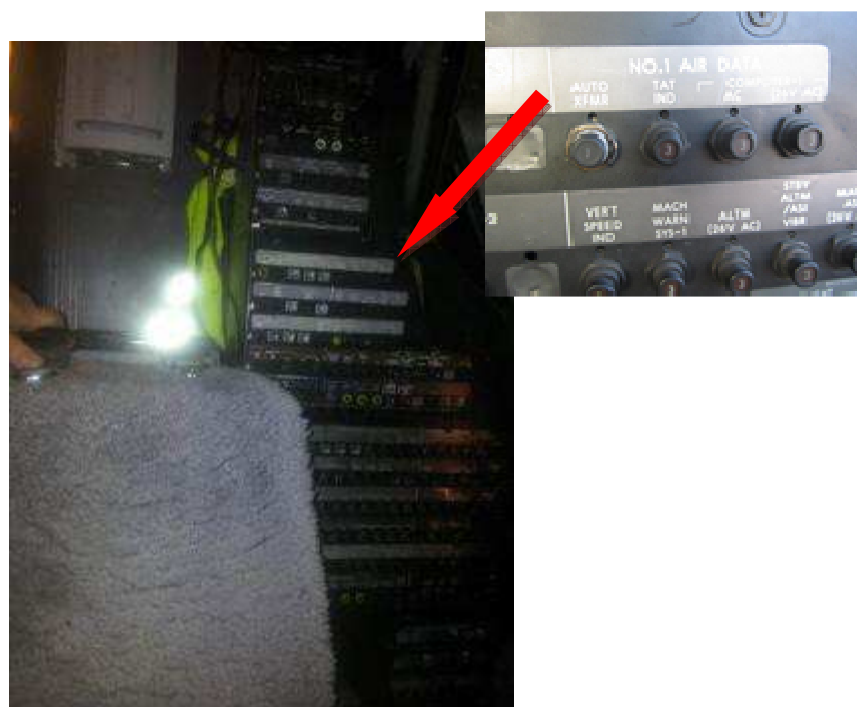
Figure 4: P28 circuit breaker panel showing #1 central air data computer system.

1.14.2 The crew reported seeing smoke coming from behind and to the left of the captain's seat, where the circuit breaker panel is situated. The smoke dissipated within a few minutes.

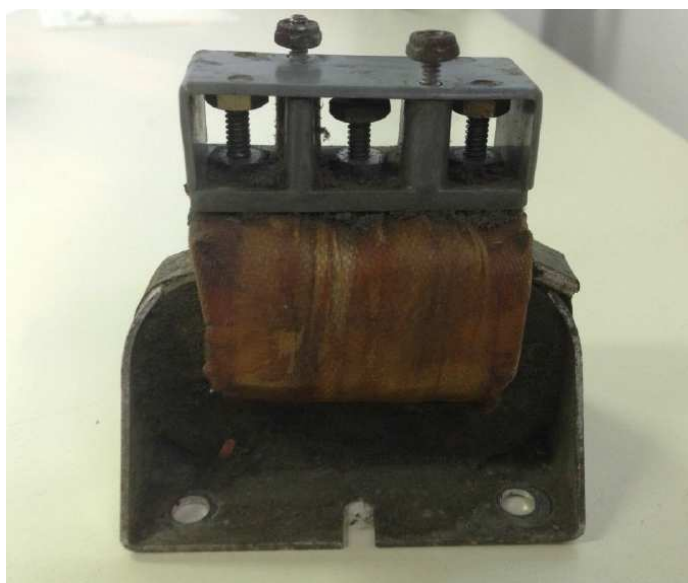
Figure 5: The T98 transformer that was removed from the aircraft.

1.16.4 The T98 transformer was returned to the AMO for inspection and investigation by the engineering department. No significant findings were noted. After the inspection, the transformer was load-checked for approximately six hours. No problems were observed, and there was no heat gain in the unit under normal load conditions.

- 2.2.2 The removed transformer was sent for further inspection and investigation. No significant findings were noted. The transformer was also load-checked for approximately six hours. No problems were observed and there was no heat gain in the unit under normal load conditions.

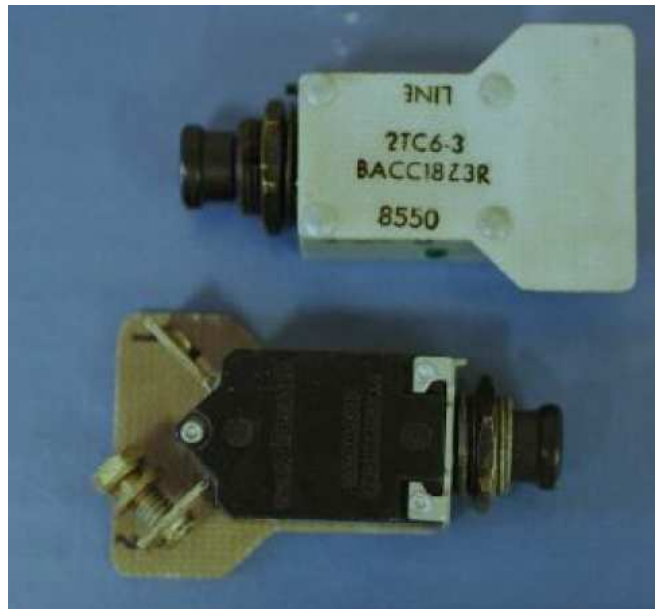
- 1.1.2 While the aircraft was passing through flight level F170, several of the captain's primary flight instruments failed. The crew continued the climb to F210. The captain then smelt burning and noticed a significant amount of smoke emanating from behind and to the left of his seat. The smoke was coming from the circuit breaker panel and the crew noticed that circuit breakers C498 and C425 had popped.

Figure 6: Circuit breakers C498 and C425.

- 2.2.4 The P5, P6 and P18 circuit breaker panels were also opened to inspect for any signs of smoke damage. None was found. Connectors were removed and cleaned in case of any moisture or contamination. The two circuit breakers that tripped during the flight were removed and sent to Megchem for further investigation. No fault could be found with the systems or components in the cockpit.
