Serious Incident - Final Report -

AAIS Case No. AIFN/0009/2013

Prolonged Runway Closure Due to Disabled Aircraft

Operator: Air Ukraine International
Type: Boeing 737-800
Registration: UR-PSA
Location: Dubai International Airport
State of Occurrence: United Arab Emirates
Date of Occurrence: 14 September 2013

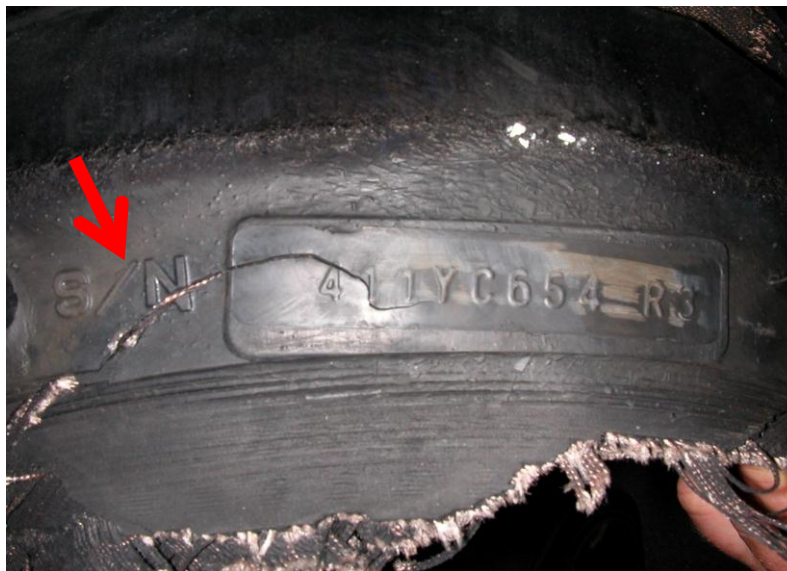
The Aircraft records and the pieces of tire collected from the take-off runway revealed that the burst H44.5X16.5-21 sized tire had Part Number (P/N) APS06015 and, Serial Number (S/N) 411YC654-R3, and was installed on No.2 (LH inboard) wheel assembly (figure 1).

Figure 1: Collected tire piece from the departure airport

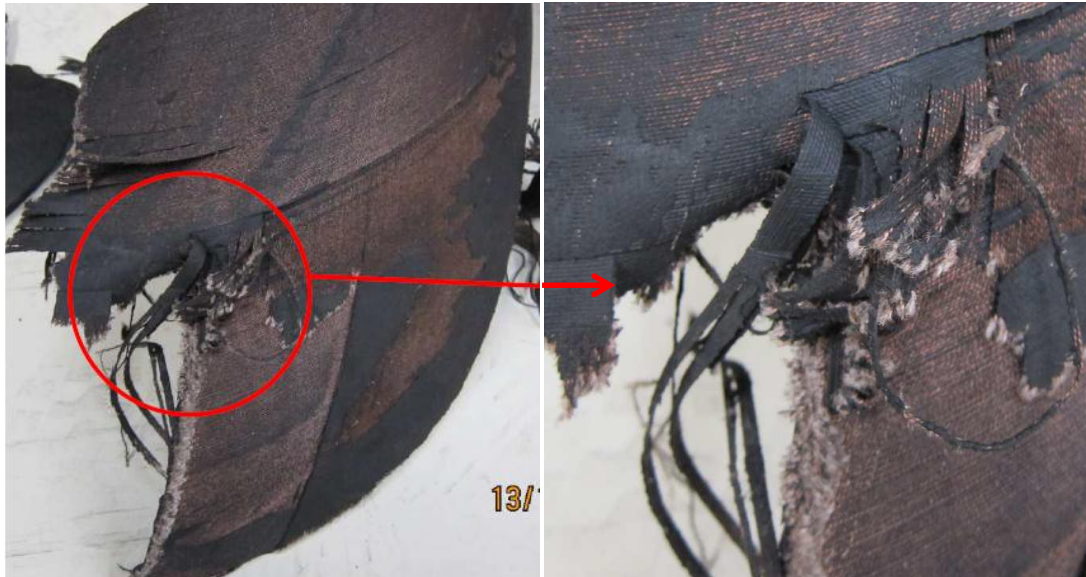
- Two main pieces were recovered from the departure airport and one from the arrival airport
- All pieces showed a diamond shape
- The recovered pieces showed a separation at the casing plies. The separation occurred at about 30% of the casing total plies from the outside
- The casing separation could be explained by a sudden mechanical rupture
- The tread was still bonded to the casing which could give an indication that the tread separation was not caused by any production anomaly
- An identified suspected cut at the casing plies was observed on the debris which could be caused by an external impact (figure 2).
- The footprint of the remaining tire debris shows signs of overload which was mainly the result of an underinflated condition.

Figure 2: Sharp cut on the No.2 tire piece

The manufacturer's report concluded that the tire rupture was due to contact with a foreign object leading to sudden tire burst. The first debris casing pieces were thrown at the departure airport while the remaining pieces disintegrated at the arrival airport.

The shape of the recovered pieces of the No.2 tire showed indications of sharp cuts due, most probably, to contact with a foreign object. The Investigation believes that the foreign object was on the departure runway as evidenced by the crew's request to ATC to check whether there was debris left after the departure. Moreover, the recovered pieces showed a separation at the casing plies at about 30% of the casing total plies from the outside. The tire manufacturer's laboratory examination concluded that, it is, most probably, that casing separation was caused by a sudden mechanical rupture. The identified suspected cut of the casing plies that was observed on the debris supported the probability of foreign object impact. The tread was still bonded to the casing which provided an indication that the tread separation was not caused by any production anomaly.
