AIRCRAFT ACCIDENT REPORT AND EXECUTIVE SUMMARY

Reference:	CA18/2/3/9221	
Aircraft Registration	ZS-DWJ	Date of Accident	15 September 2013		Time of Accident	1030Z	
Type of Aircraft	Piper Cherokee 235		Type of Operation		Private		
Pilot-in-command Licence Type		Private Pilot	Age	55	Licence Valid	Yes	
Pilot-in-command Flying Experience		Total Flying Hours	465.5		Hours on Type	450.6	
Last point of departure		Mabalingwe Aerodrome (FAMA), Limpopo Province					
Next point of intended landing		Vryburg Aerodrome (FAVB), North West Province					
Location of the accident site with reference to easily defined geographical points (GPS readings if possible)							
150 m North west of the extended centre line of Runway 04 at Mabalingwe Aerodrome (GPS position S 24°49'53"E 028°34'18").							
Meteorological Information		Wind: 350°/10KT Visibility:10000m Temperature:35°C Dew point: Unknown Cloud cover: No clouds					
Number of people on board		1+3	No. of people injured	1+1	No. of people killed	0

AIRCRAFT ACCIDENT REPORT

Name of Owner : A J Fourie
Name of Operator : A J Fourie
Manufacturer : Piper Aircraft Corporation
Model : PA-28-235
Nationality : South African
Registration Marks : ZS-DWJ
Place

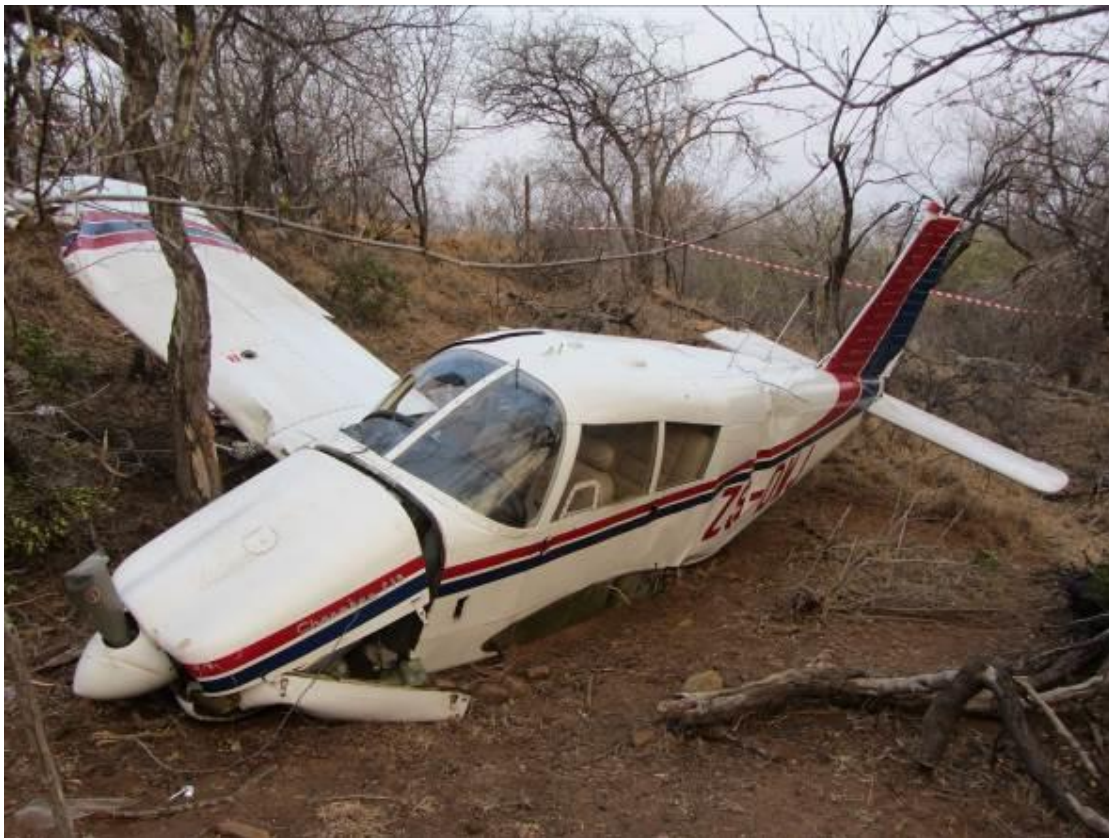
1.3.1 The aircraft sustained substantial damage during the sequence of the accident.

Figure 1. A view of the aircraft as it came to rest.

1.12.5 The left wing was broken off and found underneath the right wing on the opposite side of the fuselage. The right wing sustained leading edge crush damage along the entire length, with substantial damage to the wing tip.

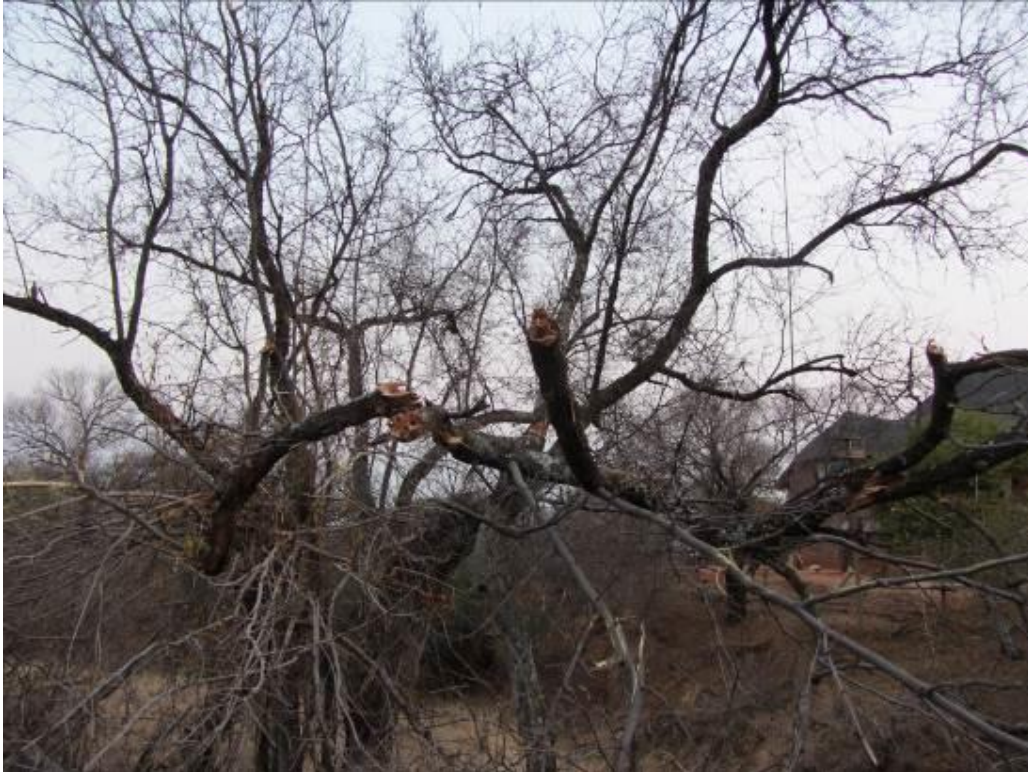
- 1.4.1 Damage was caused to the surrounding vegetation when the aircraft collided with trees before hitting the ground.
- 1.4.2 Minor damage was also caused to surrounding grass, and the ground was contaminated by Avgas fuel and engine oil.

Figure 2. Damage caused to the surrounded vegetation.

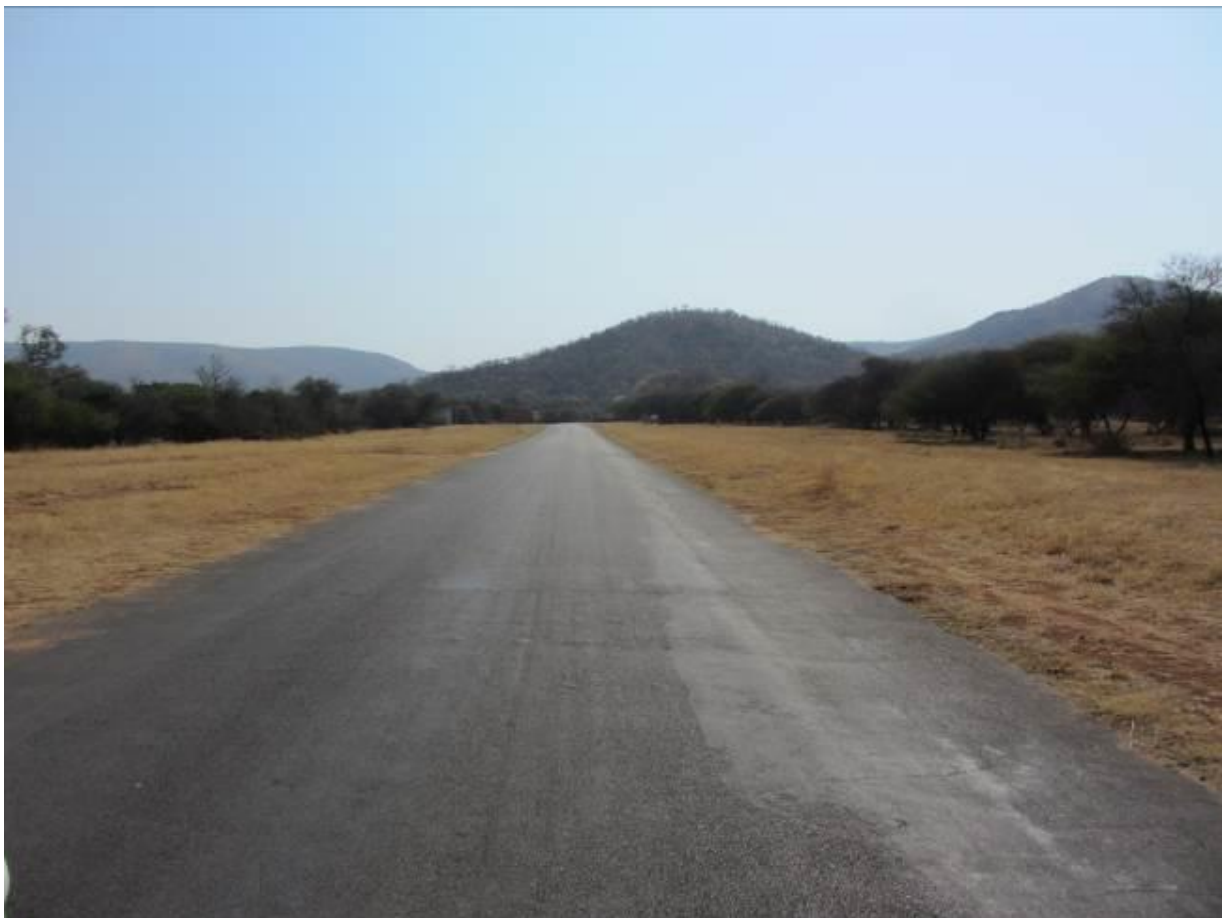
Figure 3 Runway 04 towards the mountain.

1.18.4 The take-off direction was in a 040 degree direction and towards a mountain on the extended centre line of Runway 04. Several pilots were interviewed who regularly use the runway at Mabalingwe and all of them agreed they never depart from Runway 04 due to the up-slope of the runway and the mountain at the end of the runway.

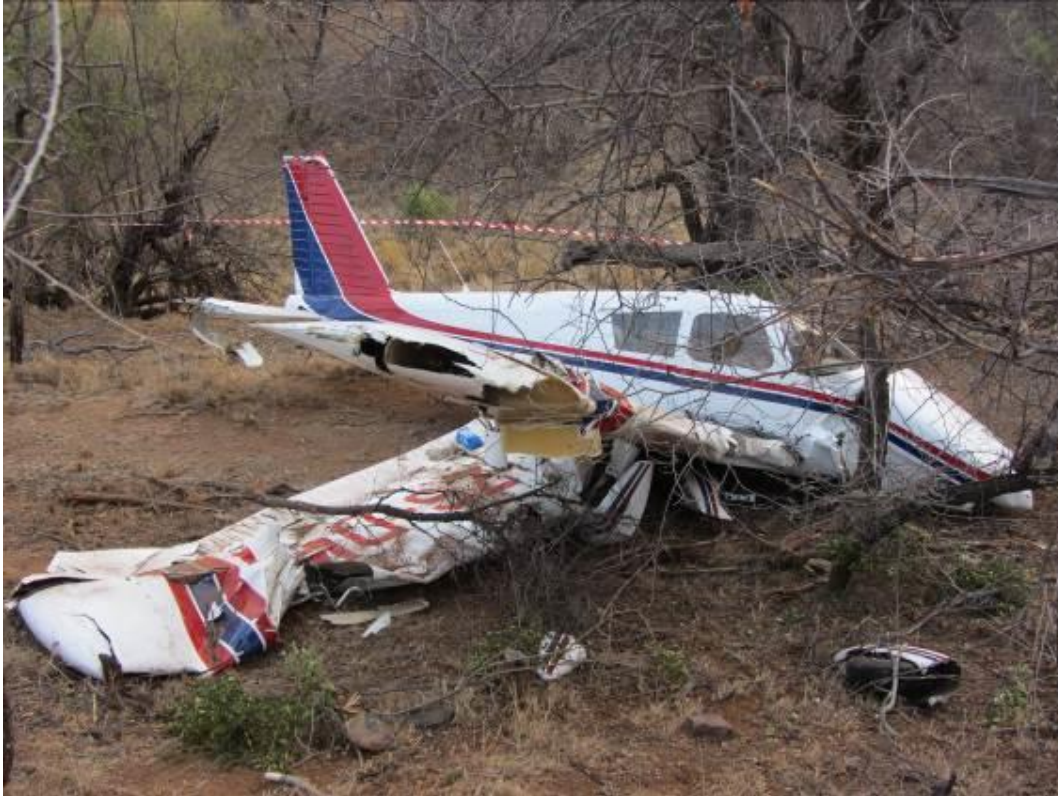
Figure 4 Position of the aircraft as it came to rest.

The final position of the flight path was at a point 150m to the North West of the extended centre line of Runway 04 and 230m from the end of the runway. The nose was pointing in a direction of 040 degrees magnetic.

The aircraft hit several trees at heights between 10 and 15 meters before it hit the ground. The skidding movement of the aircraft on the ground was stopped by a tree in the skid path of the aircraft.

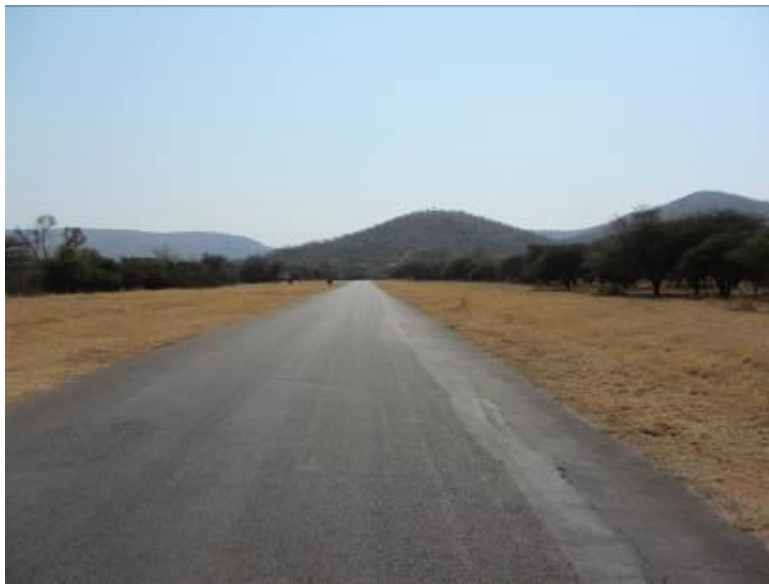
Runway 04 was used for the take-off. The slope on Runway 04 was calculated to be a +1% slope.

Figure 5 Upslope runway towards the mountain.

The low atmospheric density and up-slope of the runway, together with the weight of the aircraft had an influence on its performance which resulted in a longer than normal take-off distance.
