AIRCRAFT ACCIDENT INVESTIGATION BUREAU

**FINAL INVESTIGATION REPORT ON ACCIDENT
TO M/s UNITED HELICHARTERS
BELL 212 HELICOPTER VT-HGB
AT (TUKAWADE) THANE
ON 29/09/2013**

AAIB (India) Report No. : 2014-ACC-

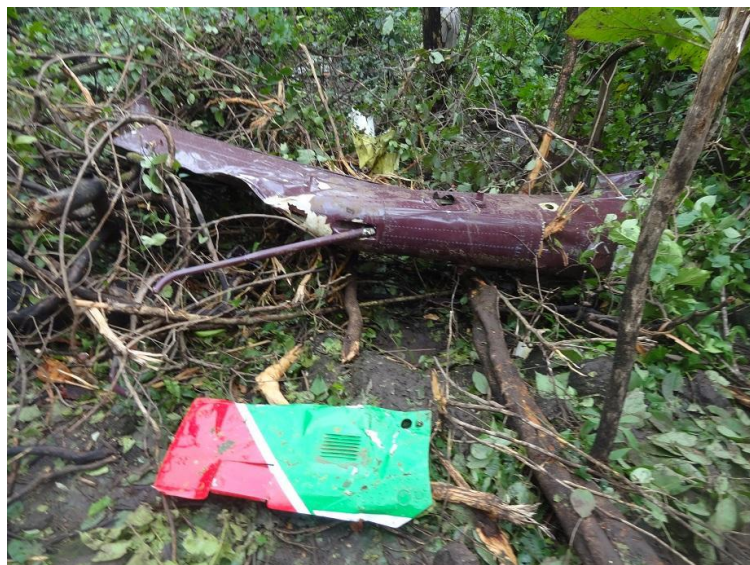
- The tail boom was broken with 90 degree gearbox intact.

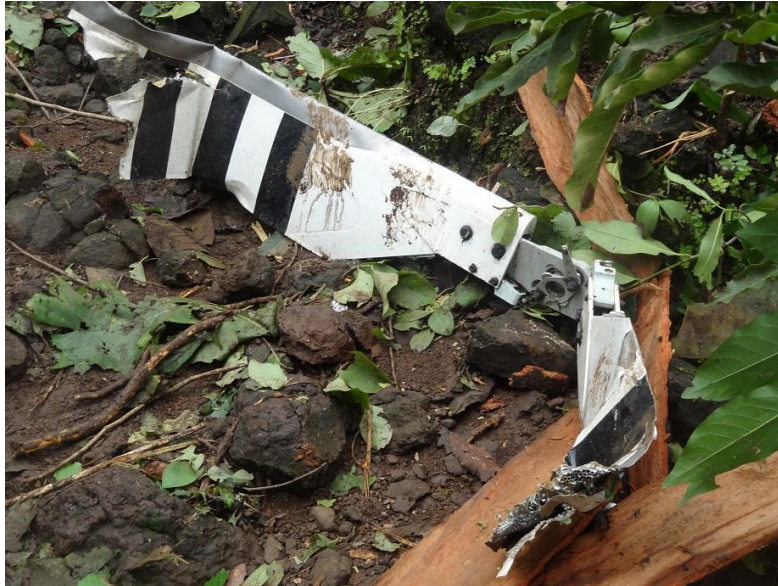
- The tail rotor hub and blade assembly were lying together at some distance from the tail boom.

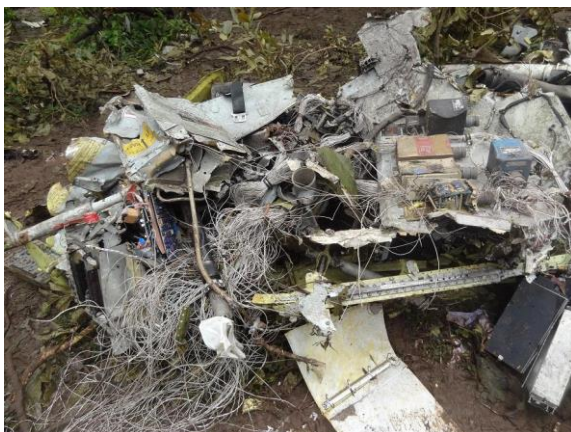
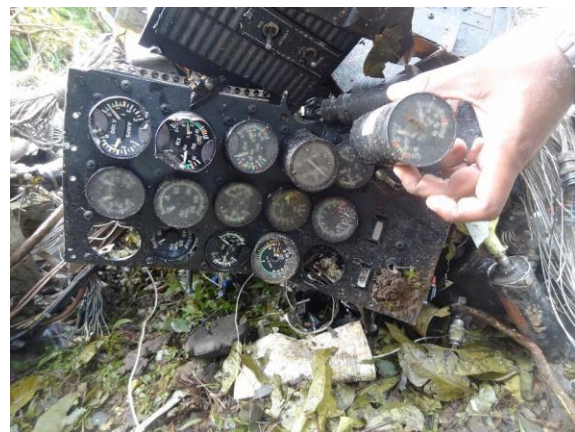
- Both the elevators were in completely distorted condition.
- The skid tubes and aft cross tube were found broken in 2-3 pieces. The forward cross tube was intact lying singly.
- The co-pilot door was in one piece lying on the ground with broken window.
- Both the passenger doors were completely broken into many pieces.
- All the flight control tubes, bell crank were found to be either bent, broken or distorted.
- The cockpit had completely collapsed along with all the instruments, equipments and collective, cyclic controls.

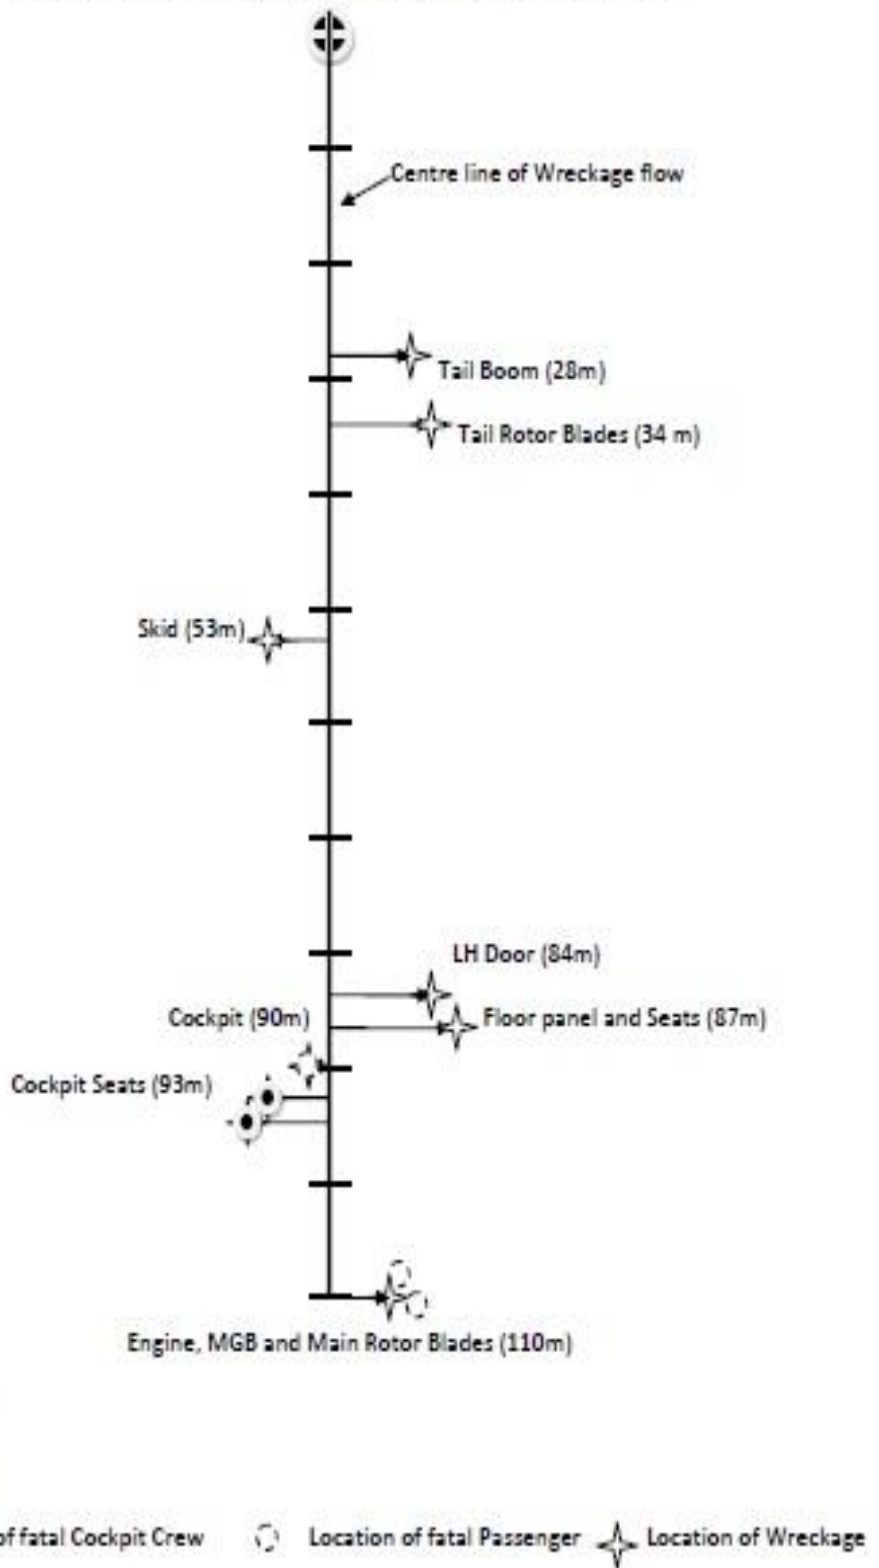
WRECKAGE PLOT

Wreckage was spread in an area measuring around 120m in a straight line in East – West direction from the first point of impact. The width of the wreckage spread was 15m. The Engine, MGB and Main Rotor Blade wreckage was completely damaged and burnt, whereas other components were severely damaged and scattered in pieces. The helicopter has not struck the hill head-on nor made any contact with High Power Electricity Cables.

Point at which Helicopter strikes first on tree 10m above ground
