**FINAL ACCIDENT REPORT**

**5Y-BWL**

**09.10.2013**

**CIVIL AIRCRAFT ACCIDENT REPORT SUMMARY**  
**CAV/ACCID/5YBWL/13**

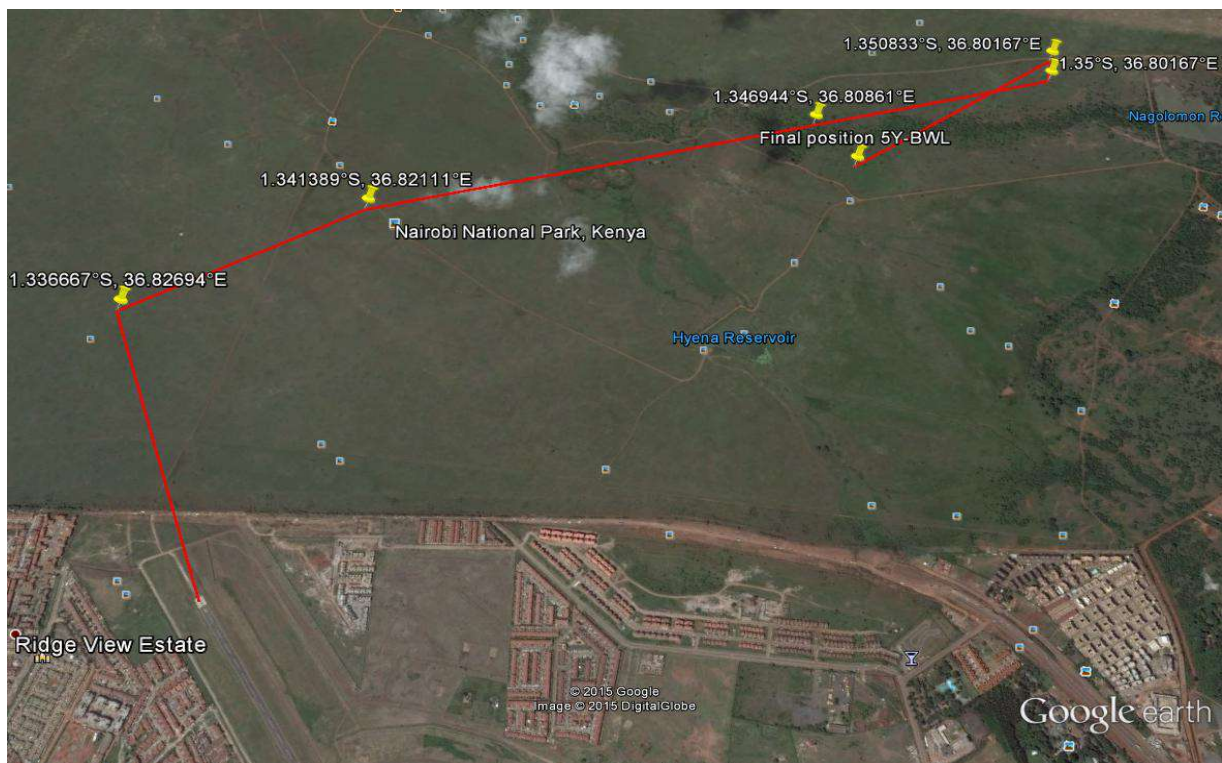
**Figure 1: Aircraft Flight Path**

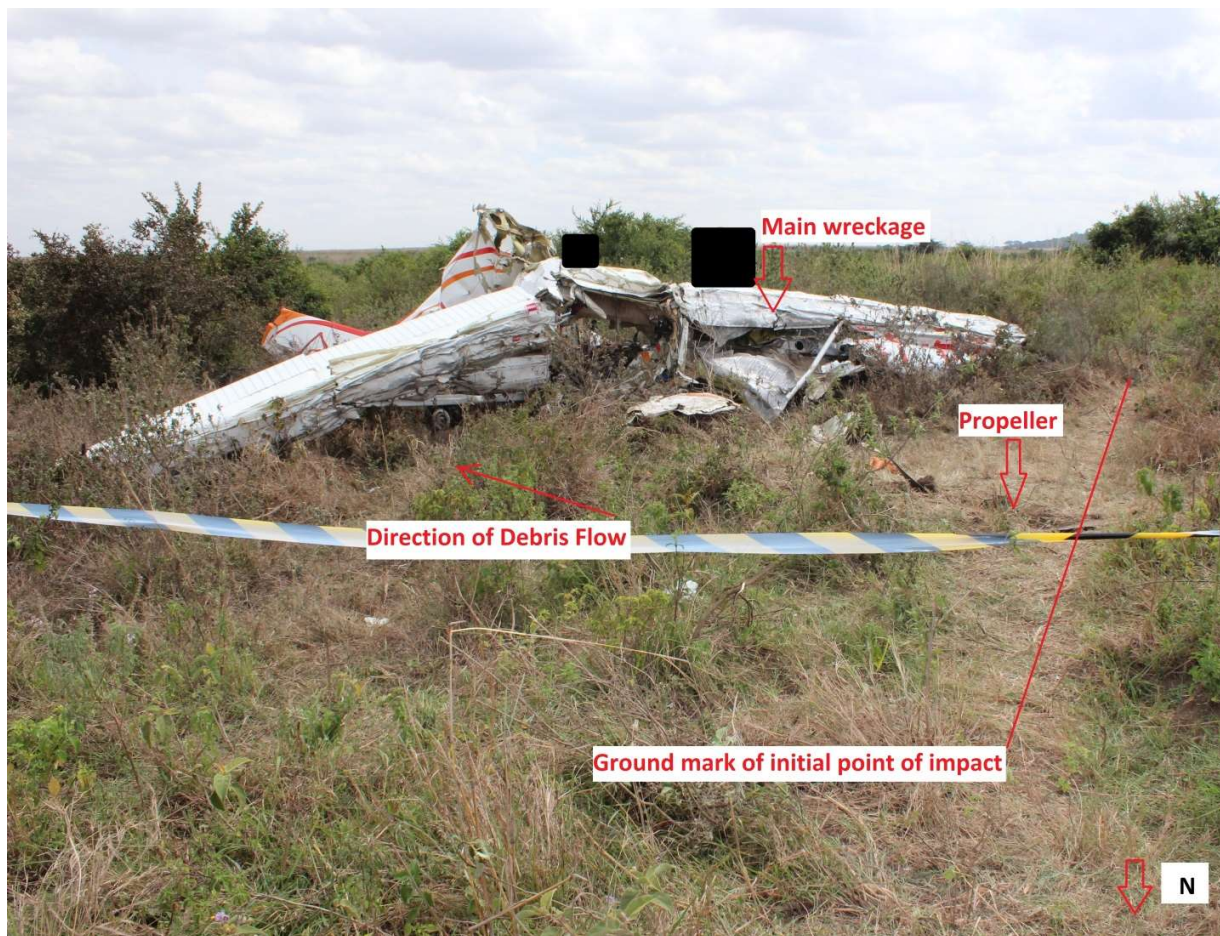
The initial impact mark on the ground was that of both wings and the propeller. There was a distinctive ground mark indicative that both wings hit the ground almost simultaneously. The front of the aircraft including the leading edge of the wings was found severely crashed and deformed. The propeller was found detached from the engine at the point of initial impact.

**Figure 1: Initial Impact point and direction of debris flow**

Glass fragments consistent with the windshield and a section of the spinner were found close to the point of separation of the propeller from the engine in the direction of debris flow. Further along the

debris trail was a detached section of the engine cowling located 3 meters from the propeller. A section of the front fuselage skin was also found separated 3.5 meters from the propeller.

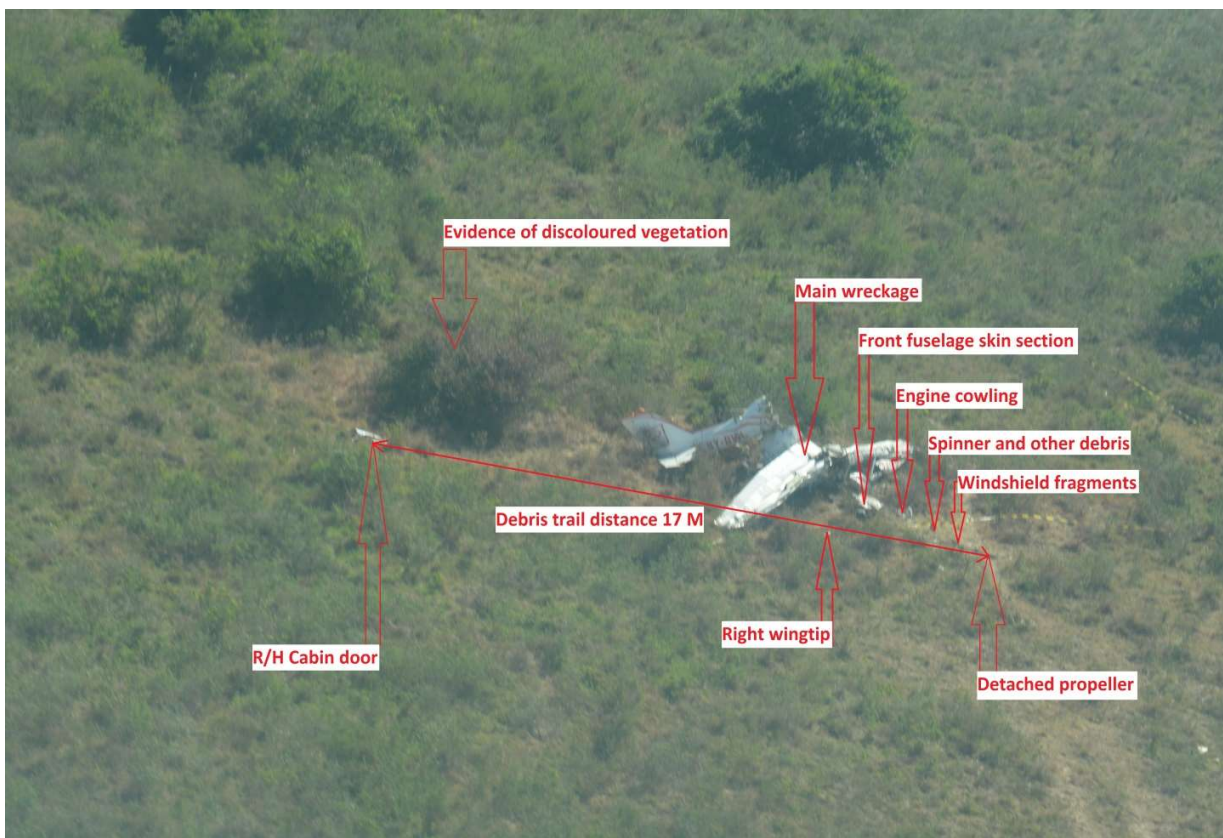
The main wreckage which included the nose wheel, engine, wings, fuselage and empennage was located 5 meters from initial point of impact. The tail section was located 10 meters from the propeller. The tail section was found to have broken from the main wreckage at about Fuselage Station FS 108.00. Other sections of the tail were found generally intact. Wingtips, left cabin door and right cabin door were found separated from the main structure. The right hand cabin door was found furthest from the initial point of impact at 17 meters from the propeller.

The right wing moved in a clockwise direction from the point of initial contact through an arc of 36° relative to the ground mark of initial impact. The left wingtip section remained relatively in the same position of initial impact as the rest of the aircraft moved in a clockwise direction. The right wing fuel tank was found ruptured and fuel was found released at high force into surrounding vegetation in the direction of debris movement. Evidence of discoloured brown vegetation in the direction of debris flow was found at the site.

**Figure 2: Wreckage debris trail at the accident site**

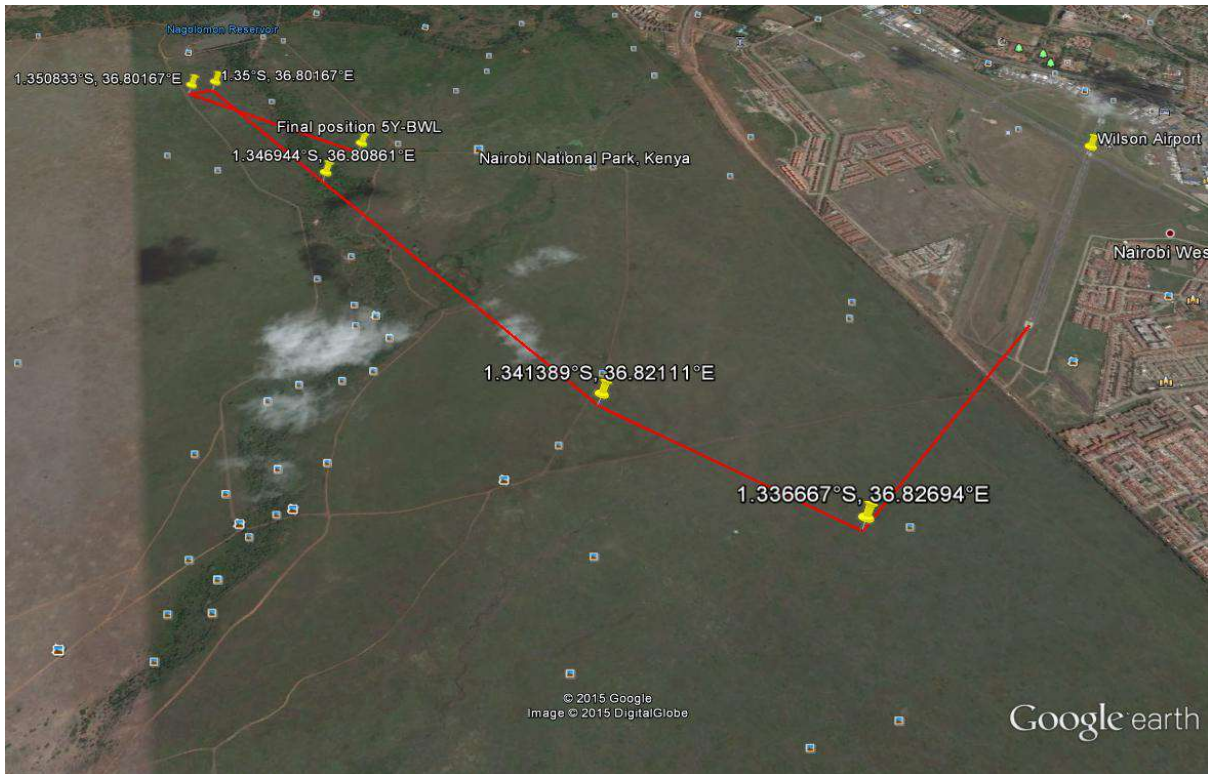
The aircraft appeared on radar at 09:15:52 while on the right downwind leg of runway 07 at an altitude of 5800 feet AMSL. The aircraft continued to climb normally until 09:16:43 when its ROC suddenly rose to 1300ft/min while at an altitude of 6200 feet AMSL. The aircraft continued to climb at 1300ft/min until it disappeared from radar at 09:17:08. The aircraft heading did not change substantially with the final heading recorded at 246°. The GS based on radar data remained constant at 88 knots from 09:16:43 until when the aircraft disappeared from radar. Figure 3 below indicates the aircraft flight track based on radar data.

**Figure 3: Accident Flight Track based on radar data**

Based on radar data, the last recorded position of the accident aircraft was on the downwind leg of runway 07 at an altitude of 6200 feet AMSL and climbing at 1300 feet per minute. This ROC would have indicated a sudden pitch-up of the aircraft. The sudden pitch-up was, however, not corroborated by witness information. It was considered that the high ROC recorded prior to the occurrence was likely to be inaccurate or as a result of a sudden and inadvertent pitch-up due to inadequate aircraft control or may have resulted from a deliberate yanking of the control column. The heading of 246° was generally consistent with an aircraft on the downwind leg of runway 07. The last aircraft groundspeed recorded was 88 knots. The aircraft disappeared from radar about 30 seconds after transmitting its last communication to TWR.

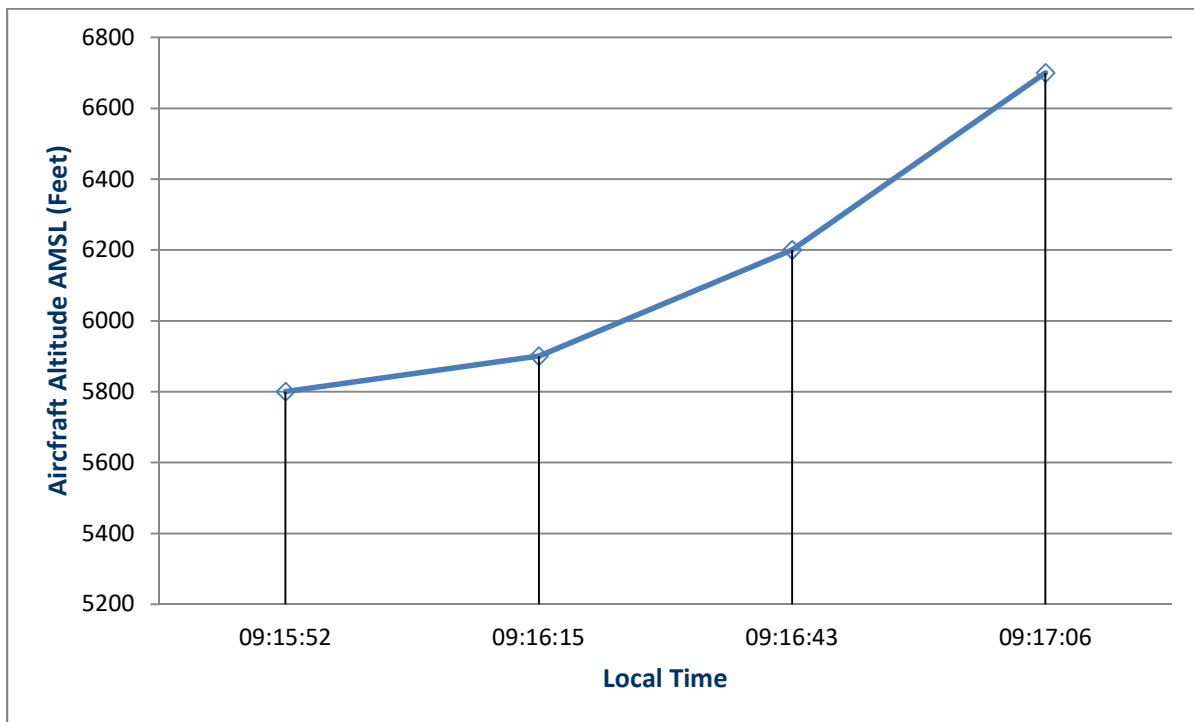
**Figure 4: Change in altitude over time for the accident flight**

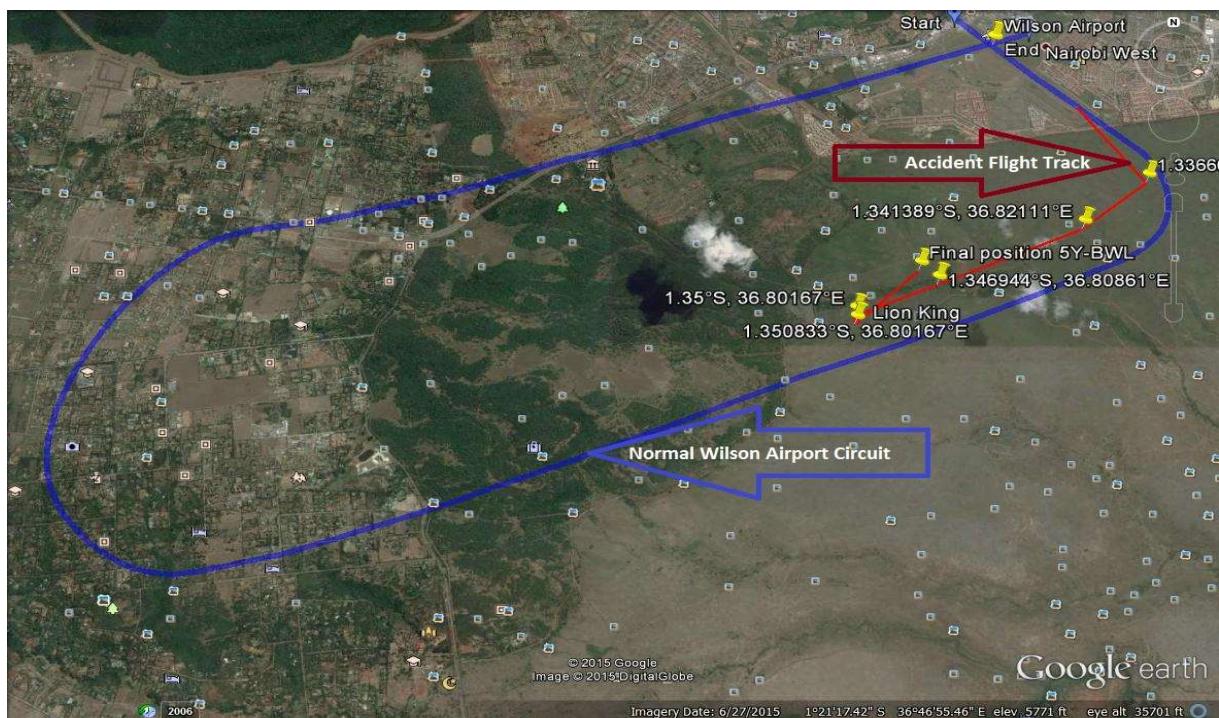
During the investigation, a flight was conducted to simulate a normal circuit pattern used for training flights at HKNW and compare it with the accident flight. The flight was conducted on a similar aircraft and with a FI. During the flight, take off was conducted from runway 14 with a right turn-out to the downwind leg of runway 07, then to the base leg and finals 07 for a touch and go. It was noted that variations do occur in the flights at the circuit pattern at HKNW, but the general pattern was always similar. The flight also provided for aerial photography of the accident site. Figure 5 below shows a comparison of the normal circuit pattern of the simulated flight with the flight track of the accident flight.

***Figure 5: A comparison of the accident flight track with a simulated normal circuit pattern at HKNW***

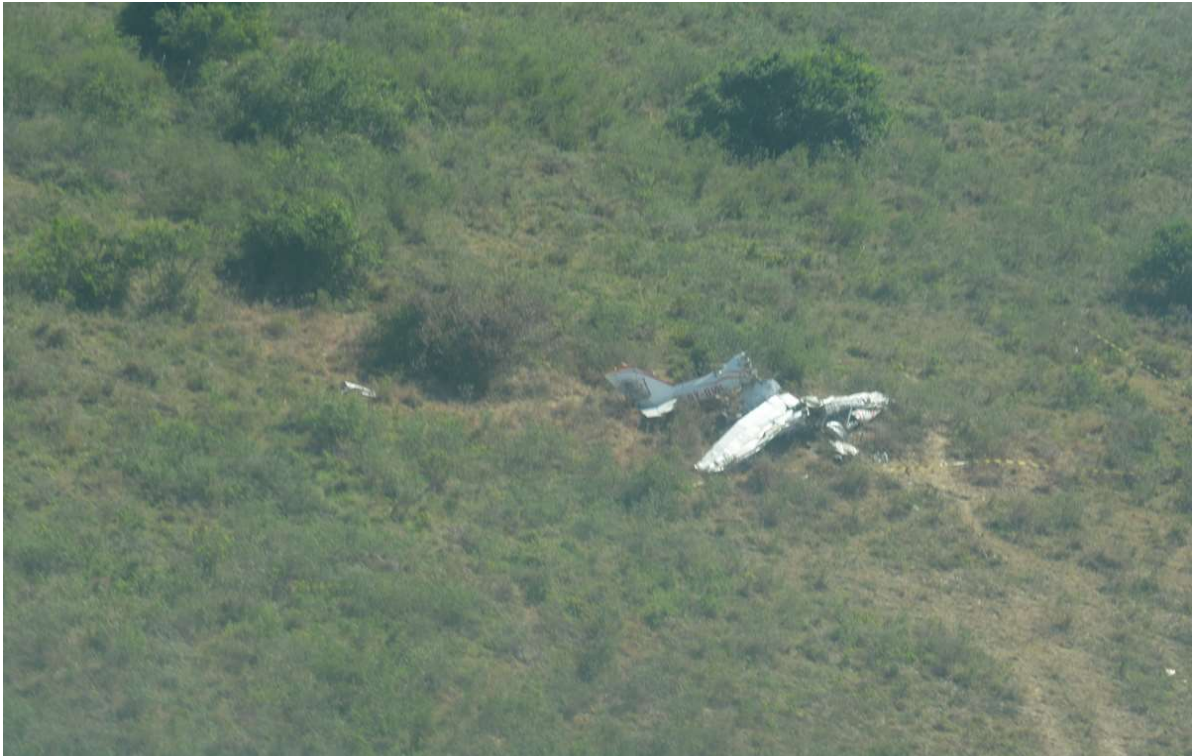
**Figure 6: Wreckage as seen from the right hand side of the aircraft**

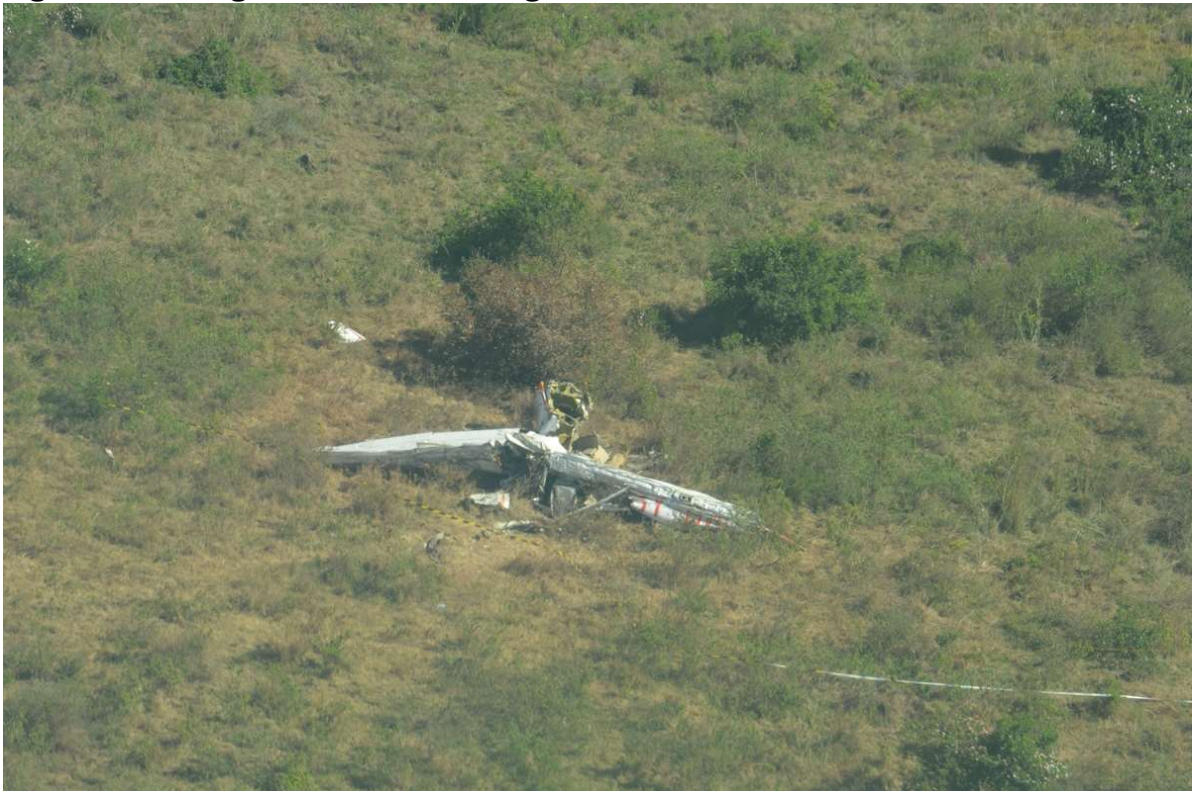
**Figure 7: Front aerial photograph of the wreckage taken in the direction of debris flow**

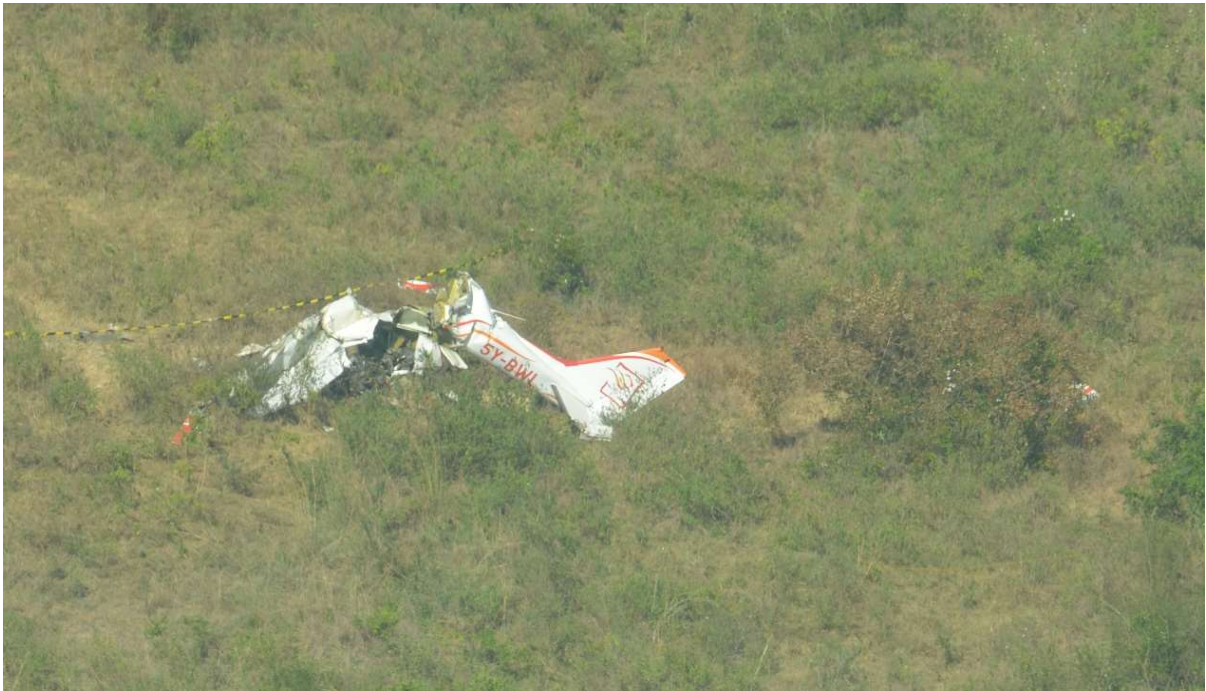
**Figure 8: Aerial photograph of the wreckage taken from the left hand side of the aircraft**

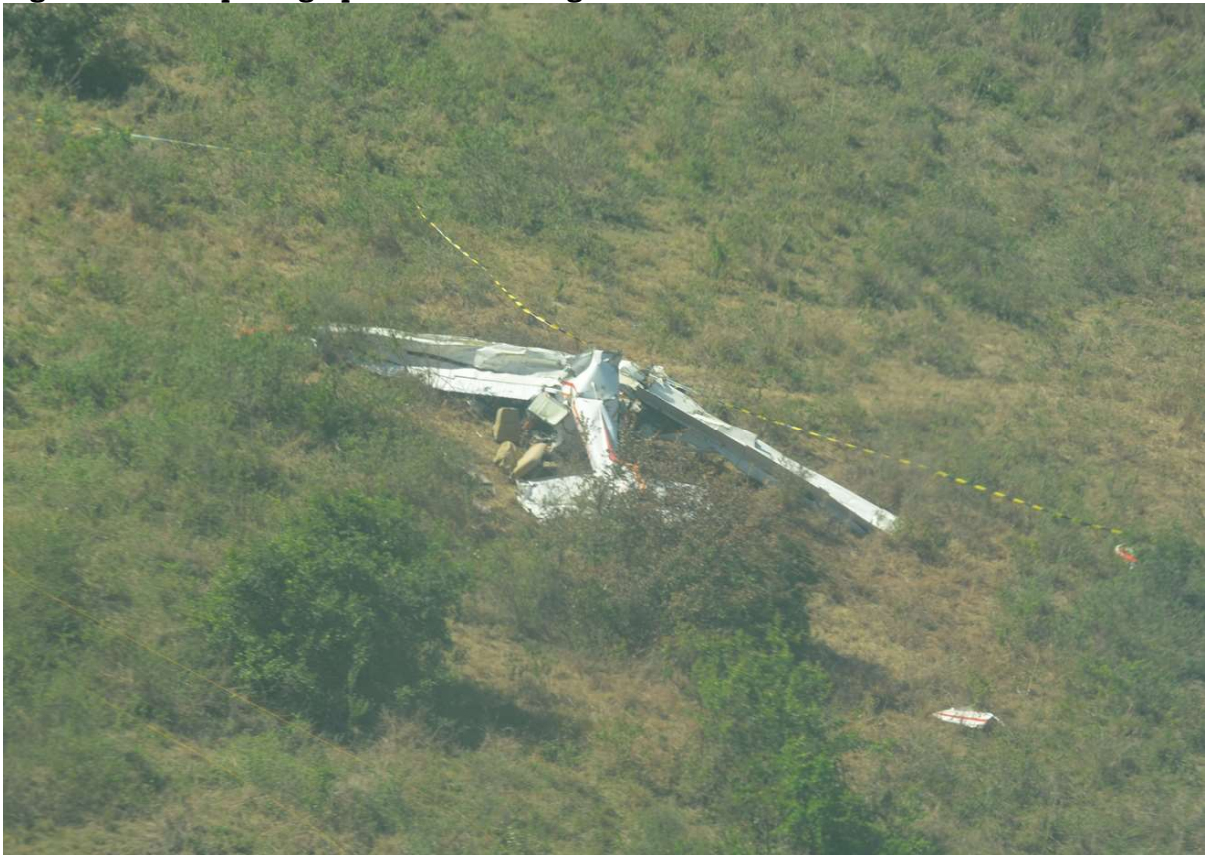
**Figure 9: Aerial photograph of the wreckage taken from the rear**

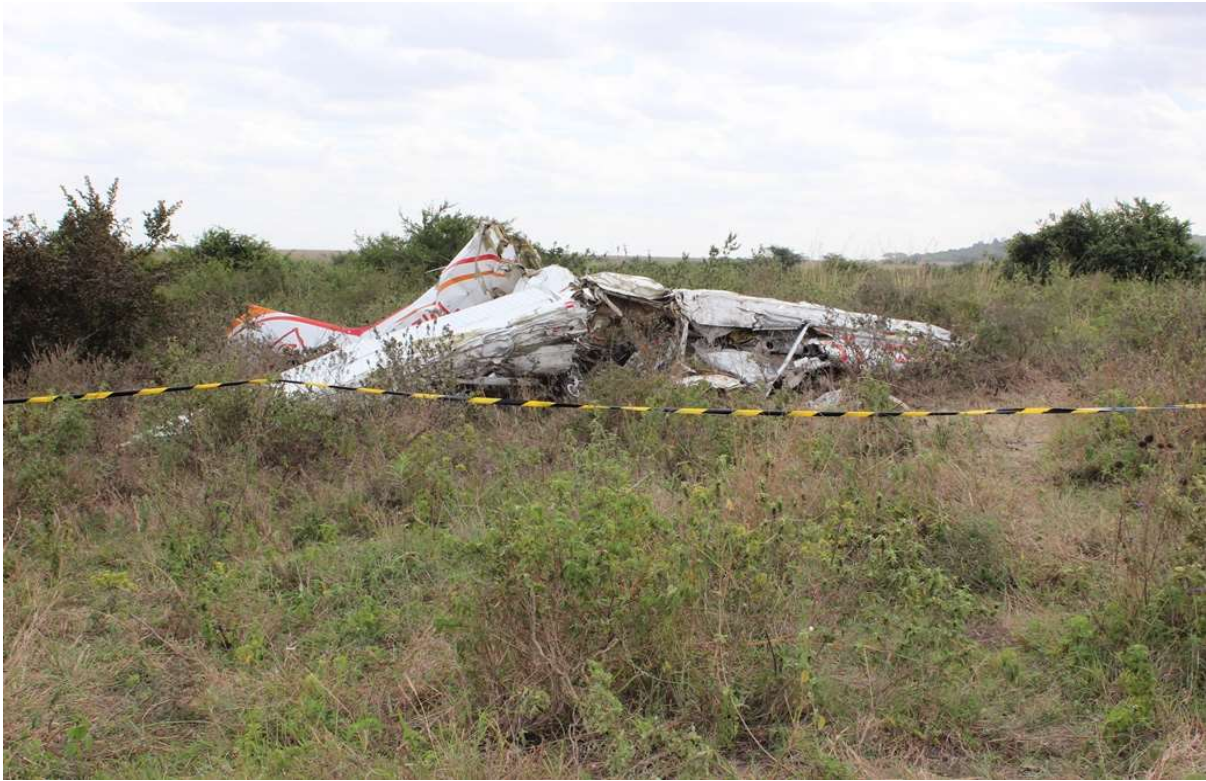
**Figure 10: Main wreckage**

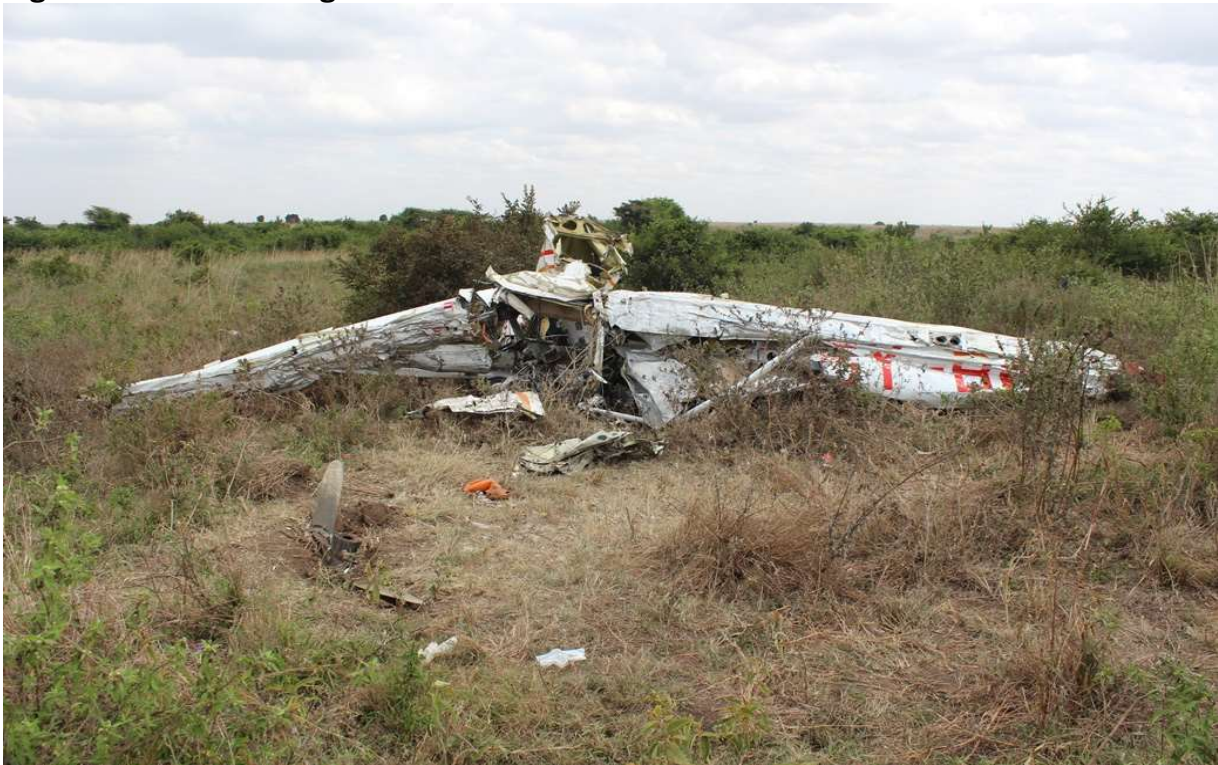
**Figure 11: Aircraft front section taken in the direction of debris flow**

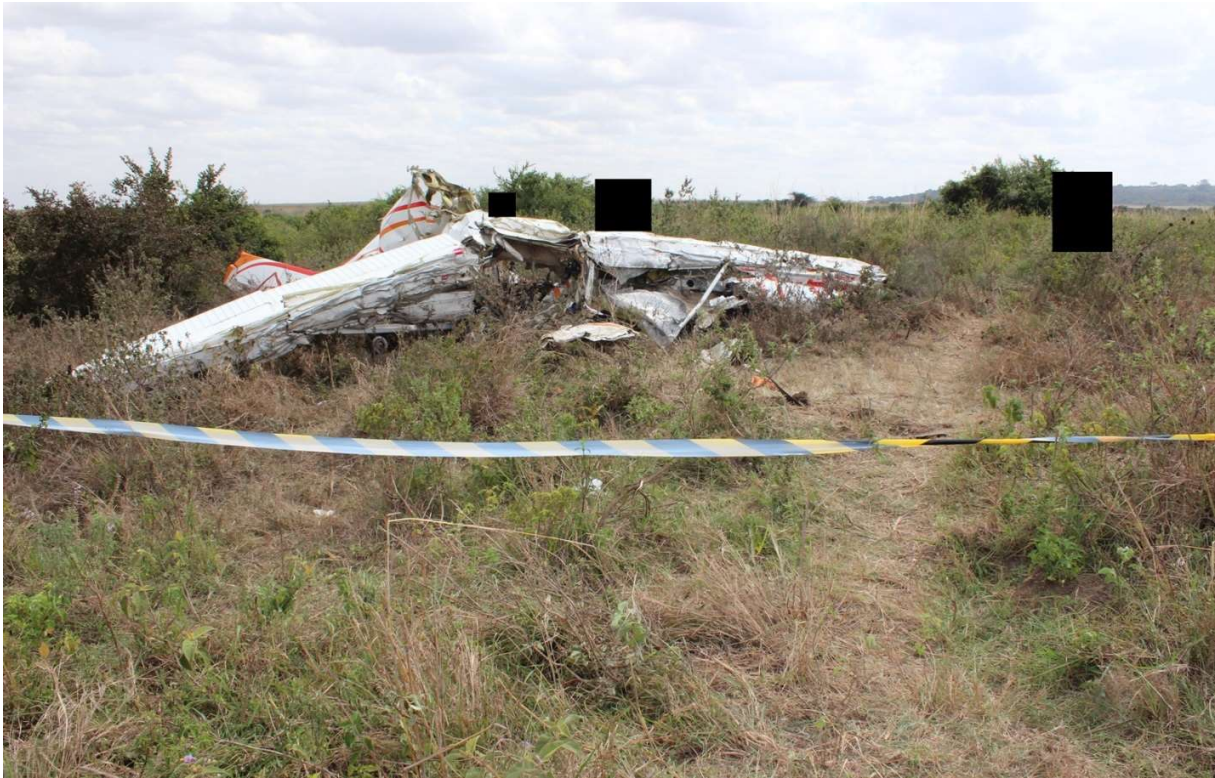
**Figure 12: Ground mark of initial point of impact and main wreckage**

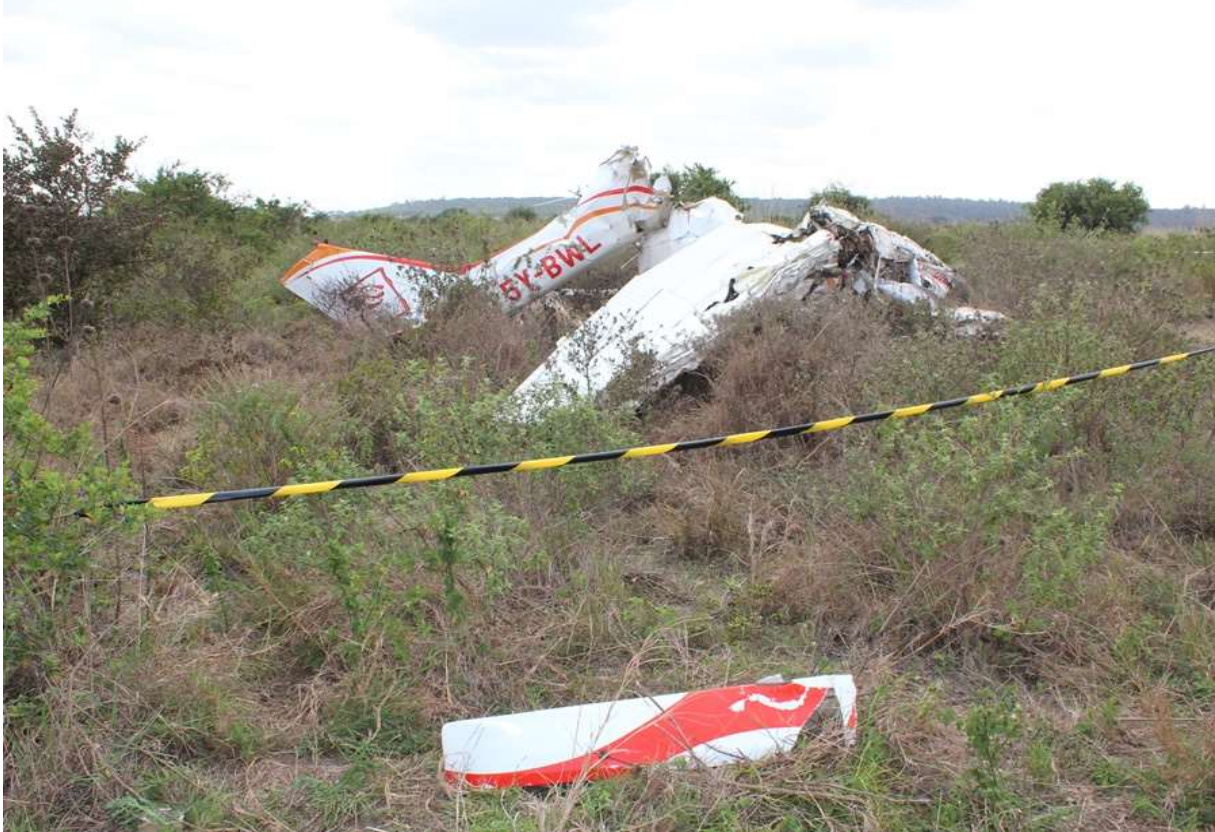
The aircraft right wing moved in a clockwise direction from the initial point of impact through an arc of 36°. The left wingtip section remained relatively in the same position of initial impact as the rest of the aircraft moved in a clockwise direction. This difference in alignment of the ground mark of initial impact and the final resting position of the main wreckage was a clear indication that the aircraft was in a spin to the right at the time of impact. This was corroborated by witness statements of those who had observed the spin.

**Figure 13: Right wing tip and main wreckage**

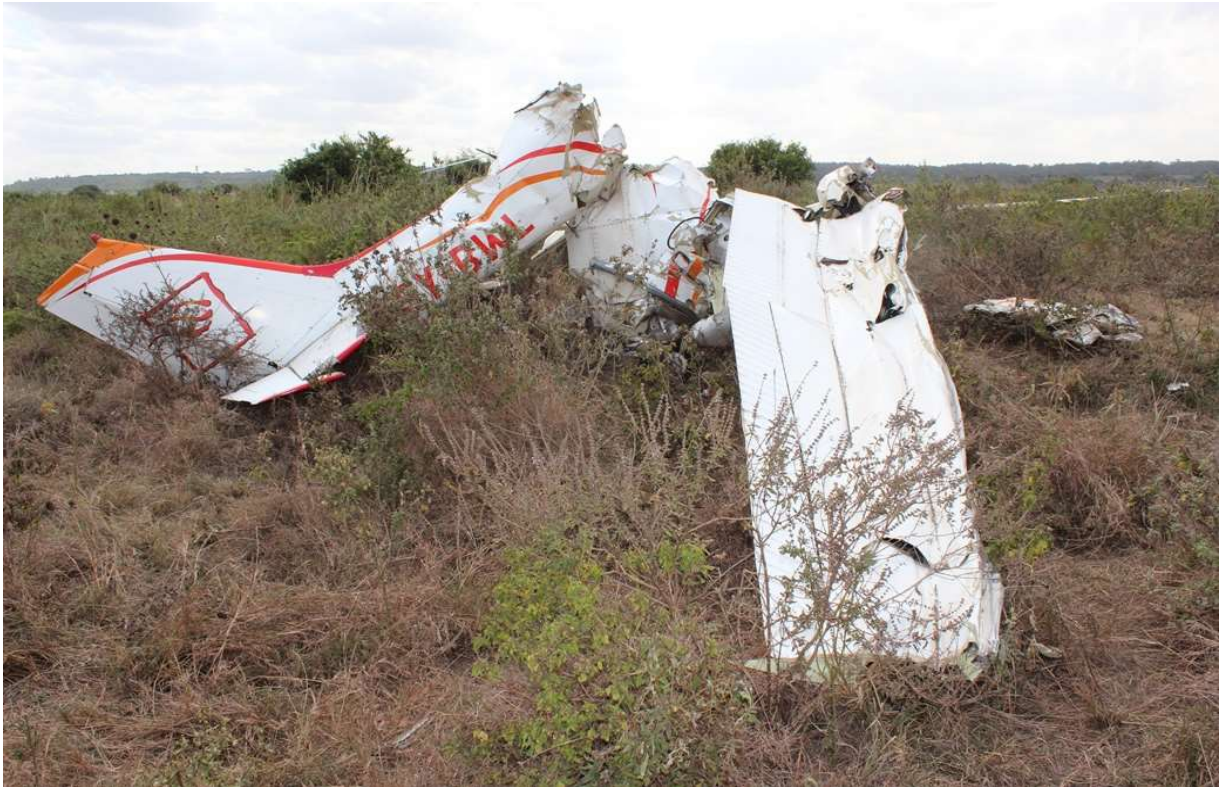
**Figure 14: Right wing and tail section as seen from the right side of the aircraft**

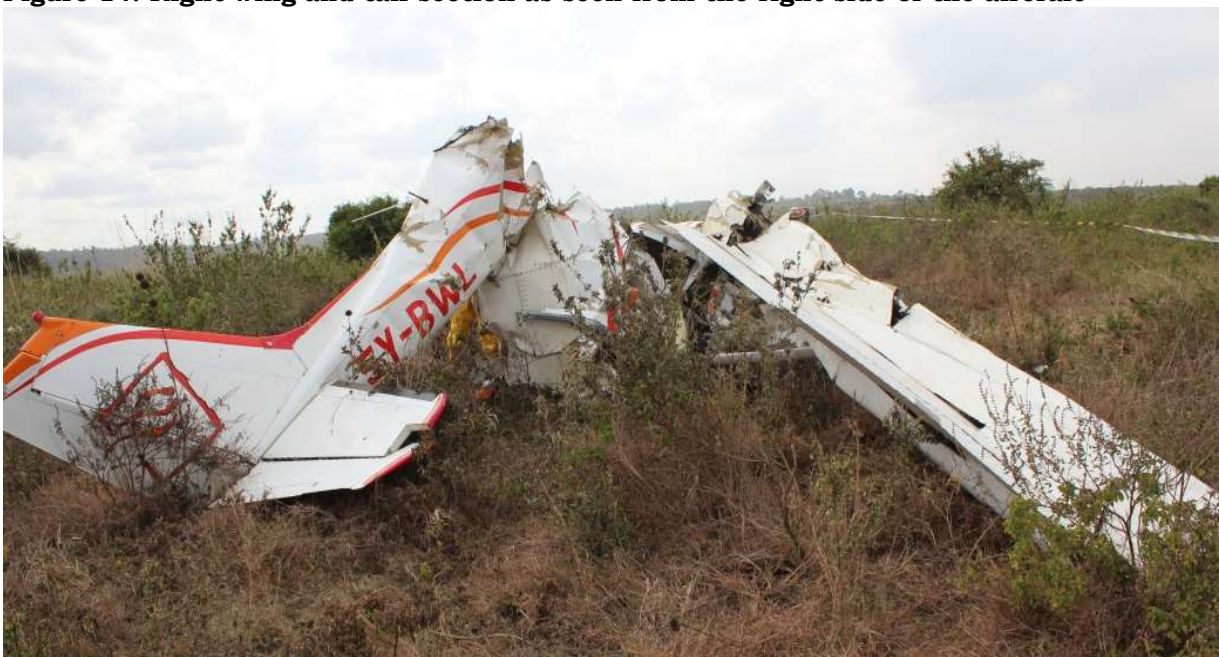
**Figure 15: Tail section and right wing**

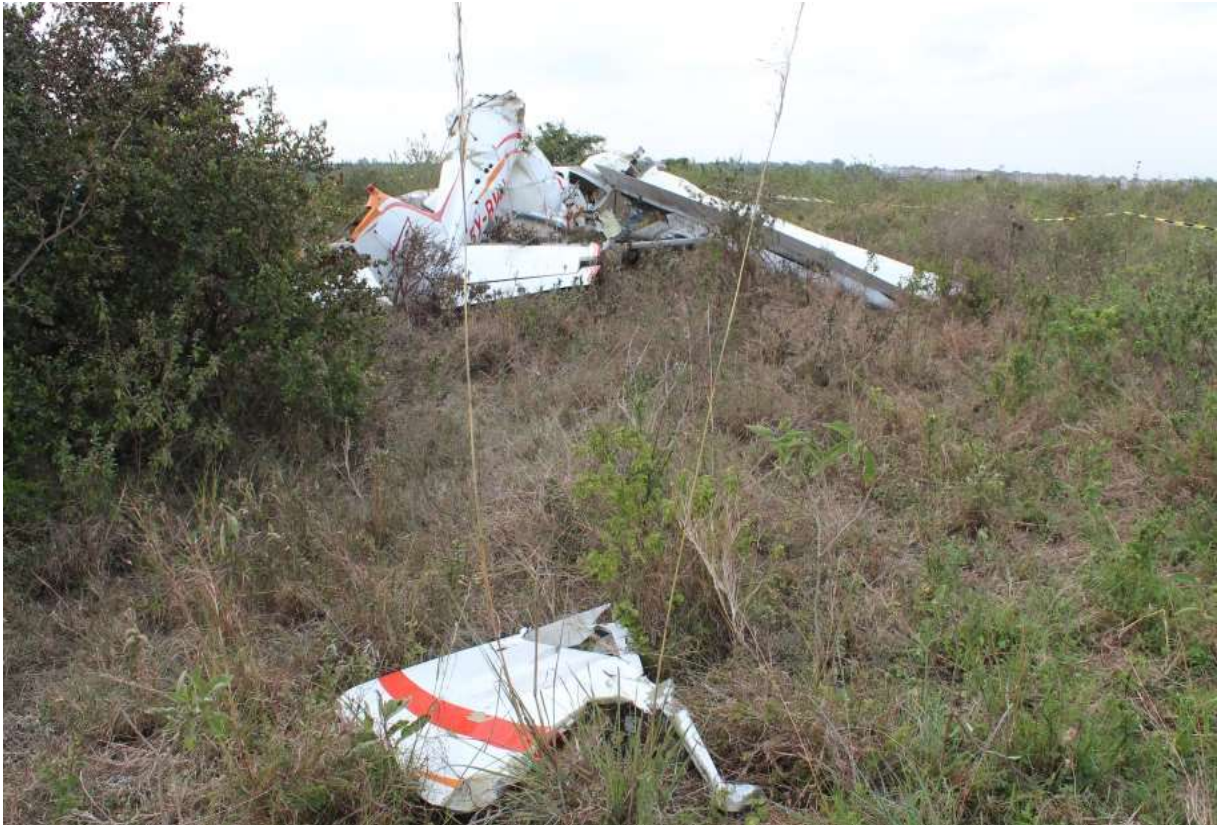
**Figure 16: Right cabin door and main wreckage as seen from the rear section of the aircraft**

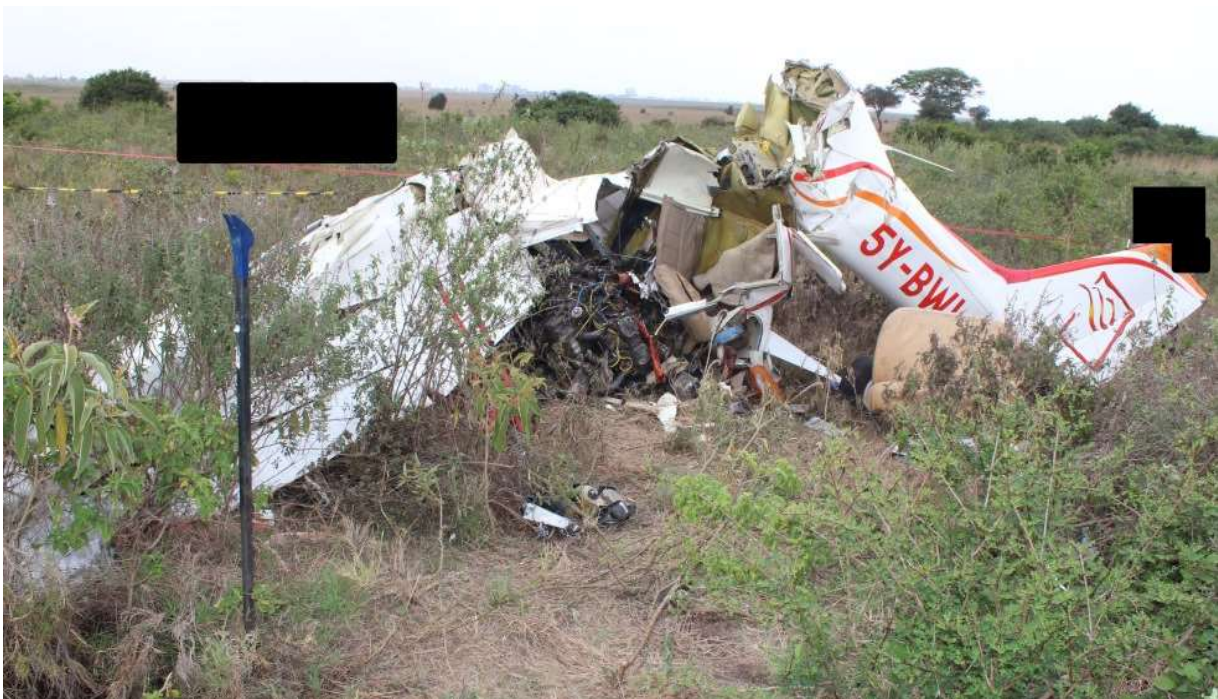
**Figure 17: Main wreckage as seen from the left side of the aircraft showing the engine**

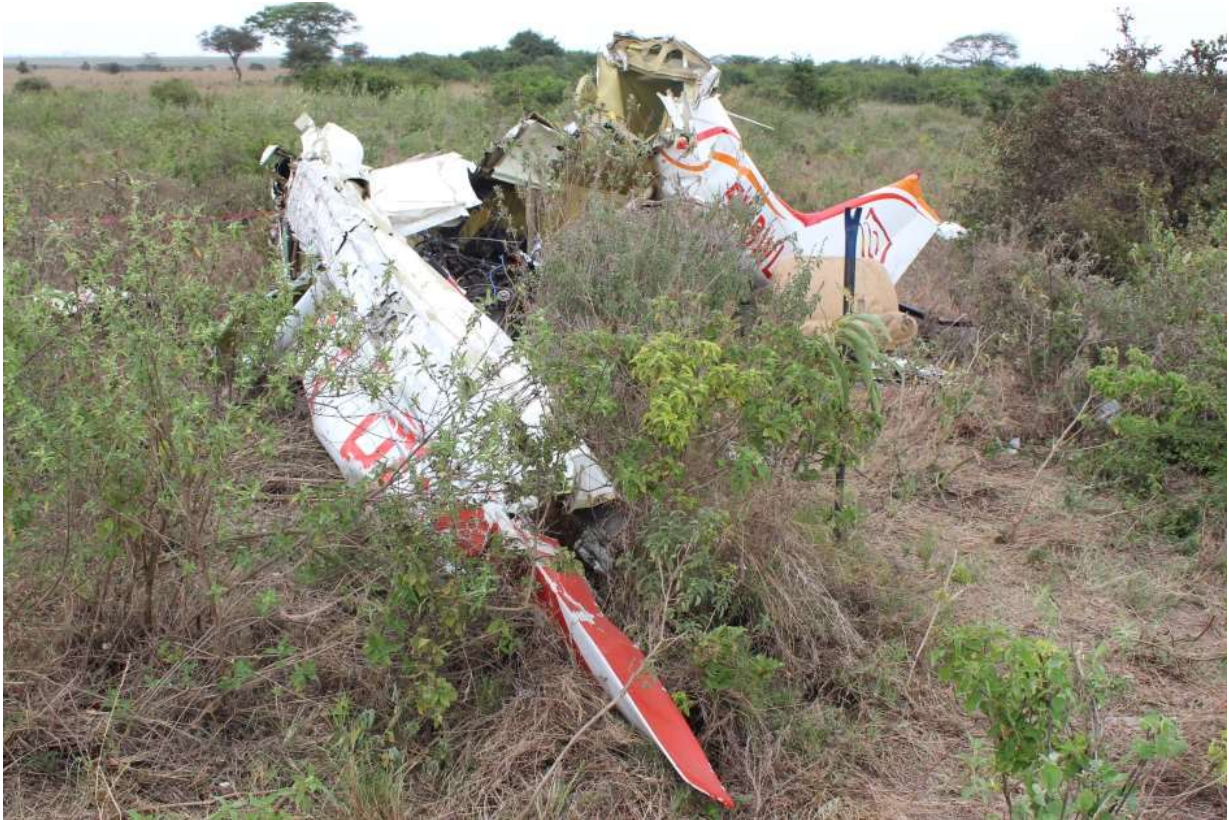
**Figure 18: Main wreckage as seen from the left side of the aircraft**

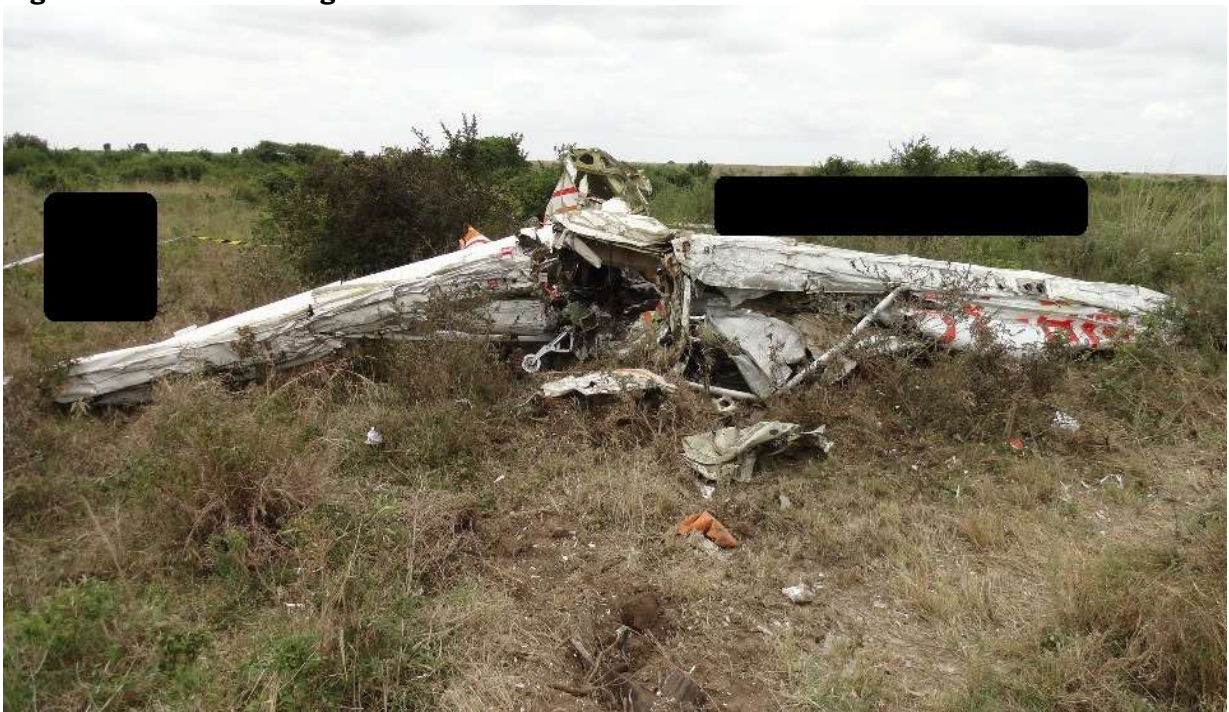
The aircraft crashed in an almost vertical, nose-down attitude on a relatively flat terrain. The cockpit area was badly damaged and disrupted as a result of ground impact at a high vertical velocity. The main wreckage was located 5 meters from the initial point of impact which was indicative of very low horizontal velocity. The aircraft did not disintegrate much at impact with the exception of the front section of the fuselage. The furthest piece of debris was

**Figure 19: Main wreckage indicating impact damage on the cabin and wing leading edges**

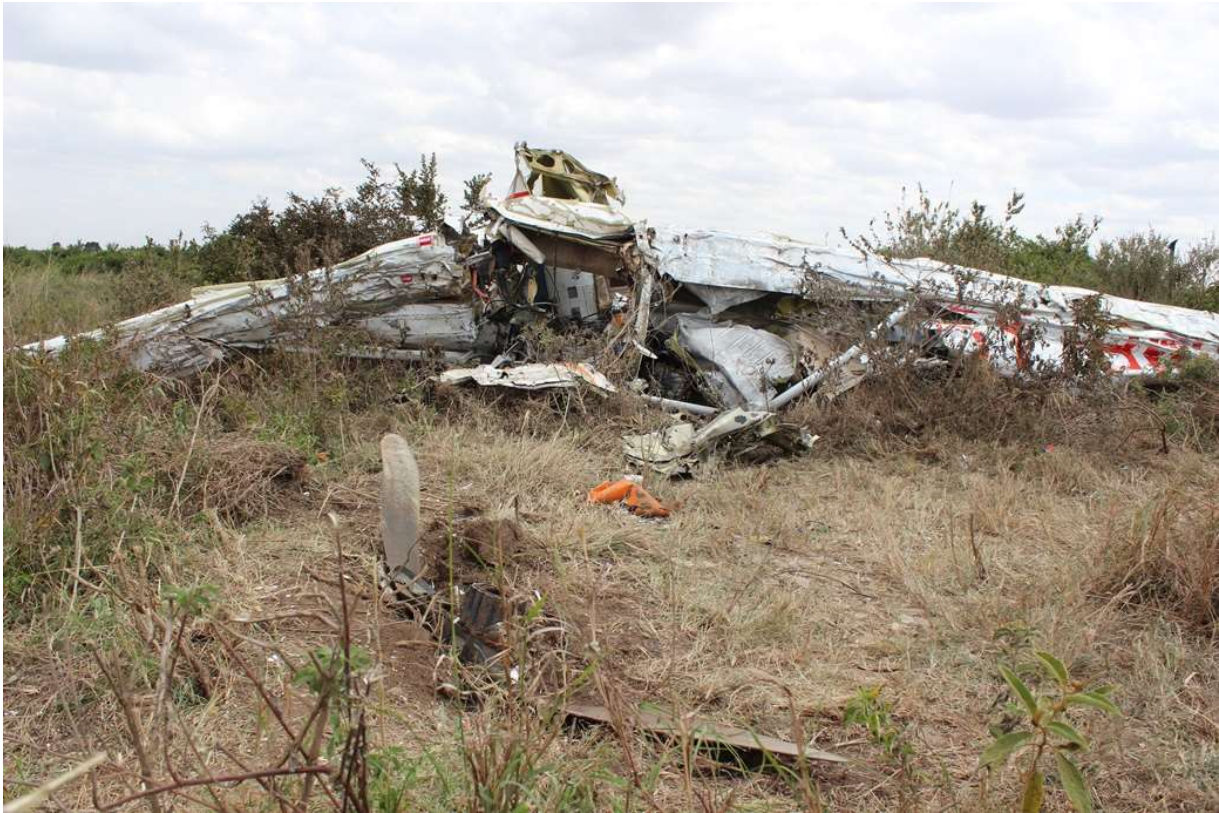
**Figure 20: Main wreckage and separated propeller assembly**

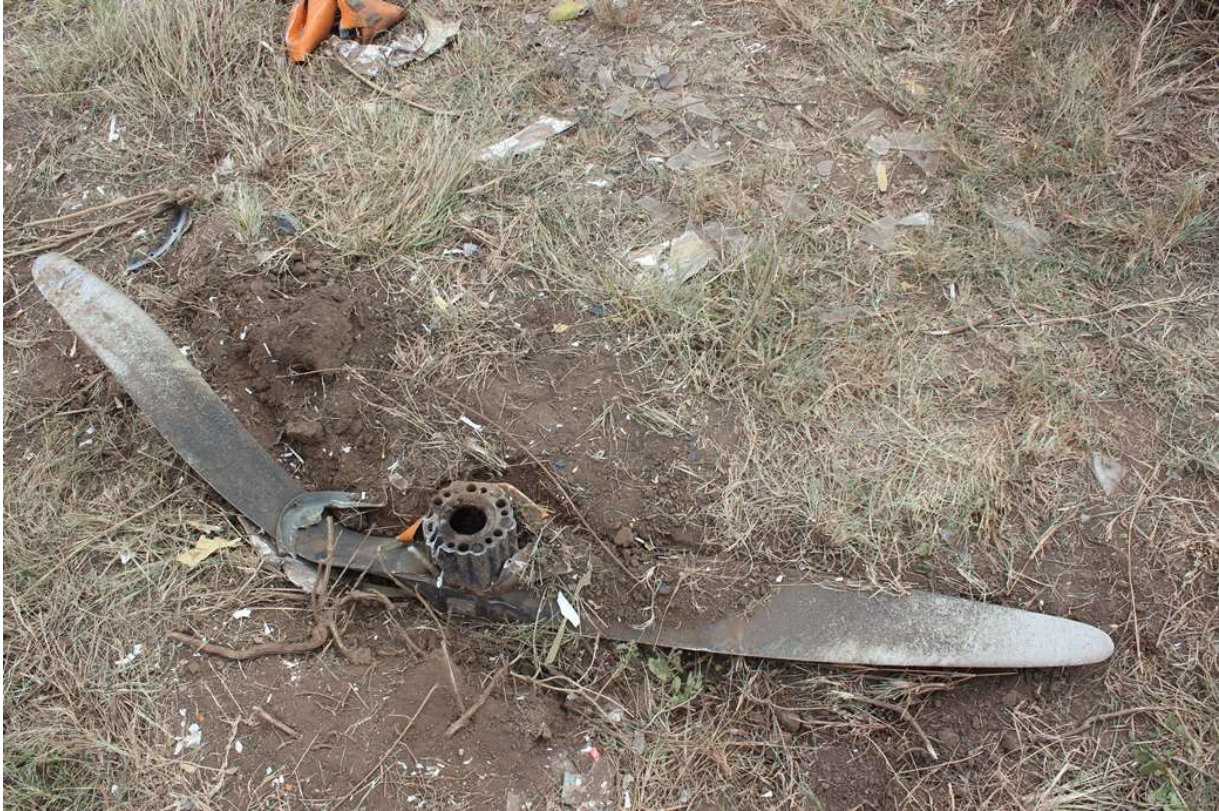
The propeller assembly separated from the engine at the hub at the point of initial impact. Further examination of the aircraft propeller at the accident site revealed that the blade which rested on the right side of the aircraft was bent close to the hub and had some chordwise scratches. The other blade was relatively intact with no substantial bending or twisting.

**Figure 11: Separated propeller assembly**
