**FINAL ACCIDENT REPORT**

**5Y-BWL**

**09.10.2013**

**CIVIL AIRCRAFT ACCIDENT REPORT SUMMARY**  
**CAV/ACCID/5YBWL/13**

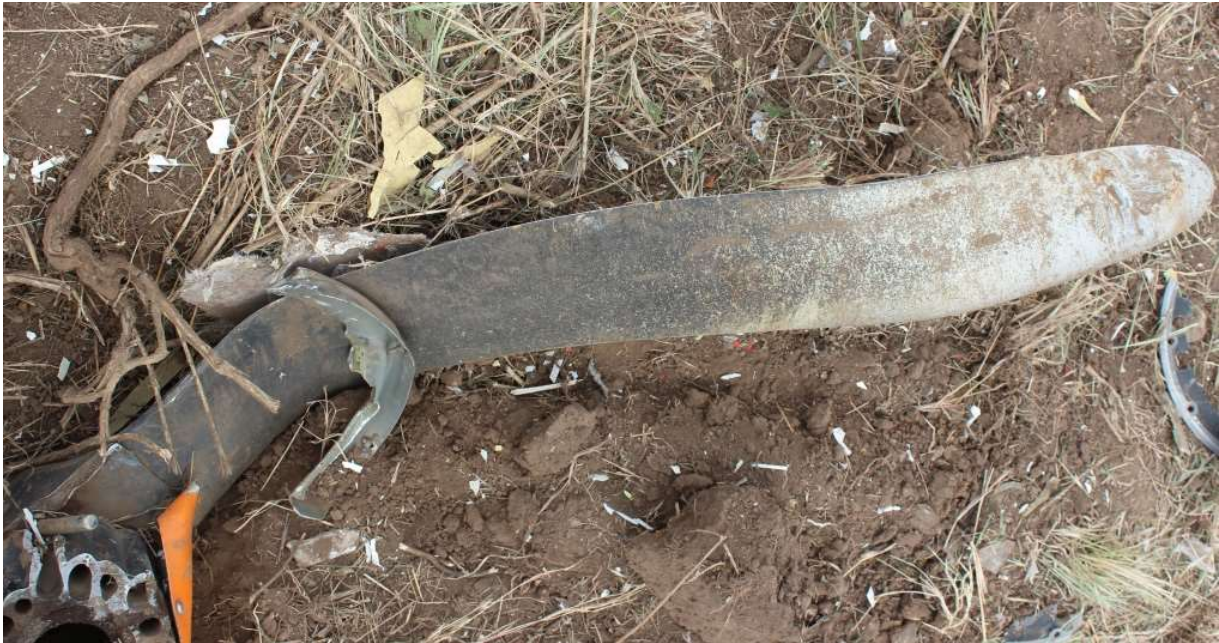
separation of the propeller due to the nose down attitude of the airplane. A propeller under power that strikes the ground in a vertical attitude usually comes to a stop in microseconds of impact and the energy gets absorbed into the propeller separating due to the dissipation of the torque loads. It was considered that during the steep attitude impact, the blade that struck the ground first caused the engine to stop suddenly resulting in power related damage to the single blade and none to the other.

**Figure 22: Propeller blade close-up indicating damage**

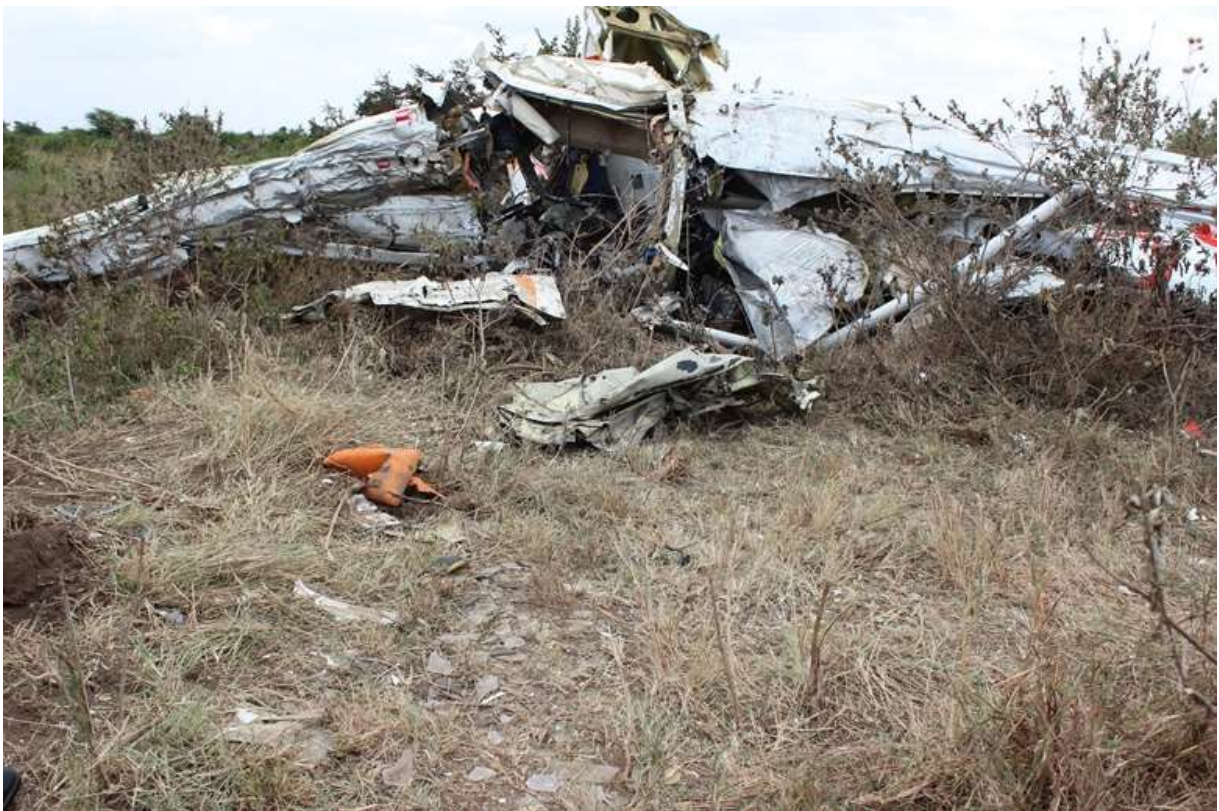
The cockpit area of the aircraft was found badly damaged and disrupted as a result of the ground impact. There was significant damage to the rudder, aileron and elevator controls. Flaps were found in the full up position. The elevator was not trimmed and the

**Figure 23: Damage to cabin and the front section of the aircraft**

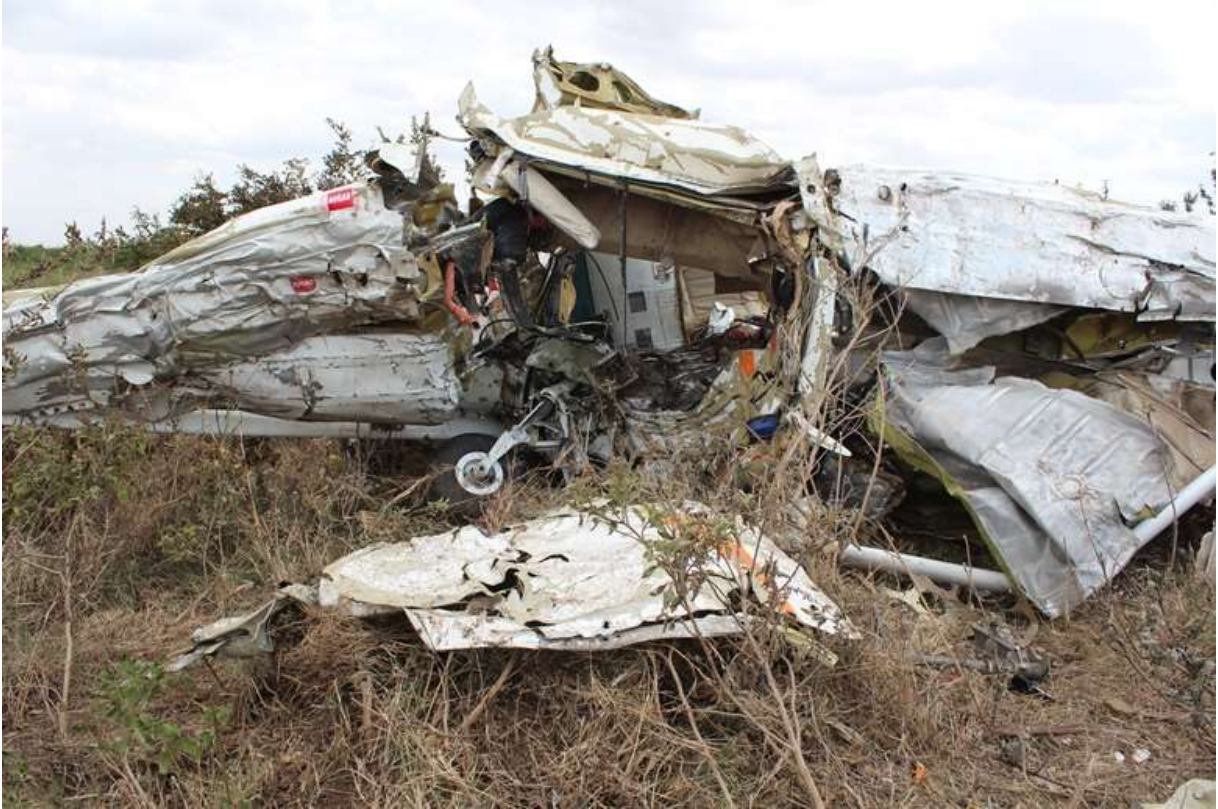
**Figure 24: Close-up of damage to the front section of the aircraft**
