<b>AIRCRAFT ACCIDENT REPORT AND EXECUTIVE SUMMARY</b>
---

Reference:	CA18/2/3/9235	
<b>Aircraft Registration</b>	ZU-FLE	<b>Date of Accident</b>	24 October 2013		<b>Time of Accident</b>	1002Z
<b>Type of Aircraft</b>	YAK-18T (Fixed Wing)		<b>Type of Operation</b>		Private	
<b>Pilot-in-command Licence Type</b>		Private Pilot	<b>Age</b>	40	<b>Licence Valid</b>	Yes
<b>Pilot-in-command Flying Experience</b>		Total Flying Hours	2980.0		Hours on Type	63.35
<b>Last point of departure</b>		Stellenbosch Aerodrome (FASH) in Western Cape Province				
<b>Next point of intended landing</b>		Stanford in Western Cape Province				
<b>Location of the accident site with reference to easily defined geographical points (GPS readings if possible)</b>						
On Ingwi Farm, 100 m outside the boundary of Stellenbosch Aerodrome (FASH) in Western Cape Province						
<b>Meteorological Information</b>		Wind direction:210°, Wind Speed: 11 knots, Temperature: 25°C, Visibility: CAVOK.

## AIRCRAFT ACCIDENT REPORT

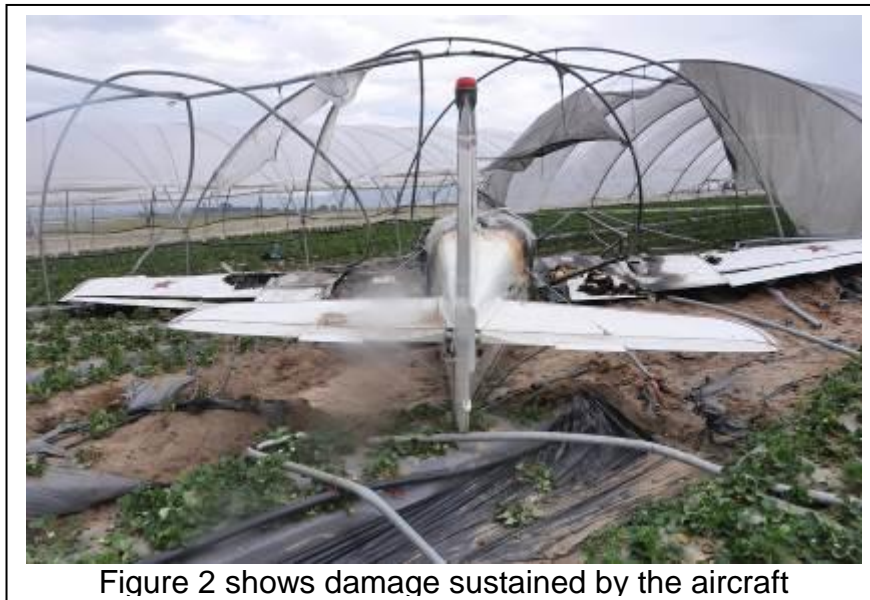
1.3.1 The aircraft was destroyed in the accident. See below a picture of the aircraft wreckage as it was found immediately after the accident.

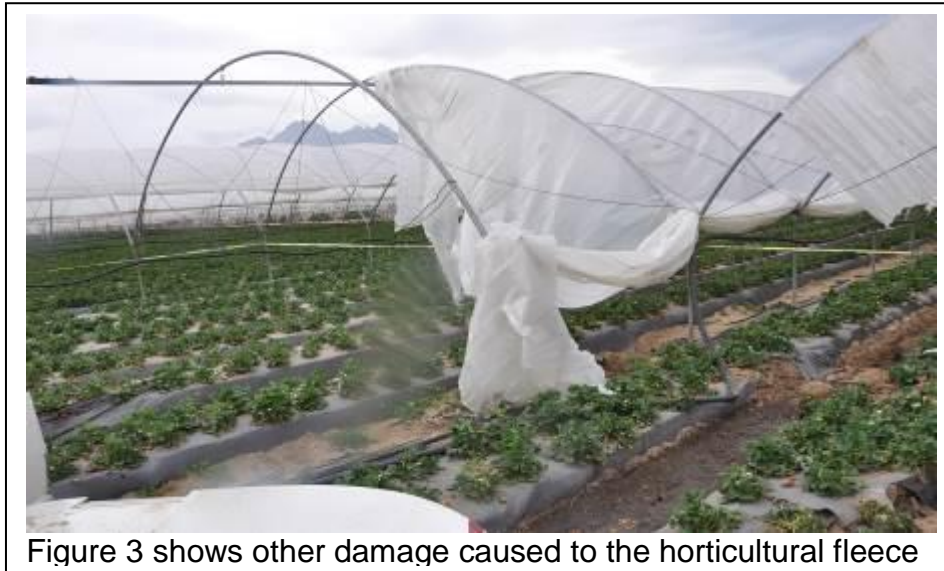
- 1.4.1 Other damage was caused to the strawberry plant patch (row tunnels) and horticultural fleece covering. .

Figure 3 shows other damage caused to the horticultural fleece

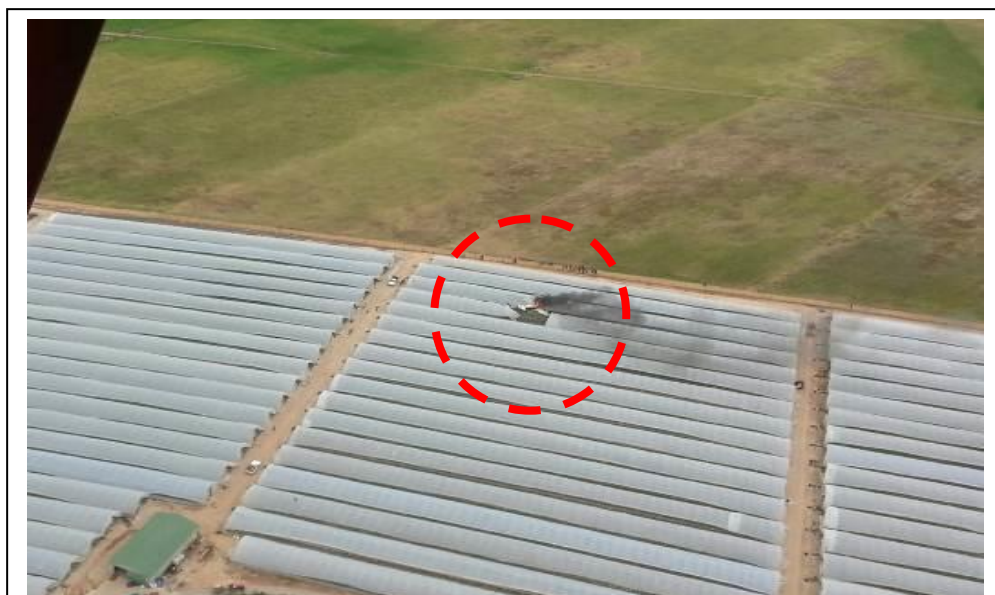
1.12.2 The witnesses stated that as the aircraft was entering the RH bank/turn it was seen descending and hit the ground. The accident site was at GPS co-ordinates: 33°59'12.71"S 18°49'22.85"E, elevation (98 m).

Figure 4 shows the accident site at Polkadraai Strawberry Farm

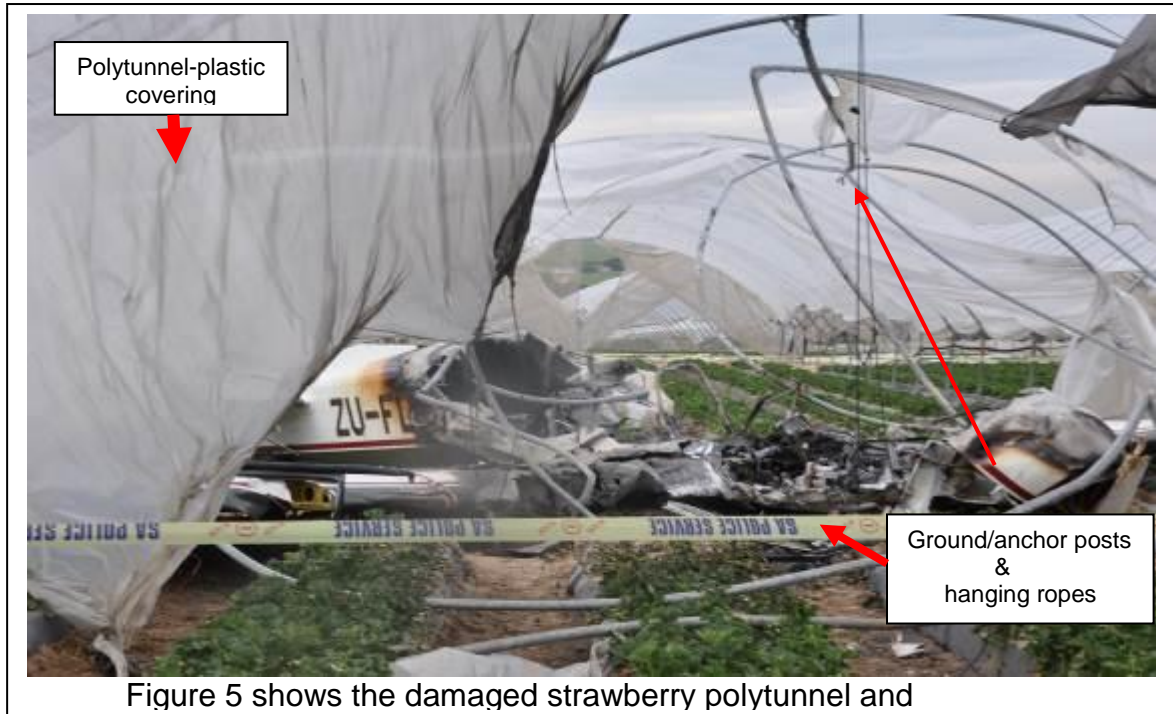
1.12.3 An onsite investigation then followed. Information gathered during the onsite investigation showed that the aircraft first hit the semi-circular covered polytunnel or high tunnel structures before hitting the ground. Several of the polytunnel ground or anchor posts were destroyed in the impact sequence. The ropes used to hold the plastic covering close to the hoops was found tangled around the nose section (bottom engine cowling) of the aircraft.

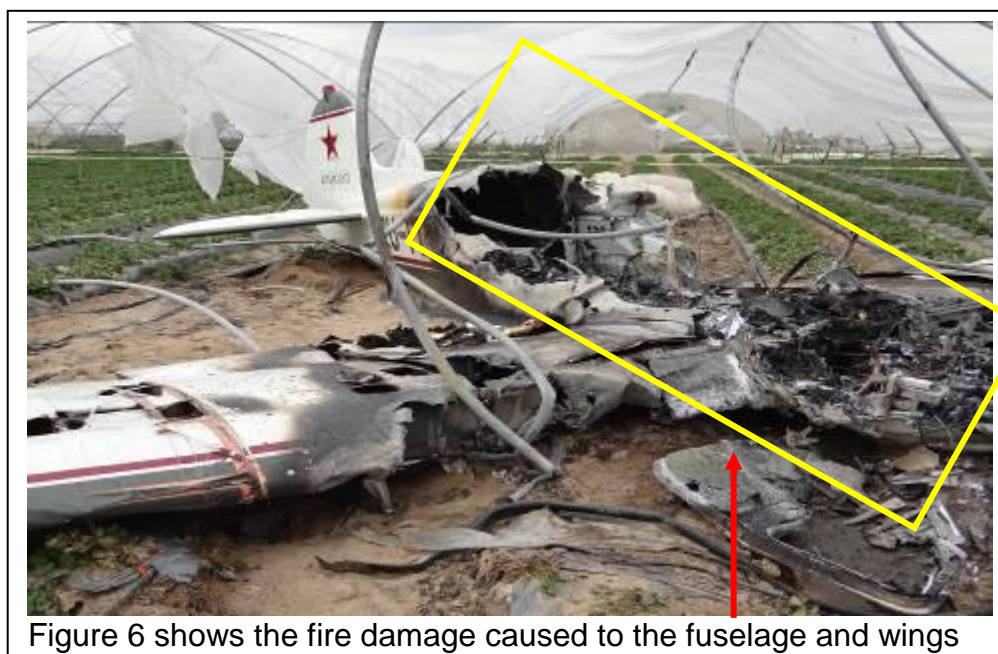
1.12.4 The observation was that when the aircraft hit the ground, a post impact fire started. The witness who attempted to assist the pilot indicated that he saw a small fire at the nose section (flames coming from the engine). The fire started to spread and destroying the aircraft. The fire damage was seen predominantly on the fuselage (cockpit and cabin) and inboard wing areas.

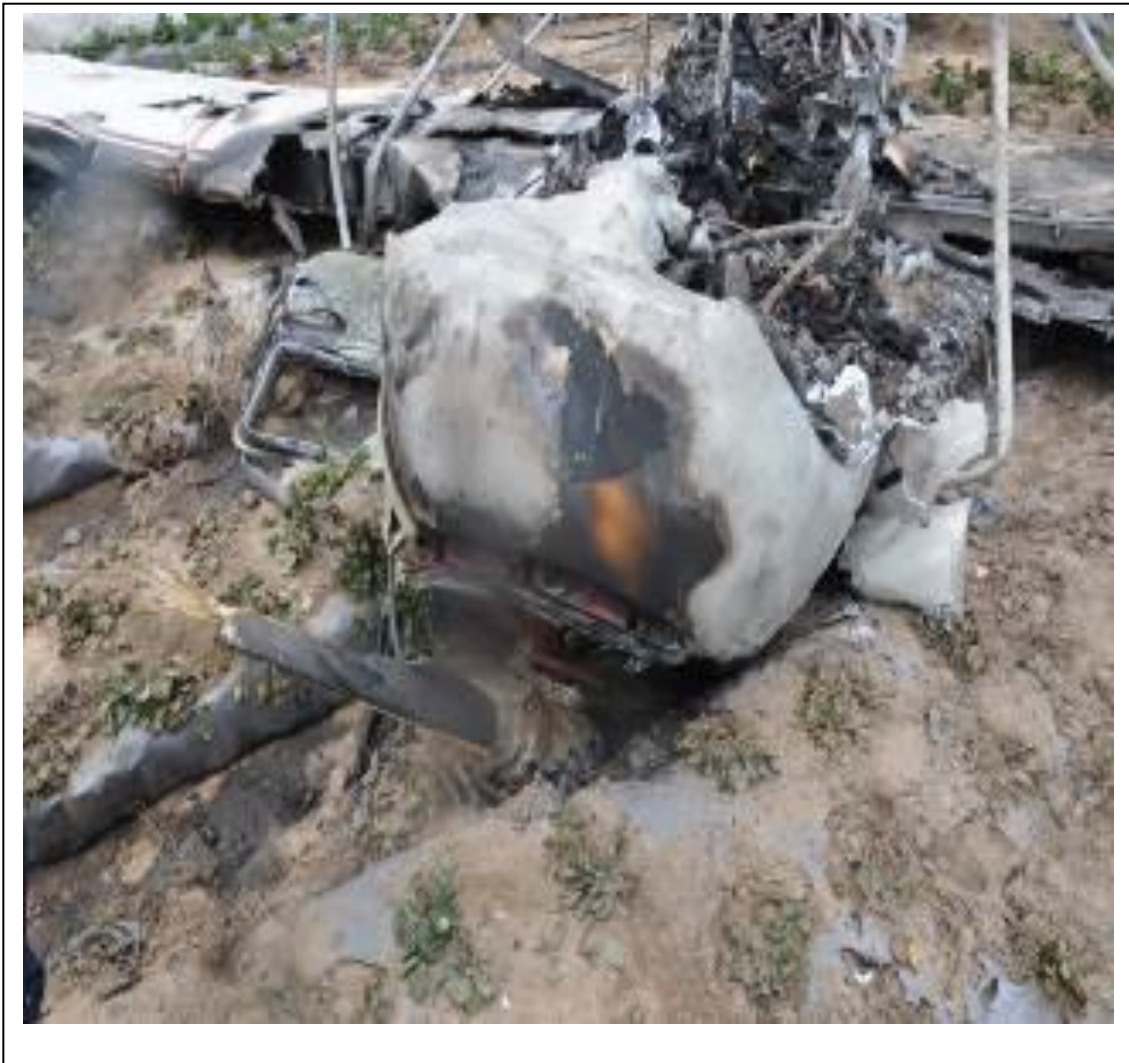
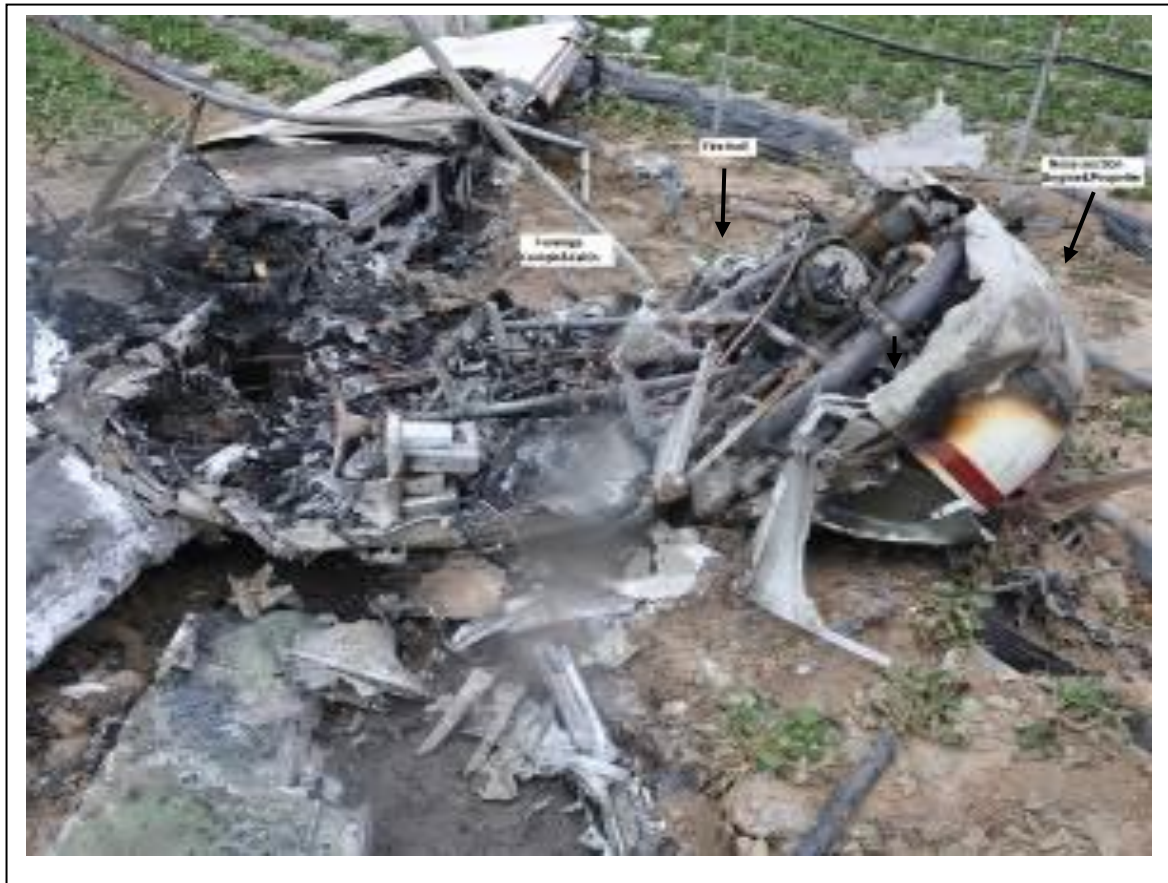
- (i) All indications are that the aircraft hit the ground at a high angle relative to the ground. It was in a right- turning motion and low speed at the time. This evidence can be seen by the shallow impact crater caused by the nose section. The wreckage was still intact after the aircraft impacted the ground. The manner in which the aircraft impacted the ground is consistent with one of the witness account stating that *“an aircraft banking hard to his right at a very low altitude”* He noticed that the aircraft was flying rather slowly to attempt such a sharp turn.

- (ii) There was no ground scar, which is evidence that the aircraft did not skid during the impact. This implies that the flight path angle (pitch) of the aircraft was such that it hit level ground in a nose-down attitude. The evidence for this can be seen in how the nose section (engine and propeller) of the aircraft hit the ground.

- (iii) The wreckage further shows that after the high angle (nose-down) attitude impact, the airframe broke in the area of the firewall causing the fuselage to smashing down hard on the ground.

Figure 7 & 8 shows the nose section (engine and propeller) of the aircraft

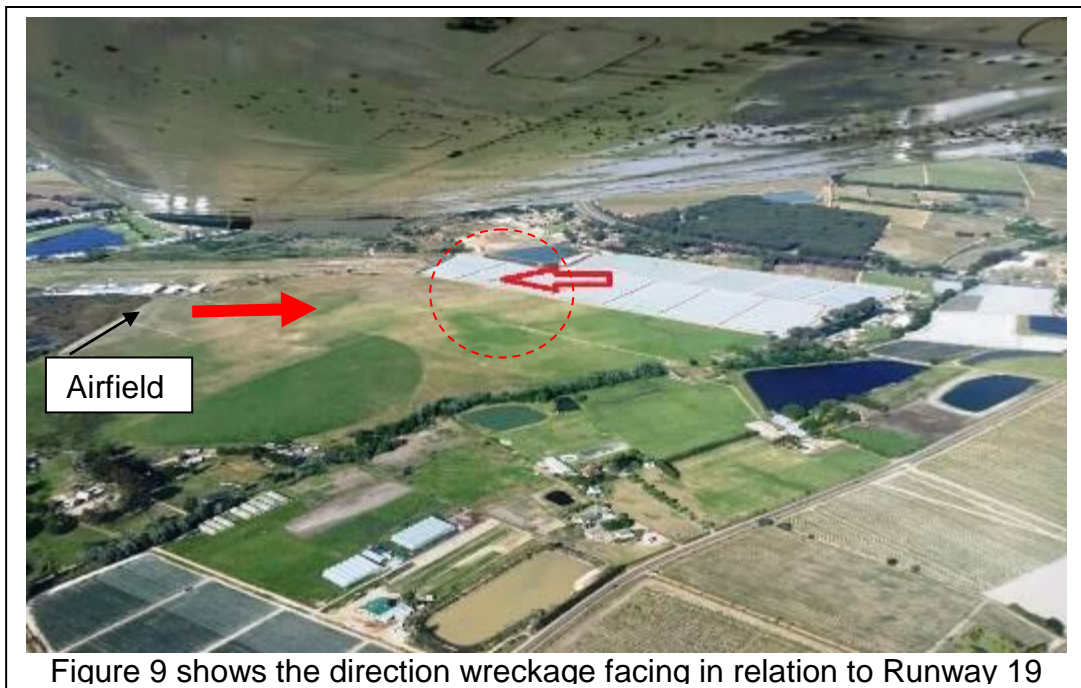
- (iv) The wreckage was found facing in a south westerly direction. The main wreckage was located approximately 316 m (heading 190°) from the end of Runway 19.

Figure 9 shows the direction wreckage facing in relation to Runway 19

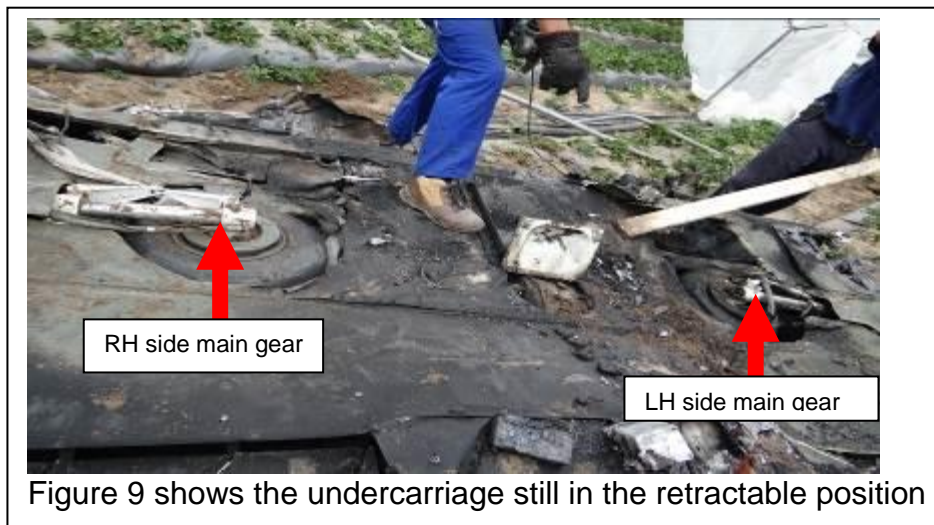
1.12.6.2 The wreckage investigation showed that the main landing gear was still in the retracted (up and locked) position.

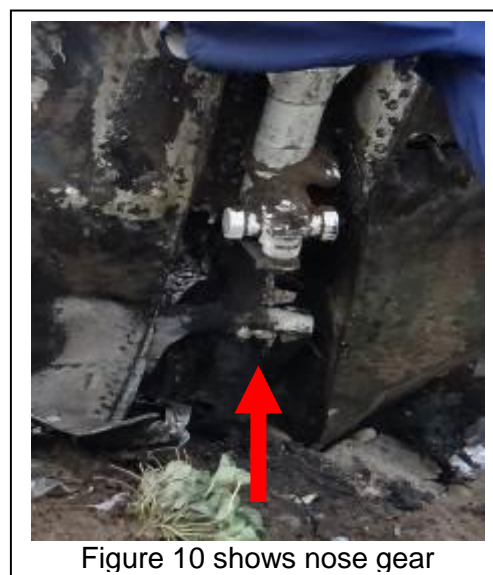
1.12.6.3 A similar finding, as with the main landing gear, was made with the nose gear strut assembly. The wreckage investigation showed that the nose gear was also still retractable in up-locked position.

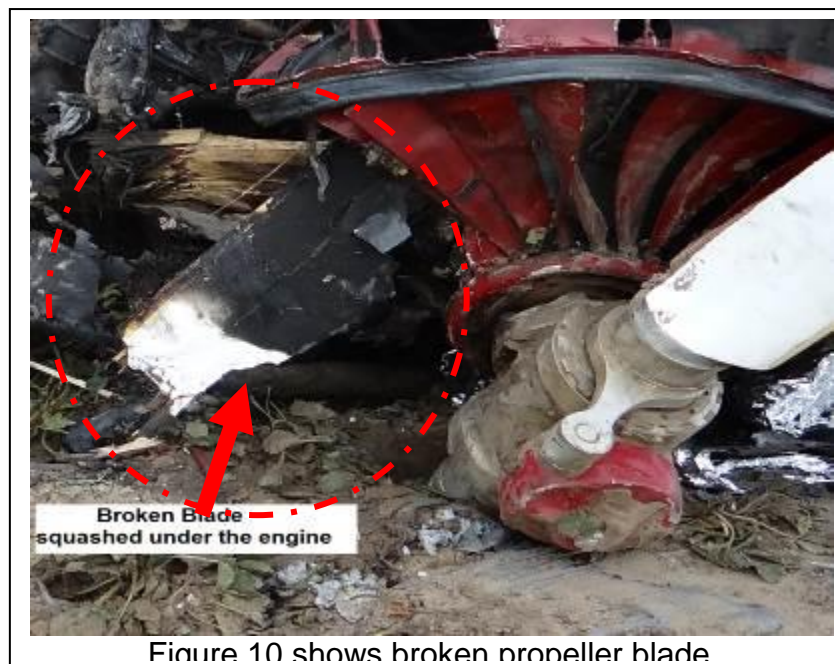
- (i) The propeller sustained substantial impact damage. Both propeller blades were destroyed.
- (ii) One of the blades broke off at the hub after hitting the ground and was subsequently also squashed under the weight of the engine as the aircraft ploughing nose-first into the ground. The blade seems to have broken in half during the impact, coupled with tensioning pulling force of a rope from the strawberry patch, which resulted in its breaking into pieces.

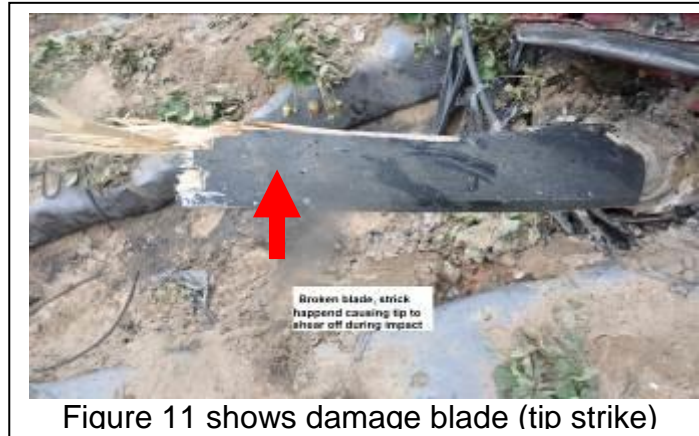
- (iii) The other propeller blade was still intact at the hub, but its tip broke off. There appears to have been a propeller blade strike during the impact sequence. The prop tip probably hit the metal tubing structure of the strawberry patch or the ground. This resulted in the blade tip shearing off. The prop blades are made of wood; there were a few pieces of wooden threats sharp ends pointing. The opposite side (trailing edge) of the blade was torn due to the tip shearing off.

Figure 11 shows damage blade (tip strike)

1.12.7.3 The damage caused to the two propeller blades suggests that it did not rotate at full r.p.m at the time of the impact. Also, it was set at a reduced angle (probably more coarse pitch) to maintain the crankshaft rotational speed of 82%-84%, as directed by the flight operations manual.

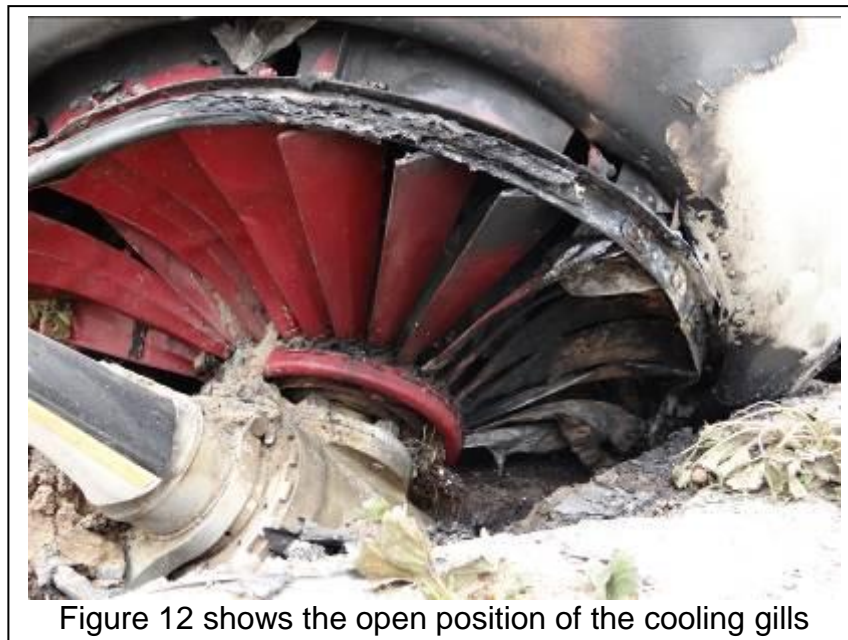
1.12.8.1 According to the aircraft technical data, the YAK18T aircraft radial gills are there to keep the engine at its optimum temperature during flight. The gills are operated manually from the cockpit by the pilot. Therefore it is extremely important for the pilot to check the cooling gills, whether open or closed. Ideally the gills should never be forgotten in the closed position, especially during the take-off. It may result in the engine quickly experiencing high cylinder temperatures which is not safe for any flight condition.

1.12.8.2 The cooling gills were also inspected during the wreckage investigation to determine their condition. The evidence indicated that the pilot had the gills open during take-off, hence reducing the risk of an unsafe rise in the cylinder temperature.

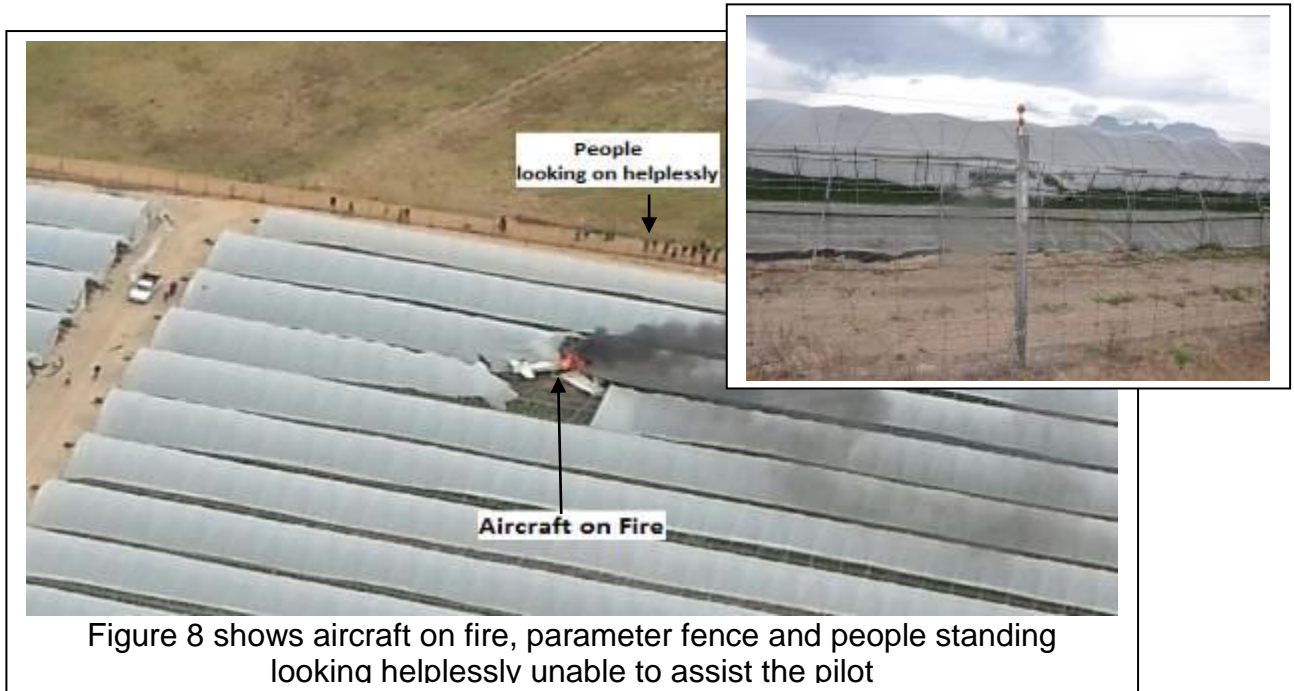
- (i) A witness working at Stellenbosch Airfield – Stell Flight Academy stated that he received a call about the accident. He immediately drove to the location of the accident where he found the aircraft on fire. However, due to security fencing of Polkadraai Strawberry Farm he could not get to the burning aircraft.

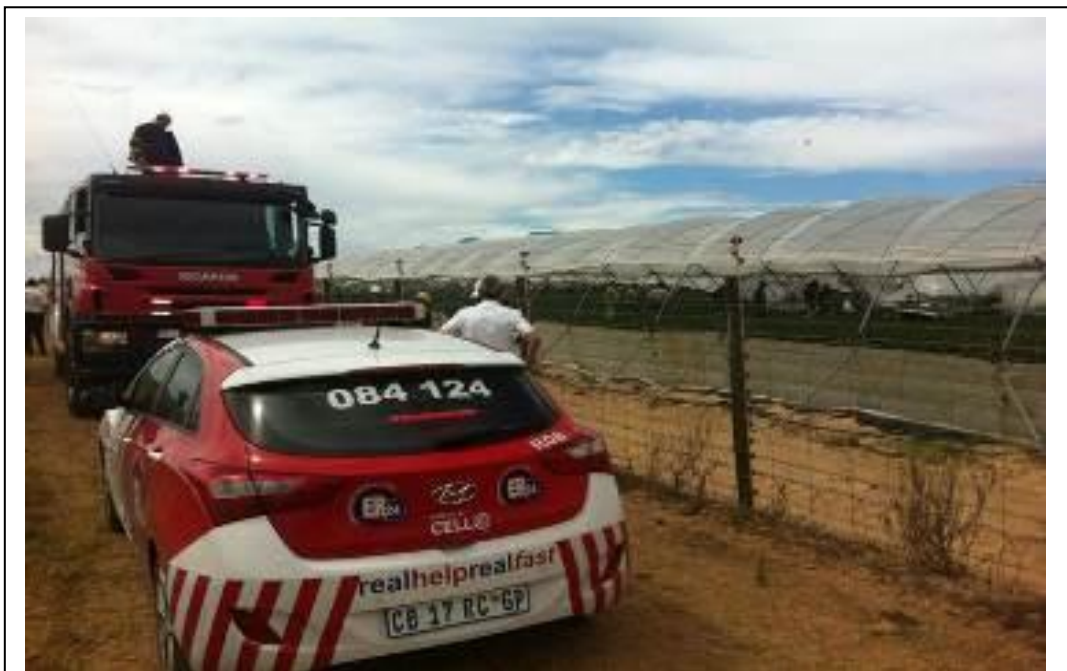
- (i) The municipality received a call at 1115Z about the accident. The response time to the scene was 1117Z and arrival at 1155Z. When arriving they found Cape Winelands District Municipality (CWDC 6), Stellenbosch Municipality 7 fire fighting services crew was in attendance. The rescue and fire fighting vehicles used on the scene were 2x Heavy Fire Appliances, 2x Service Cars and 1x Rescue Vehicle. When they arrived on the scene the aircraft had already caught fire. The fire was coming from the engine compartment and moving rearward. The equipment used was 1x jet from CWDC water tender. The extinguishing media was 1x jet plus foam. They managed to extinguish the fire at about 1240Z and departed from the scene back to base at 1307Z.

Figure 9 shows the emergency rescue services vehicles at the scene
