ESTONIAN SAFETY INVESTIGATION BUREAU

INVESTIGATION REPORT

SE-FVP SERIOUS INCIDENT IN KÄRDLA ON 28.10.2013

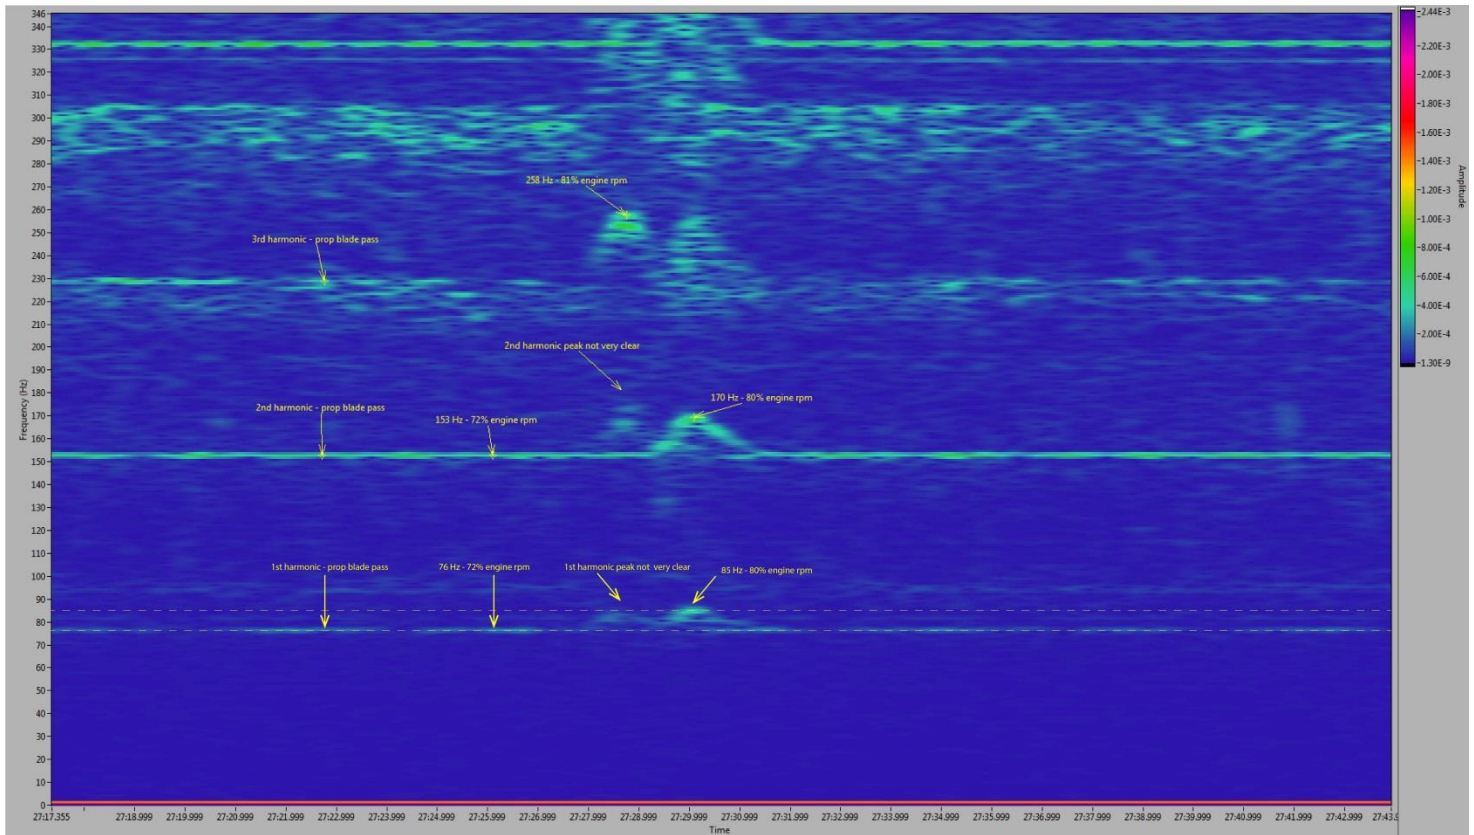
Figure 2. CVR spectrum analysis

Two hours of erased recordings were recovered from the CVR and sound spectrum analysis was performed. The CVR spectrum analysis reveal, that while the crew went through the *After Start* check list, the engines were running at approximately at 72% (76Hz). Just after co-pilot reads check-list item „*Start Locks*“, both engines were briefly brought to 81% (86Hz) and 80% (85Hz) one after the other

during the check (Figure 2 - two small peaks at 27:27). The peaks are better visible on 2nd and 3rd harmonic lines due to smaller sound wave abatement (Figure 2).

It is evident from figure 2 that even without the Captain replying, there has been some pilot action in order to disengage the start locks. The RPM applied has been enough to overcome the elastic forces of the start lock springs, what appears is, that the power levers were not being moved all the way to the REVERSE position, not waited for torque to increase, thus leaving the RH propeller on the starting locks. The fact that there is no indicator in the cockpit referring to the position of the start latches in the aircraft, the condition was left unnoticed for the flight crew during taxi and takeoff procedures.

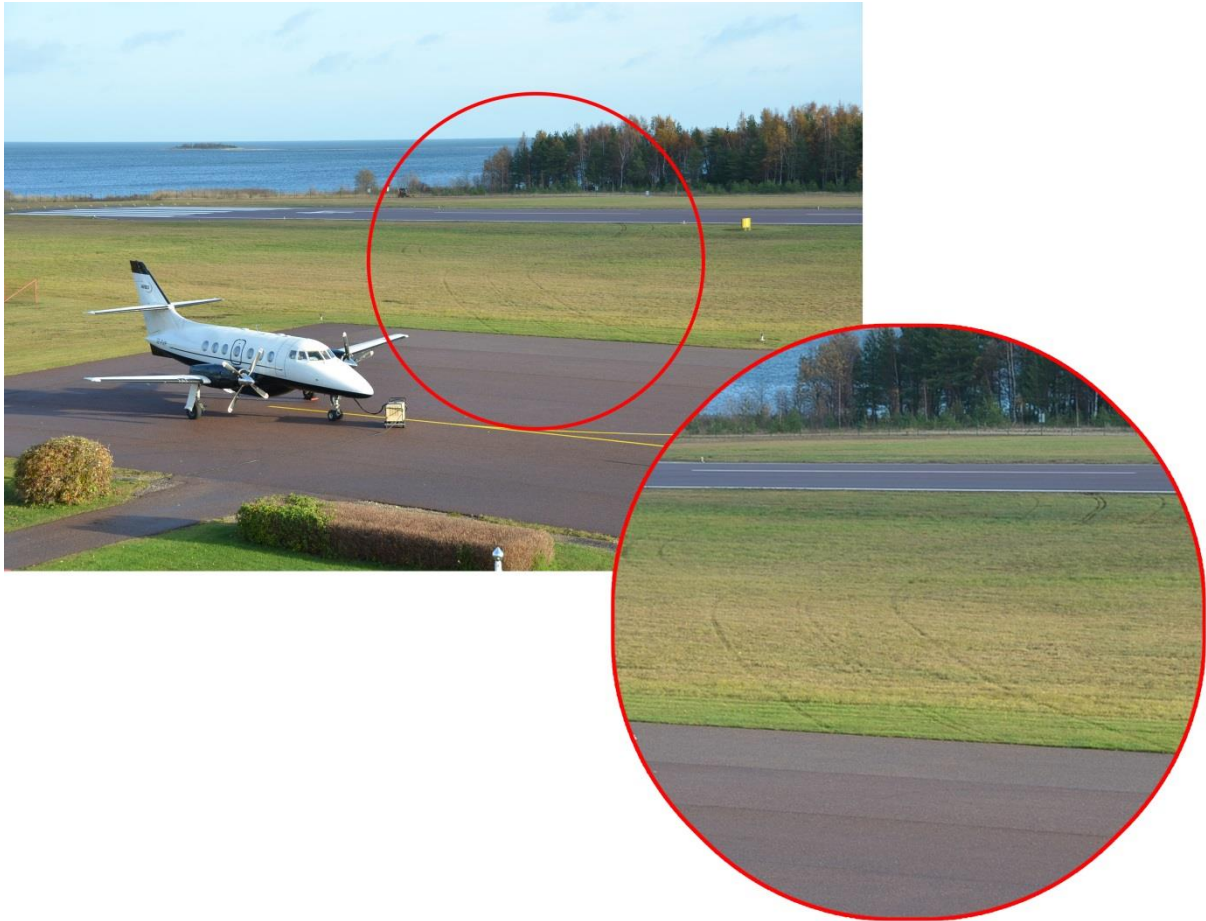
Ultimately the crew gains directional control over the aircraft (at: 30:17) approximately 35 meters from the beginning of the roll on a grass strip between runway and apron. The crew decides to continue taxi over grass to the apron where the passengers (17) were disembarked (figure 3).

Figure 3. Aircraft parked on the apron and tracks on the grass strip
