AIRCRAFT ACCIDENT REPORT AND EXECUTIVE SUMMARY

Reference:	CA18/2/3/9236	
Aircraft registration	ZS-RTV	Date of accident	29 October 2013		Time of accident	0700Z
Type of aircraft	Robinson R22 Beta – Helicopter		Type of operation		Private (Part 91)	
Pilot-in-command licence type		Private	Age	22	Licence valid	Yes
Pilot-in-command flying experience		Total flying hours	118.6		Hours on type	97
Last point of departure		Mossel Bay Aerodrome (FAMO), Western Cape				
Next point of intended landing		Mossel Bay Aerodrome (FAMO), Western Cape				
Location of the accident site with reference to easily defined geographical points (GPS readings if possible)						
On a farm approximately 4 km from George Aerodrome (GPS position: S34° 02'36.41" E022° 22'10.89")						
Meteorological information		Surface wind: 040°/5 kt, temperature: 22 °C, visibility: +10 km				
Number of people on board		1 + 0	No. of people injured	1	No. of people killed	0
Synopsis		<p>The pilot conducted a private flight from Mossel Bay Aerodrome with the intention of flying to Knysna and back to Mossel Bay Aerodrome. In the cruise at 1100 feet AMSL whilst approaching Herolds Bay and flying along the coast, the engine of ZS-RTV star

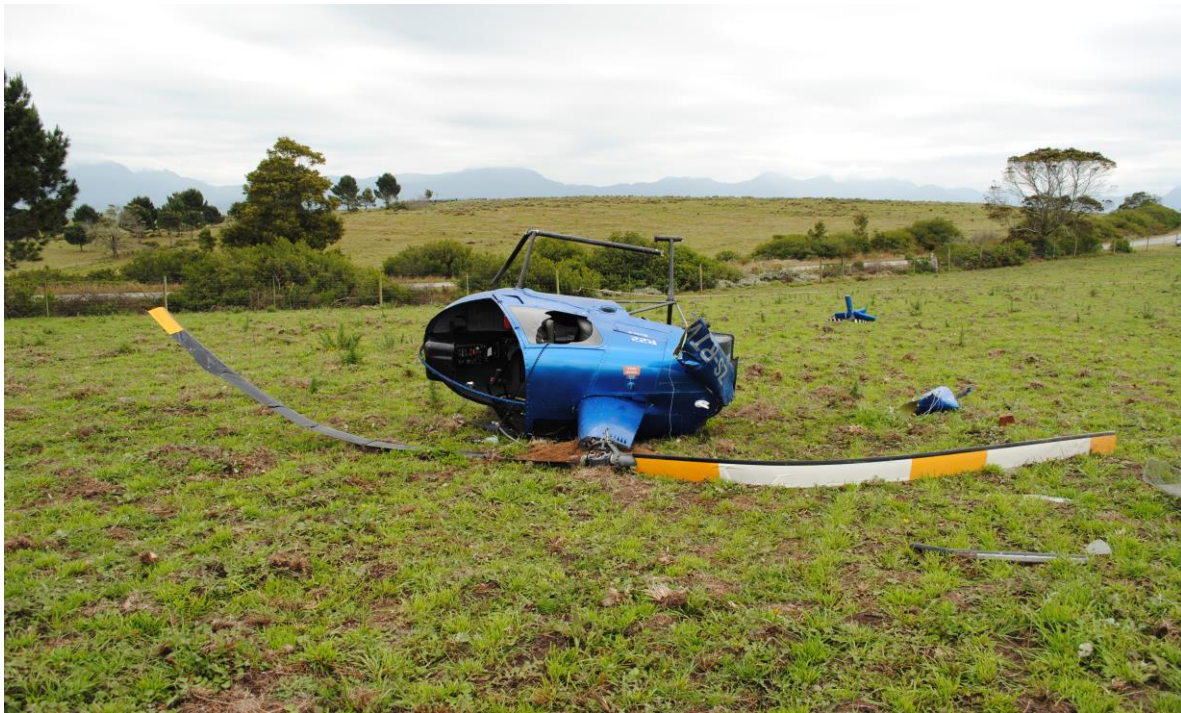
1.3.1 The aircraft sustained substantial damage.

Figure 3: A view of the aircraft wreckage and accident site

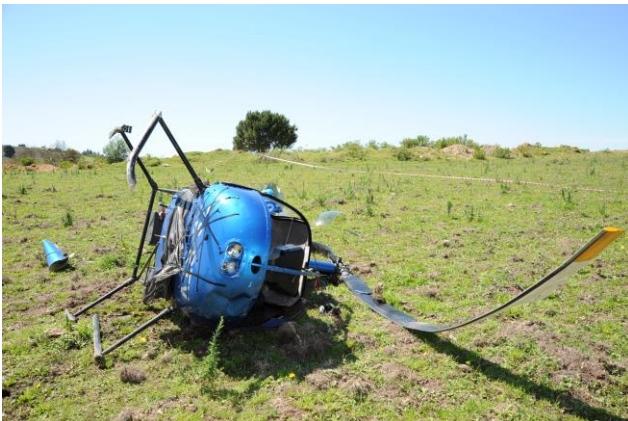
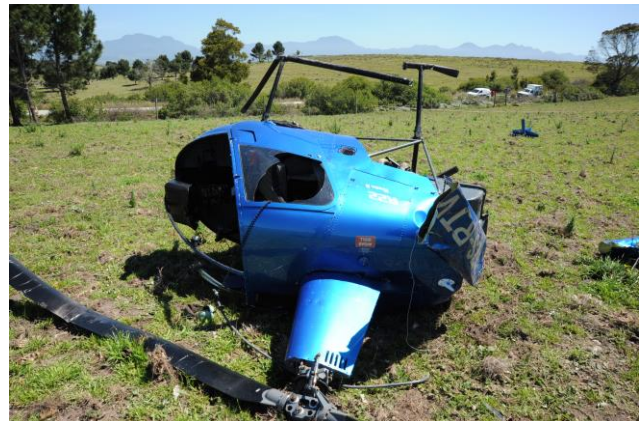
1.12.2 During the impact with the ground the helicopter sustained damage to the main rotor, tail rotor, tail boom, skids, fuselage and windscreens. The tail rotor and tail drive was located approximately 13 meters main wreckage.

Figure 5 & 6: View of the aircraft wreckage

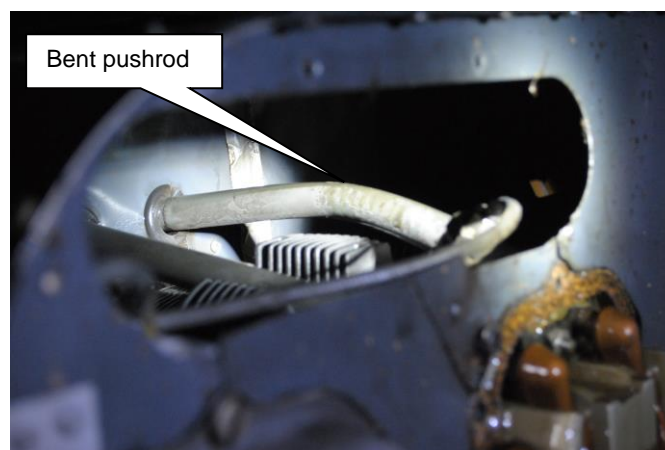
- The exhaust pushrod on No. 1 cylinder of the engine was found bent.
- After opening the No.1 cylinder rocker box cover, the pushrod was found fractured. The exhaust valve was fractured with the stem remaining in the cylinder head.
- Although the exhaust valve was fractured, the springs, spring seat, keepers, rocker arm, and rotor cap remained assembled in their normal positions and sustained no damage.
- Carbon build-up was found on No. 1 sparkplug.

Figure 7: View of the exhaust pushrod on No. 1 cylinder of the engine that was found bent

2.2 During the investigation the exhaust pushrod on No. 1 cylinder of the engine was found bent. The exhaust valve was fractured with the stem remaining in the cylinder head. History suggests that since 1980 the engine type experienced similar failures that were caused by valve sticking.

- 3.1.7 The pilot sustained minor injuries.
- 3.1.8 The exhaust pushrod on No. 1 cylinder of the engine was found bent and fractured as a result of a sticky valve.

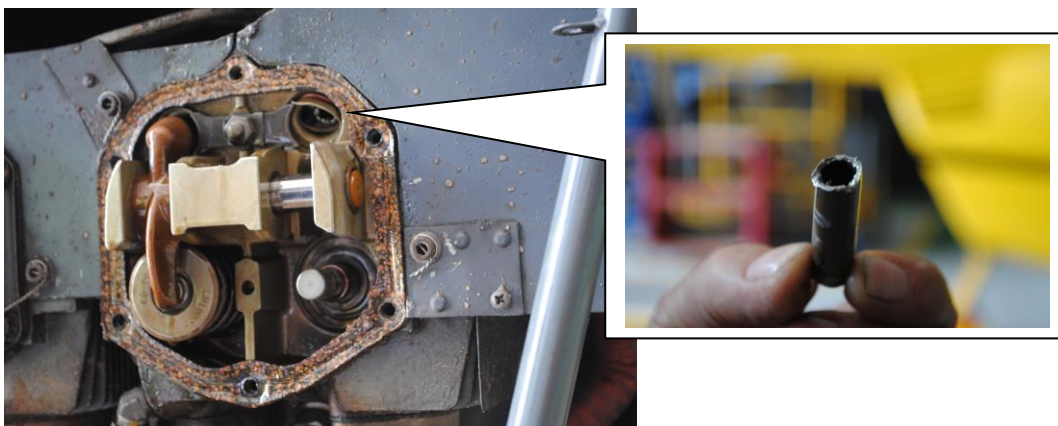
Figure 8 and Inset: A view of the broken part of the No. 1 cylinder exhaust pushrod
