*Final report RL 2014:12e*

**Accident at Bromma Stockholm Airport on 4 November 2013 involving the aircraft SE-FLS of type Rockwell Commander-112.**

File number L-158/13

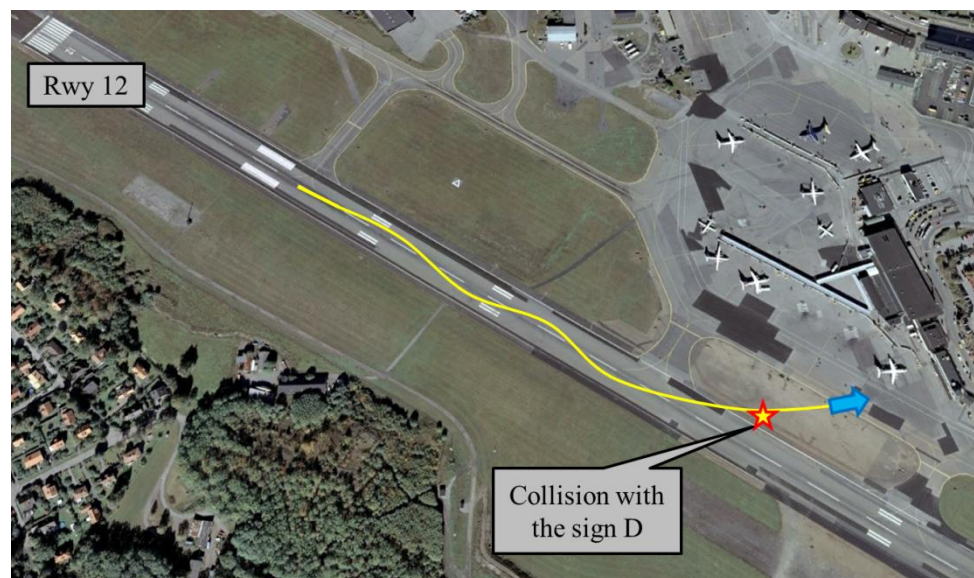
Figure 2. Sequence of events. Photo: Google Earth™

The flight and approach to runway 12 at Bromma were normal. During landing when the nose wheel was set down, the aircraft swerved and the pilot had difficulties holding the aircraft on a steady course.

In figure 2, we can follow how the aircraft swerved along the runway centre line and finally left the runway, knocking down a sign with the right wing. The swerving along the centre line is according to the pilot's estimations. The image does however provide an outline of the events. The blue arrow marks the aircraft's final position and heading.

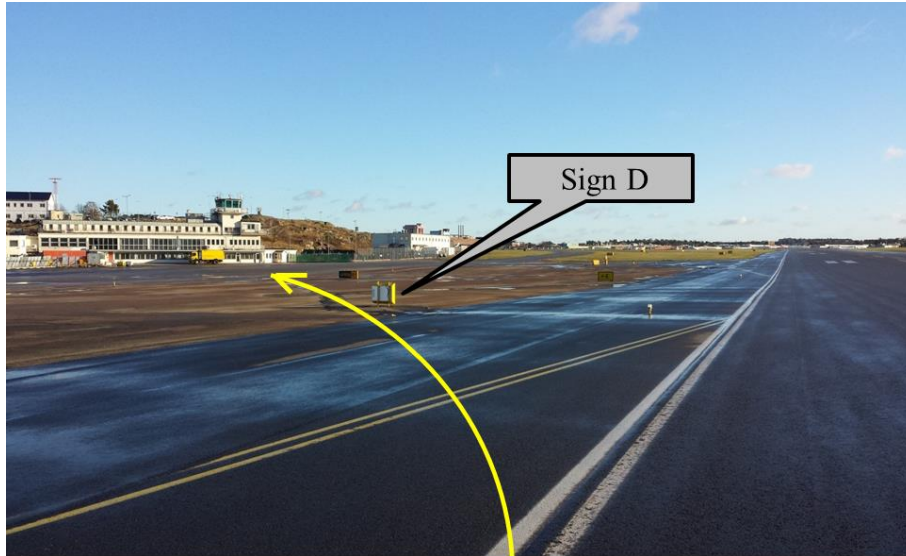
Figure 3. Flight path from the pilot's perspective. Photo: Swedavia.

The yellow arrow in figure 3 shows roughly the flight path seen from the pilot's perspective. The sign D is also marked in the image.

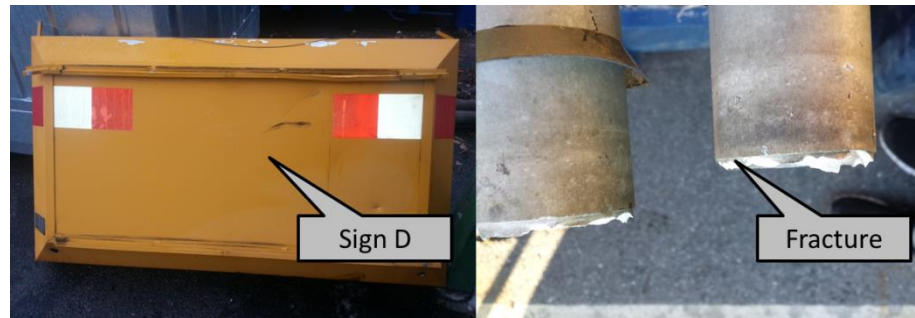
Figure 4. Sign D incl. fracture surface of legs. Photo: Swedavia.

The sign that the aircraft collided with (see figure 4) was destroyed and collapsed as intended – i.e., as per the design of the lower part of the legs. The left-hand photo shows the rear of the sign; the side which the aircraft struck.

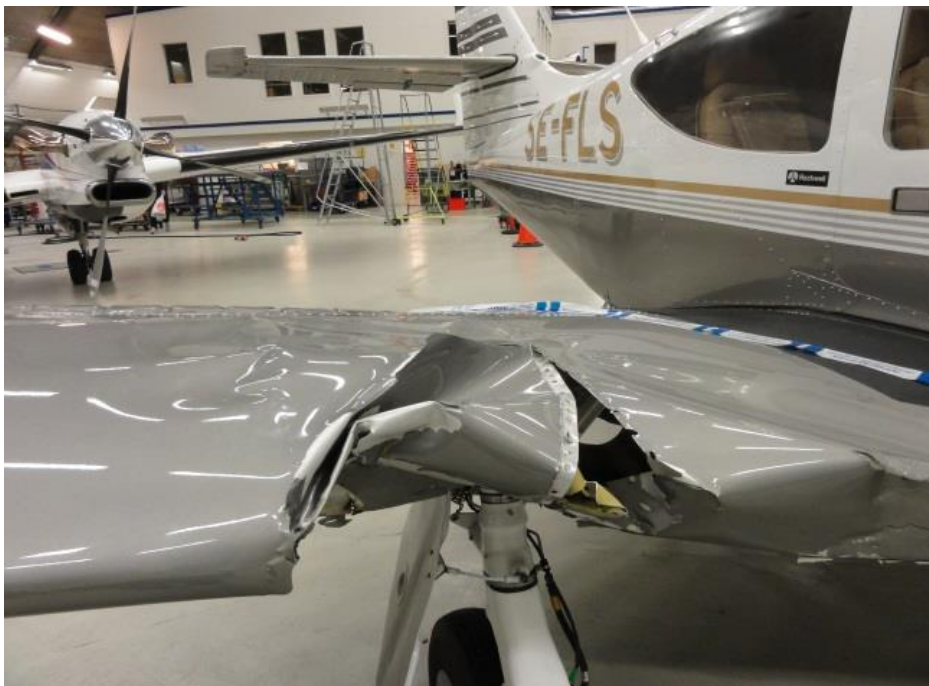
Figure 6. Damage to SE-FLS's right wing.

The aircraft received considerable damage, primarily on the right wing; see figure 6. There was also minor damage to the body of the aircraft just in front of the right wing mounting.

The imbalance measured in the nose wheel was deemed to be the cause of the swerving. Imbalance in a nose wheel causing shimmying

when landing, which in turn results in yaw oscillation, is a well-known phenomenon. In the event in question, the effect was great enough to cause difficulties for the pilot in maintaining control of the aircraft.

- Imbalance in the nose wheel caused nose wheel shimmy which led to the pilot losing control of the aircraft.
- The brakes were not used during the sequence of events.
- The pilot's lack of experience on the aircraft type may have meant that insufficient force was applied to the rudder pedals.

- Provide information on the connection between an imbalance in the nose wheel and nose wheel shimmying. *RL 2014:12 (R1)*

- Provide information on the connection between an imbalance in the nose wheel and nose wheel shimmying. *RL 2014:12 (R2)*
