AIRCRAFT ACCIDENT REPORT AND EXECUTIVE SUMMARY

Reference:	CA18/2/3/9240	
Aircraft Registration	ZS-ZZX	Date of Accident	04 November 2013		Time of Accident	0925Z
Type of Aircraft	Air Tractor-502B (Aeroplane)		Type of Operation	Commercial		
Pilot-in-command Licence Type	Airline Transport		Age	36	Licence Valid	Yes
Pilot-in-command Flying Experience	Total Flying Hours	2 793.5		Hours on Type	785.4	
Last point of departure	Kimberly aerodrome (FAKM): Northern Cape province.					
Next point of intended landing	Kimberly aerodrome (FAKM): Northern Cape province.					
Location of the accident site with reference to easily defined geographical points (GPS readings if possible)						
Approximately 11 kilometres West of Barkly West on the bank of Vaal river at GPS co-ordinates determined to be S28°34.07' E024°24.39' at an elevation of 3 677 feet above mean sea level (AMS).						
Meteorological Information	Temperature, 30°C: Visibility, 10 kilometres: Wind Direction, North Westerly: Wind speed, 10 knots: Cloud cover, 1/8.

AIRCRAFT ACCIDENT REPORT

Name of Owner/Operator : Xcalibur Resources (Pty) Ltd
Manufacturer : Air Tractor, INC
Model : Air Tractor 502-B
Nationality : South African
Registrati

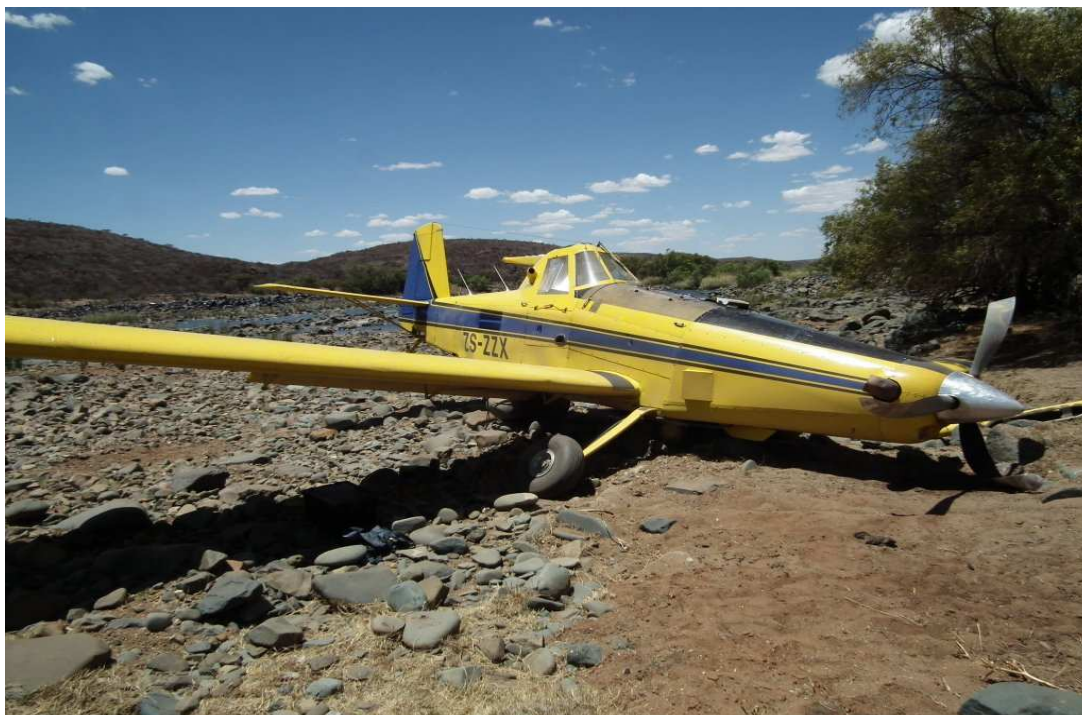
1.3.1 The aircraft was substantially damaged during the accident sequence.

Figure 2: View of the aircraft as found at the accident site on a rocky terrain.

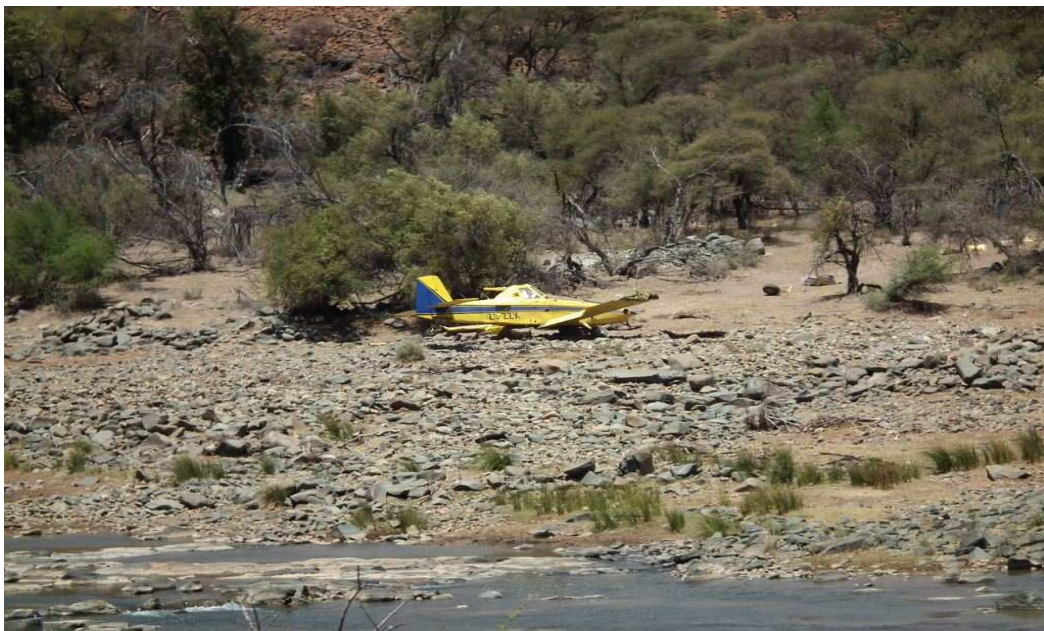
1.12.1 The accident happened during forced landing on the bank of Vaal River West of Barkly West after the pilot experienced an engine power loss in flight. The undercarriage broke and the propeller hit the ground. Damage was limited to the undercarriage, the wings, the fuselage, the propeller, the engine and the surveillance equipment fitted on the aircraft. The cockpit/cabin area was intact and flight control continuity on some of the flight control surfaces was established.

1.12.2 The wreckage distribution revealed that the aircraft had impacted the ground at a relatively low speed. The aircraft's wing flaps were estimated to be at an angle of about 10 degrees, which was consistent with the landing approach configuration. Three propeller blades bent backward and the propeller spinner remained attached and intact.

Figure 4: View of the aircraft on the bank of Vaal River.

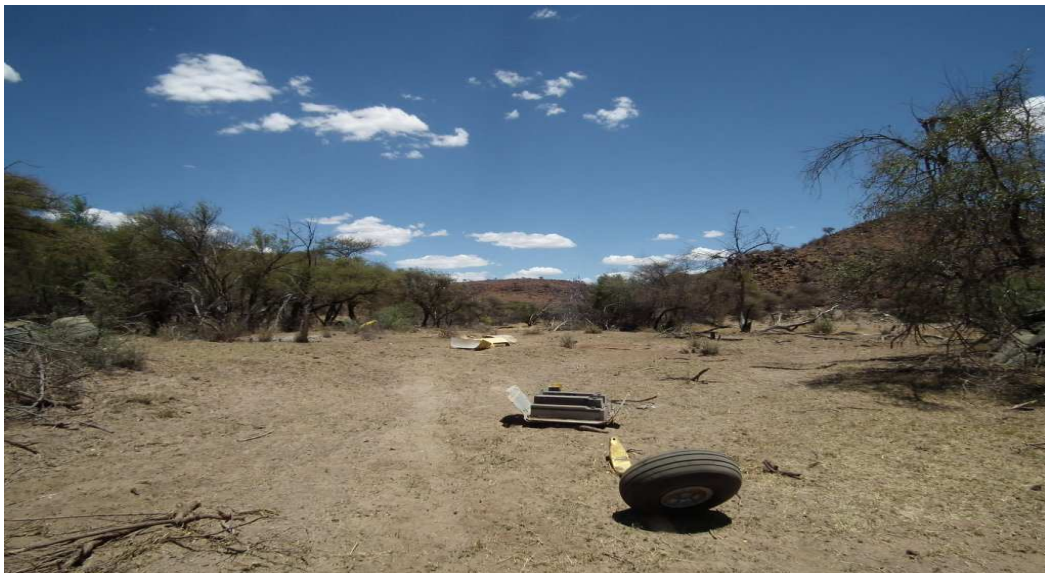
Figure 5: Position of the right gear and debris as found at the accident site.

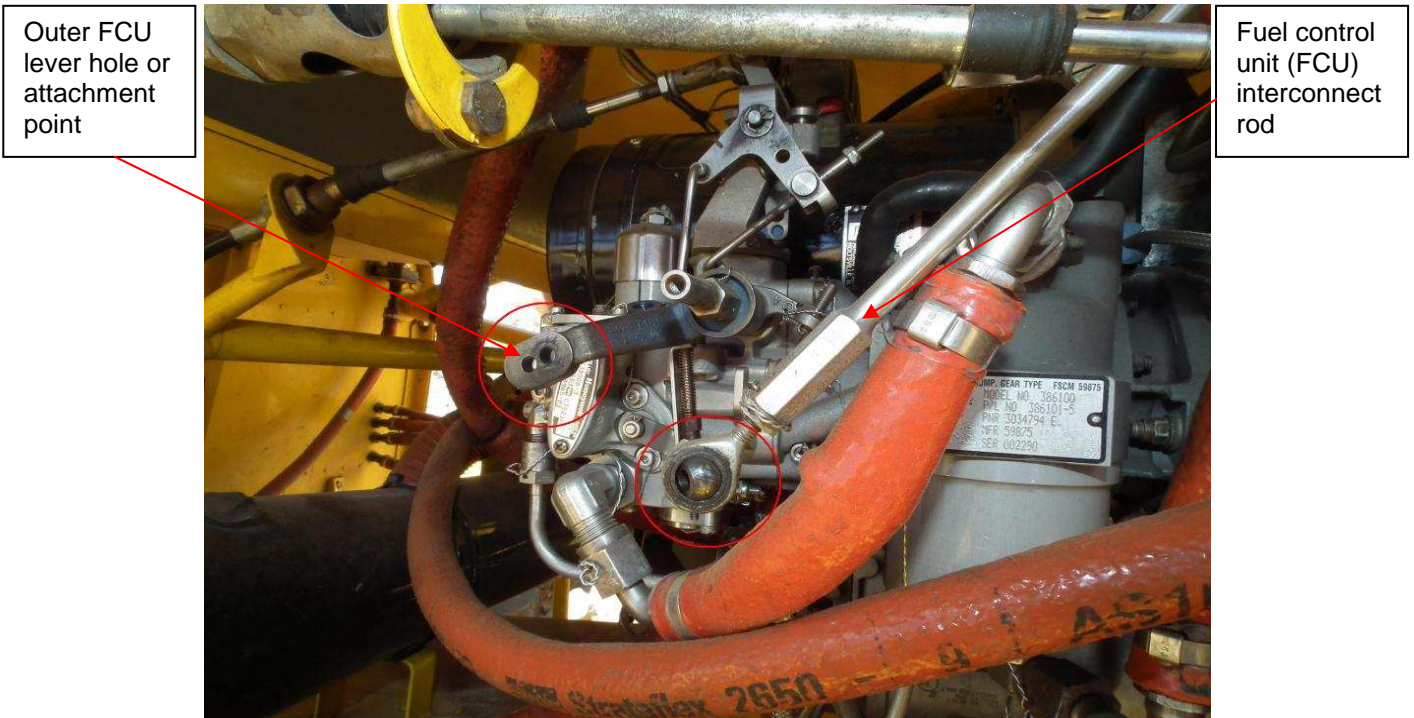
1.16.1 Post accident examination of the airframe revealed no anomalies with the aircraft flight controls. There was sufficient Jet A1 fuel on the aircraft, free from contamination and the fuel selector was found on a closed position, most probably by the pilot after the accident. Inspection on the engine revealed that the self locking castellated nut and the split pin that fasten or secure the bolt that holds the fuel control unit throttle linkage was missing and the bolt disconnected and fell to the bottom of engine onto the nacelle. Throttle “a means for the pilot to control and monitor the operation of the aircraft's powerplant or engine” response was lost and the engine instantaneously went into idle and the aircraft couldn't maintain flying speed. Below are pictures of an air tractor aircraft throttle, a detached fuel control unit linkage and the bolt that was found onto the bottom on the engine nacelle.

Figure 7: View of a detached fuel control unit linkage.

2.1.1 The pilot was properly certificated and qualified under the Civil Aviation Regulations to perform the flight. No evidence indicated any medical or behavioral conditions that might have adversely affected his performance during the accident flight. The pilot has logged a total of 2 793 total flight time and has a total of 785.4 flight hours on aircraft type. The Weather information obtained from the pilot's questionnaire indicated that fine weather conditions prevailed at the time of the flight and subsequent accident. The investigation revealed the cause of the accident as the inappropriate maintenance {(maintenance induced failure) (MIF)} by maintenance personnel who omitted to insert a split pin through the bolt hole after maintenance.

3.3.1 Disconnected fuel control unit throttle control linkage.

- 2.1.3 In this regard a commonly used means for preventing nuts coming loose from bolts in service is the use of split pins. Typically, a split pin is inserted between the castellations or slots of a castellated nut, and through a hole in the bolt, until the head of the pin fits between two castellations. The split ends of the pin are then bent 90° (degrees) over by means of a plier or wire cutter, thus retaining the pin in the hole and locking the nut onto the bolt. A potential disadvantage to this method of using split pins is that, when the nut is tightened on the bolt, the gaps between the castellations may not line up with the pre drilled hole in the bolt. If necessary, and by means of an additional tightening of the nut within the torque limit, a technician should align the hole of the screw or bolt with the groove of the nut.

- 2.1.4 Further more the nut shall under no circumstances be tightened over the values exceeding the upper margin “maximum” of the specified torque, in order to facilitate the assembly of the split pin. Finally the length of the lower point of the split pin, shall be such, that it shall not stick out from the base of the nut, so as to avoid scratches and prevent corrosion produced by its contact with whichever metal, on which the screw or bolt is assembled. In conclusion, maintenance related accidents and incidents are caused by a breakdown of the organization processes, decisions and culture. Maintenance operations are also affected by human input that shows up as weaknesses in organizational processes leading to lack of motivation, fatigue and stress, time pressure, misperception of hazards and inadequate skills.

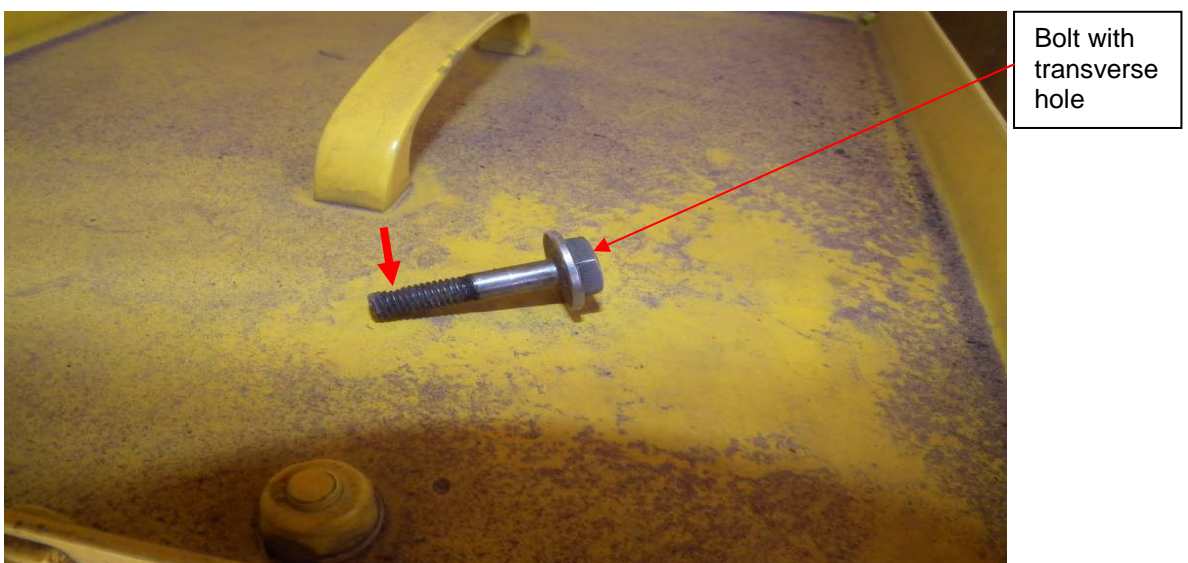
Figure 8: View of the bolt that was found inside the engine cowling.

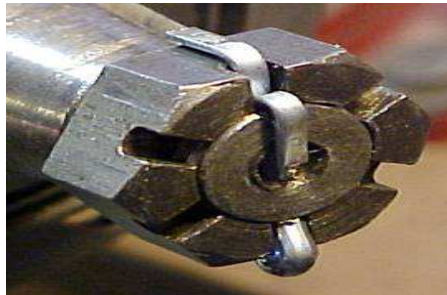
- 1.16.3 However, a PT6 power plant rigging instruction manual dated 11th October 2003, page 1 to 22 clearly shows a combination of fasteners approved to secure the FCU control linkage to the power plant and further more illustrates or demonstrates how the FCU control linkage should be secured and rigged before service. It is again well known to aircraft technicians and engineers that a combination of this category of fasteners “castellated nut and a bolt with a transverse hole” should be secured by means of a split pin or cotter pin with the intention to hold the nut against rotation. Further testing or analysis of the engine and its components by the investigating team was considered not necessary and the wreckage was released to the owner. Below is an illustration of how a castellated nut should be secured by a split pin.

Figure 9: Locking of a castellated nut on bolt .
