AIRCRAFT ACCIDENT REPORT AND EXECUTIVE SUMMARY

Reference:	CA18/2/3/9246	
Aircraft Registration	ZS-KCI	Date of Accident	22 November 2013		Time of Accident	0845Z
Type of Aircraft	BE36		Type of Operation	Private		
Pilot-in-command Licence Type		Commercial Pilot Licence (CPL)	Age	62	Licence Valid	Yes
Pilot-in-command Flying Experience		Total Flying Hours	4 369,4		Hours on Type	792,2
Last point of departure		Tempe Aerodrome (FATP): Free State				
Next point of intended landing		Wave Crest Aerodrome (FAWR): Eastern Cape				
Location of the accident site with reference to easily defined geographical points (GPS readings if possible)						
Threshold of Runway 07 at FAWR (GPS coordinates S 32° 35' E 028° 31')						
Meteorological Information		Surface wind: 100/20 gusting up to 40 knots; Temperature: 22°C; Visibility: CAVOK				
Number of people on board	1 + 1	No. of people injured	0	No. of people killed	0	
Synopsis						
<p>The pilot reported that on final approach during landing, a tractor and trailer unexpectedly crossed the runway, and the pilot performed a go-around successfully. The tractor then parked on the right, close to the threshold of the runway. The pilot then prepared to land

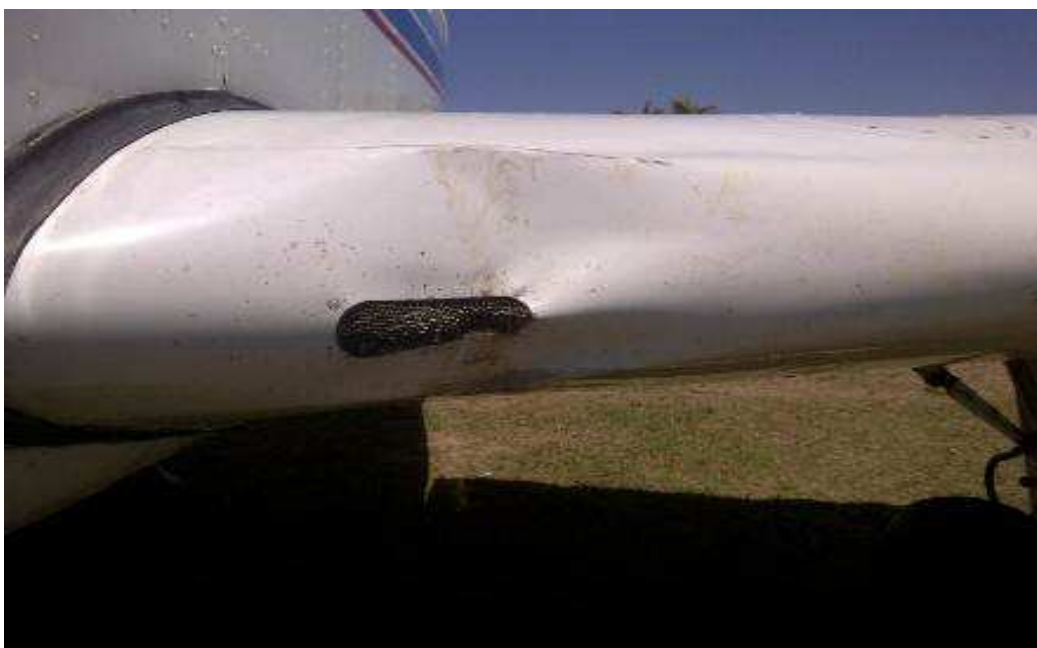
1.1.4 The pilot inspected the aircraft and realised that it had sustained damage to the left landing gear door and the left wing.

1.12.1 On final approach during landing, a tractor and trailer unexpectedly crossed the runway, and the pilot performed a go-around successfully. The tractor parked on the right, close to the threshold of the runway. The pilot then prepared to land again, his final approach was low with low airspeed and the aircraft stalled and landed hard on the threshold of Runway 07 and sustained damage to the left landing gear the aircraft then hit a tree branch with its left wing. The pilot taxied to the hangar without further problems.

Figure 1: Damage to wing

3.2.1 The aircraft landed hard on the threshold of Runway 07 following a stall and the aircraft impacted a tree with the left hand wing.

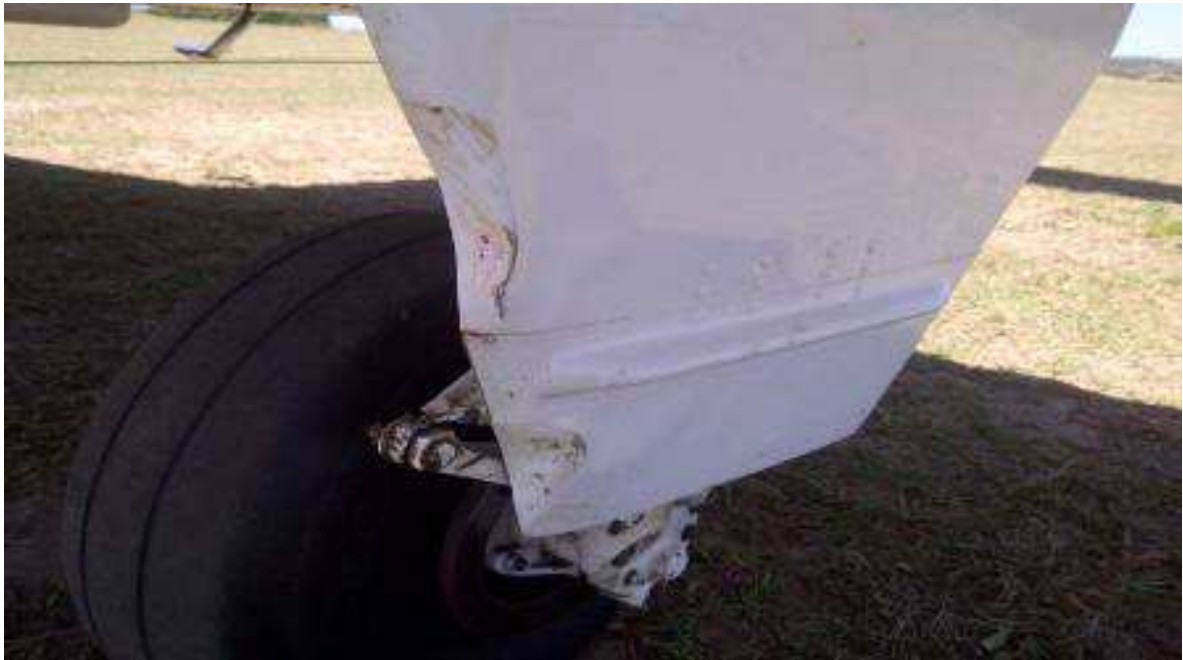
Figure 2: Damage to landing gear door
