AIRCRAFT ACCIDENT REPORT AND EXECUTIVE SUMMARY

Reference:	CA18/2/3/9256	
Aircraft Registration	ZS-DLF	Date of Accident	22 December 2013		Time of Accident	13:10Z
Type of Aircraft	Robinson – R22 Beta		Type of Operation	Private		
Pilot-in-command Licence Type		CPL	Age	22	Licence Valid	Yes
Pilot-in-command Flying Experience		Total Flying Hours	230		Hours on Type	80
Last point of departure		Grand Central Airport (FAGC), Gauteng				
Next point of intended landing		Grand Central Airport (FAGC), Gauteng				
Location of the accident site with reference to easily defined geographical points (GPS readings if possible)						
An open field near a quarry 3 nm south-west of FAGC (GPS S26° 02' 17" E028° 07' 27")						
Meteorological Information		Surface wind 030° at 06 knots, visibility > 10 km, clouds scattered at 2000 ft., temperature 27°, dew point 07° QNH 1024				
Number of people on board	1+0	No. of people injured	1	No. of people killed	0	
Synopsis

AIRCRAFT ACCIDENT REPORT

Name of Owner : Aviation Towards Success (ATS)
Name of Operator : Aviation Towards Success (ATS)
Manufacturer : Robinson
Model : R22 Beta
Nationality : South African
Registration Marks : ZS-DLF
Place : Midrand
Date : 22

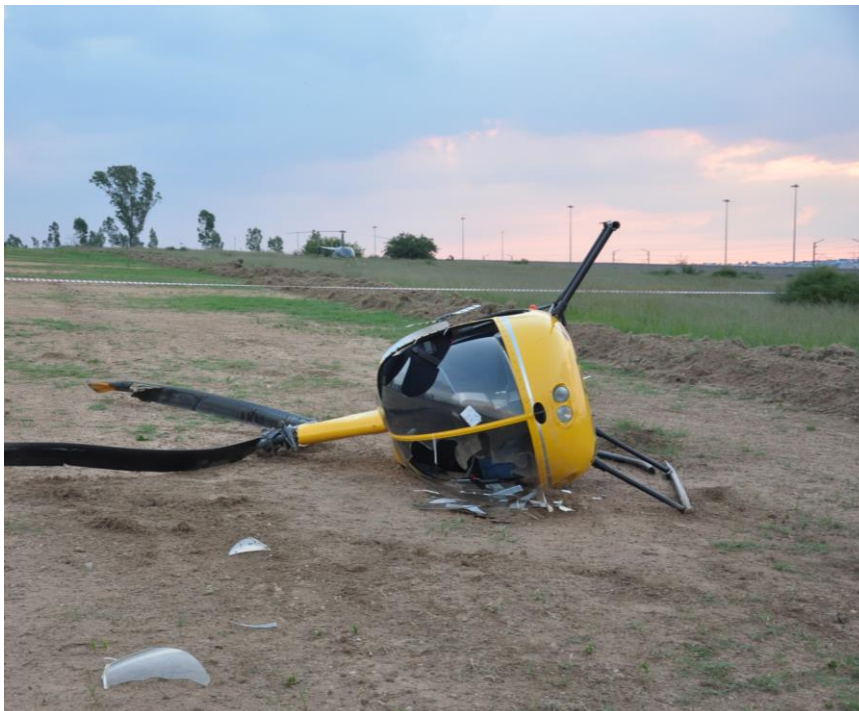
1.12.2 During the impact the main rotor blades flexed up in a coning fashion indicating that the rate of descent was high. The rotor blades and windscreen were completely destroyed in the accident. The front part of both skids broke off and the drive belts were severed after the aircraft came to rest. The aircraft did not have any doors, hence the pilot’s face was bruised by the ground. The instrument column suffered minor damage and all the debris was found approximately 4m from the aircraft as seen in Figure 1.

- a) There was a higher than normal rate of descent (***the upward coning of the main rotor blades on Figure 1 supports this descent rate***)
 - b) Raising the collective to reduce impact forces had no effect.

- 3.1.5 Since the doors had been removed and the aircraft ended up resting on its side, the pilot suffered minor injuries to his face.
- 3.1.6 There was no evidence of airframe failure or system malfunction prior to the accident. The damage to the main rotor, tail boom, windscreen, landing skids and the severing of both V-belts were attributed to the severe impact forces.
