AIRCRAFT ACCIDENT REPORT AND EXECUTIVE SUMMARY

Reference:	CA18/2/3/9260	
Aircraft Registration	ZS-MTY	Date of Accident	23/12/2013		Time of Accident	1430Z
Type of Aircraft	Piper 34-200T (Aeroplane)		Type of Operation	Training		
Pilot-in-command Licence Type	Airline Pilot Licence		Age	60	Licence Valid	Yes
Pilot-in-command Flying Experience	Total Flying Hours		2550		Hours on type	102
Pilot-completing conversion Licence Type	Private Pilot Licence		Age	52	Licence Valid	Yes
Pilot-completing conversion Flying Experience	Total Flying Hours		345.2		Hours on Type	29.2
Last point of departure	Lanseria International Airport (FALA), Gauteng Province					
Next point of intended landing	Lanseria International Airport (FALA), Gauteng Province					
Location of the accident site with reference to easily defined geographical points (GPS readings if possible)						
Right of runway 07 at FALA (GPS position: 25°56'31.84" South 027°55'36.01" East)						
Meteorological Information	Temperature: 28°C, Wind: 330°7kts, Visibility: CAV OK, Dew point: 12°C

Name of Owner : Neumeier HC
Name of Operator : Aeronav Academy
Manufacturer : Piper Aircraft Corporation
Model : PA34-200T
Nationality : South African
Regi

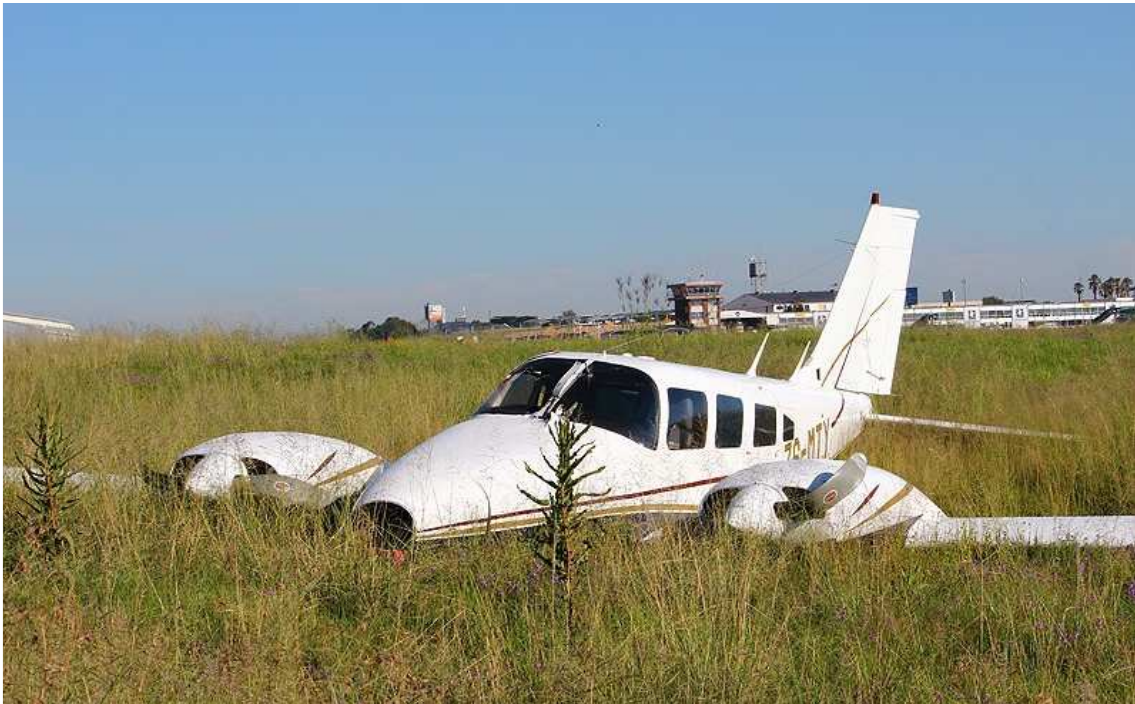
- 1.12.1 The aircraft made contact with the ground and came to rest approximately 90 meters from the initial impact point in a southerly direction.
- 1.12.2 The aircraft sustained substantial damage to the propeller, undercarriage, wings and fuselage.
- 1.12.3 The main undercarriage separated from the aircraft on impact.
- 1.12.4 The damage to the propellers indicated a low power setting at impact and neither of the propellers were feathered.
- 1.12.5 Following the accident the pilots indicated that the mixture setting was fully rich for the flight exercise.

Figure 1: Aircraft as it came to rest
