MINISTRY OF TRANSPORT AND INFRASTRUCTURE
STATE DEPARTMENT OF TRANSPORT
AIR ACCIDENT INVESTIGATION

PRELIMINARY REPORT

AIRCRAFT TYPE: BELL HELICOPTER B407

AIRCRAFT REGISTRATION: 5Y RDU

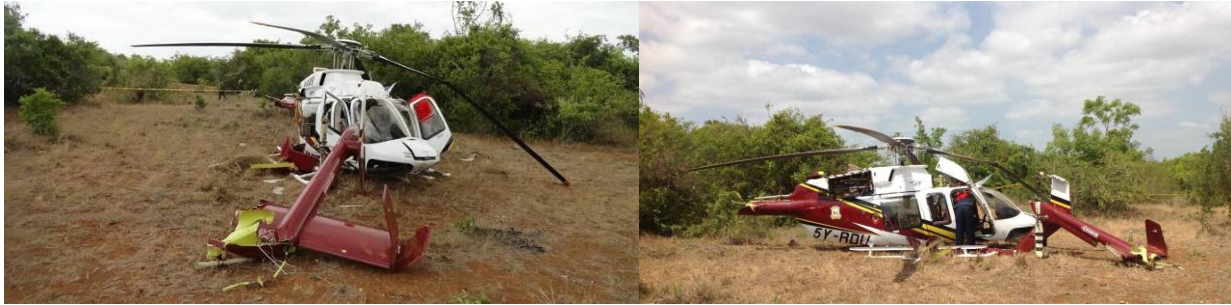
PHOTO

NATURE OF DAMAGE: Substantial (damage to the main rotor blades, tail boom was separated from the aircraft. Landing gear skids extended outwards on either side of the fuselage making the belly to come into contact with the hard ground. Further internal structural damage was evident on the fuselage.

The aircraft suffered substantial damage after it impacted the terrain. The tail boom was separated from the main wreckage and lay adjacent to the main wreckage. The landing gear skids extended outwards of the fuselage making the belly to come into contact with the hard ground. Further internal structural damage was evident on the fuselage. The ground near the fuel tank was saturated with fuel. Damage was noted in the bush line located next to the site. The terrain is relatively flat.
