<b>AIRCRAFT ACCIDENT REPORT AND EXECUTIVE SUMMARY</b>
---

<b>Reference:</b>	CA18/2/3/9268	
<b>Aircraft Registration</b>	ZU-DVM	<b>Date of Accident</b>	4 January 2014		<b>Time of Accident</b>	1510Z	
<b>Type of Aircraft</b>	Rans S-6ES Coyote II		<b>Type of Operation</b>		Private		
<b>Pilot-in-command Licence Type</b>		Private Pilot License	<b>Age</b>	46	<b>Licence Valid</b>	Yes	
<b>Pilot-in-command Flying Experience</b>		<b>Total Flying Hours</b>	223.6		<b>Hours on Type</b>	51.4	
<b>Last point of departure</b>		Khunskraal Farm in Cape Infanta, Western Cape					
<b>Next point of intended landing</b>		Swellendam Airfield (FASX), Western Cape					
<b>Location of the accident site with reference to easily defined geographical points (GPS readings if possible)</b>							
Khunskraal Farm in Cape Infanta (GPS position: 33°01'47" South 18°54'40" East, elevation 276 ft. AMSL)							
<b>Meteorological Information</b>		<b>Temperature:</b> 27°C; <b>Surface wind:</b> 225°/10kts; <b>Visibility:</b> <1000m <b>Cloud cover:</b> Broken; <b>Cloud base:</b> 1000ft; <b>Dew point:</b> 4°C

COMPILED BY  	<b>CrashLAB</b>	PAGE 1 OF 10	
COMPILED FOR: S.A. Civil Aviation Auth.		DOCUMENT NUMBER AAI-003-02-14

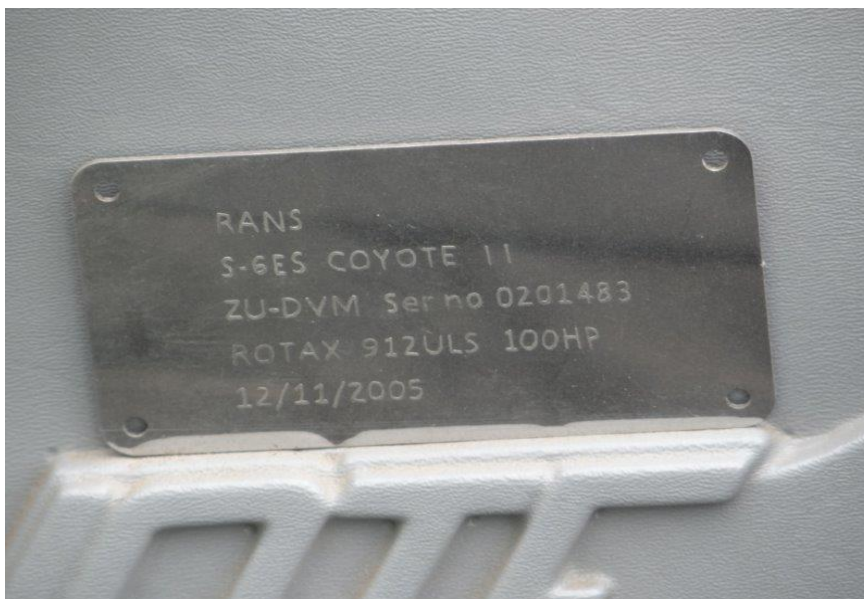
**NOTE 1:** The serial number on the data plate did not correspond with the serial number on the Certificate of Registration.

**Figure 2:** Aircraft fireproof data plate reflecting Serial Number **0201483**

**NOTE 2:** The owner confirmed in writing that he made a typing error when he sent the information to the engraver to have fire proof data plates manufactured for the aircraft.

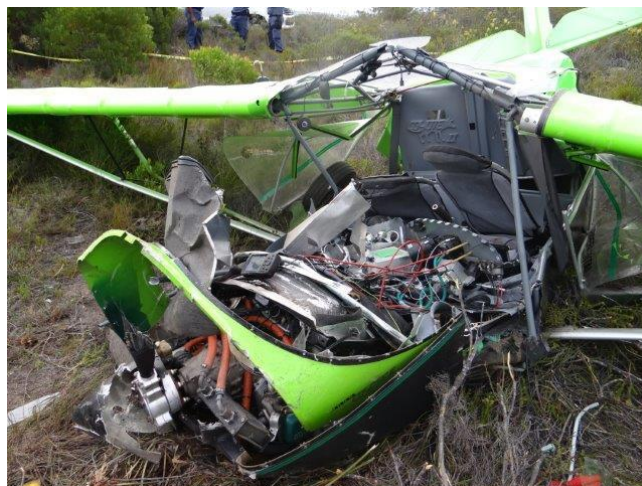
1.12.2 The aircraft sustained substantial damage to the forward engine section of the fuselage, propeller, wings, tail plane and undercarriage.

**Figure 7:** The destroyed forward section of the aircraft

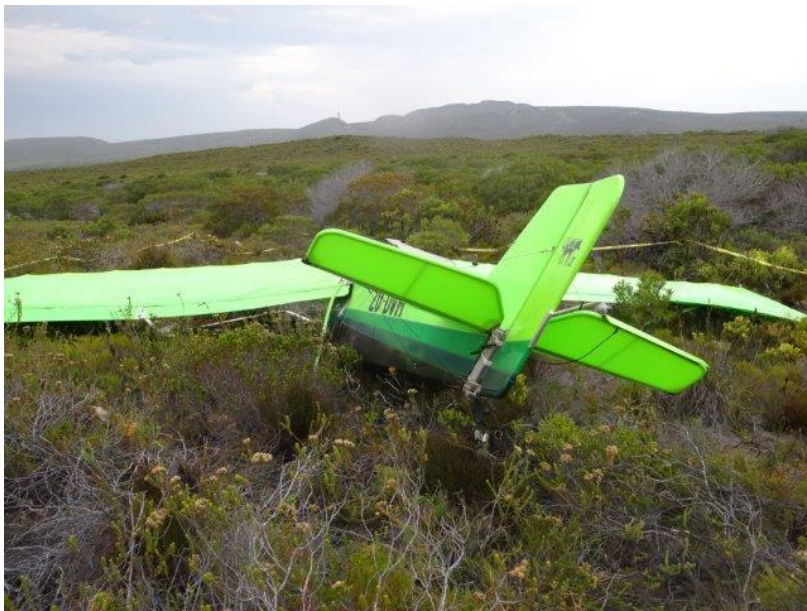
**Figure 8:** View from the back

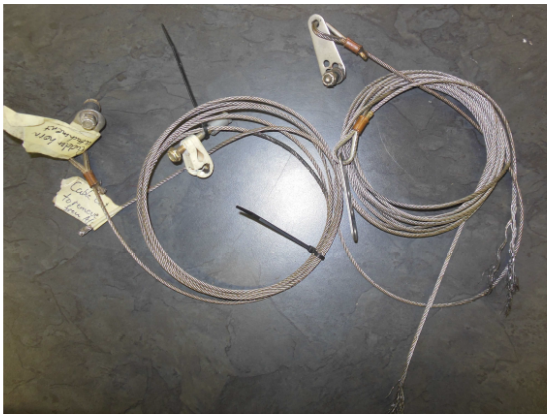
1.1. A failed right hand (pilot's perspective) rudder control cable (Photo 1) from a Rans 65 aircraft, number ZU-DVM, was submitted to determine most probable reason/s for failure during operation resulting in a fatal accident.

**Photo 1: Supplied parts (digital)**

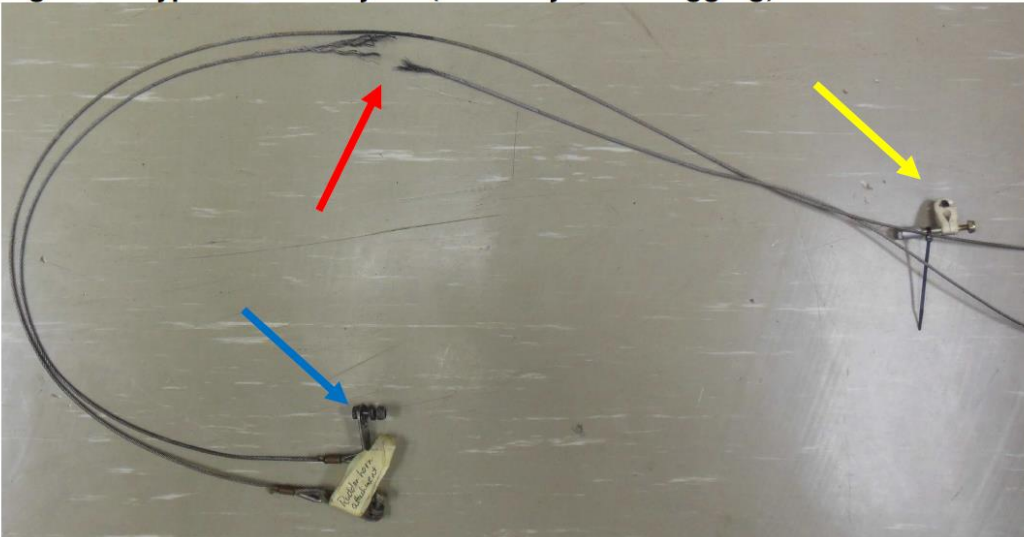
The visual inspection revealed a fracture (Photo 2, red arrow) at the position of the Teflon based cable guide (yellow arrow) in the right hand rudder control cable in close proximity to the rudder horn attachment position (blue arrow). Extensive mechanical abrasive wear of the outer strand wire surfaces were evident at the fractured position. The fracture revealed extensive break-up and delamination of the cable core as well outer strands.

Photo 2: Supplied parts showing position of fracture (digital)

- 7.1 The investigation results indicate that the right hand rudder control cable fractured at the position of the cable guide (right hand) due to extensive abrasion induced mechanical wear. Over an undetermined period of operational time the mechanical abrasion wear between the Teflon guide and cable resulted in the failure of the outer strands while the inner core fractured during operation under 'normal' tensile conditions.
- 7.2. Although to a lesser degree, the left-hand cable revealed similar damages at the same guide position. This may be an indication that both cables have been exposed to comparable operational hours.
- 7.3. Both cables revealed wear damages at other locations suggesting extended operational exposure to the assembly under adverse conditions.

- 8.1. Considering the severe detrimental effect of the failure of such a critical component to Flight Safety, it is strongly recommended that the SACAA urgently alert corresponding

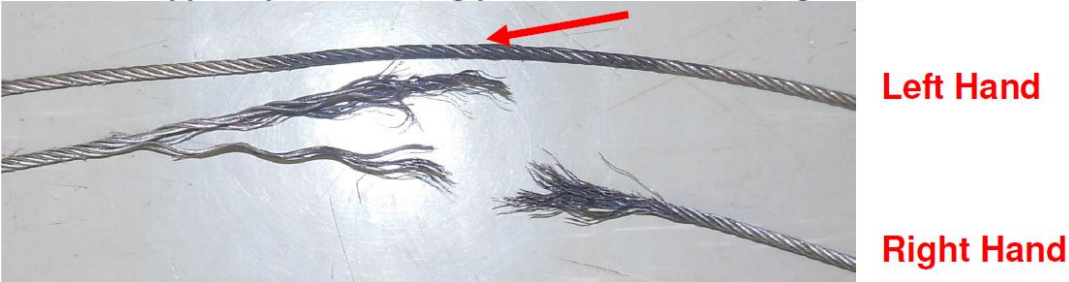
The left hand cable revealed a similar darkened area (Photo 3, red arrow) as well as significant wear and indications of fractured wires at the relevant position (Photo 5, red arrow). Significant surface abrasive wear were also noted at other positions on both cables (Photo 6, red arrow).

Photo 3: Corresponding positions on left- and right hand cables (digital)

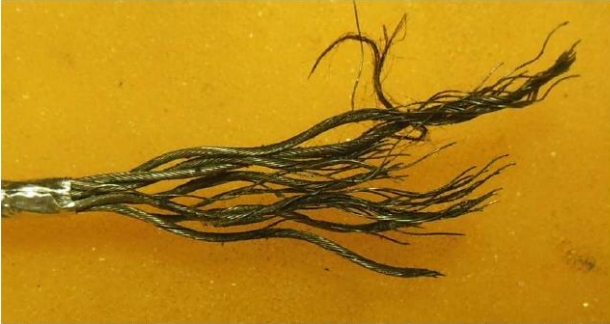
Photo 4: Fractured right hand cable (digital)

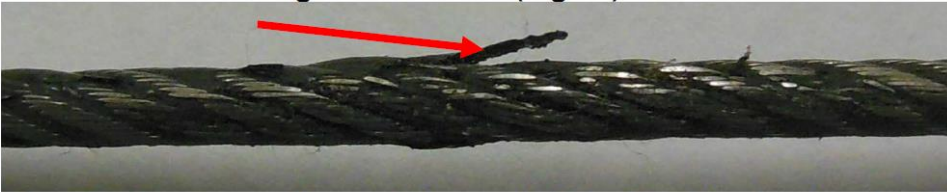
Photo 5: Corresponding position on left hand cable showing fractured wires (digital)

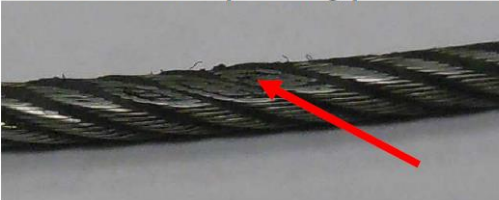
Photo 6: Mechanical abrasive wear evident at other cable positions (digital)

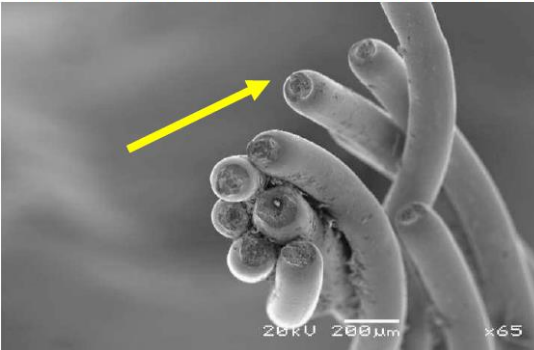
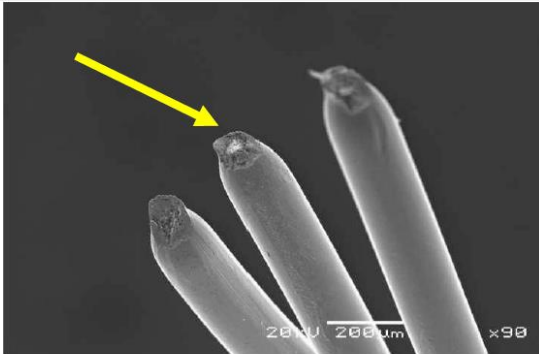
At higher magnifications the SEM investigation revealed the core wires to have failed under a tensile load (Photo's 7 and 8, yellow arrows) with clear indications of 'necking' (Photo 9) while the fracture surface revealed the typical 'dimple' geometry synonymous with a ductile failure (Photo 10).

Photo 7: Fractograph showing core wire fractures (x65, SEM)

Photo 8: Fractograph showing core wire fractures (x90, SEM)

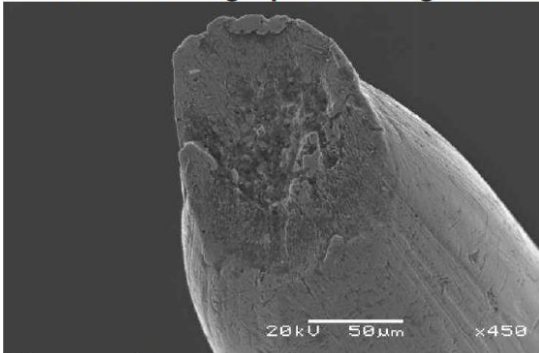
Photo 9: Fractograph showing typical core wire fracture geometry (x450, SEM)

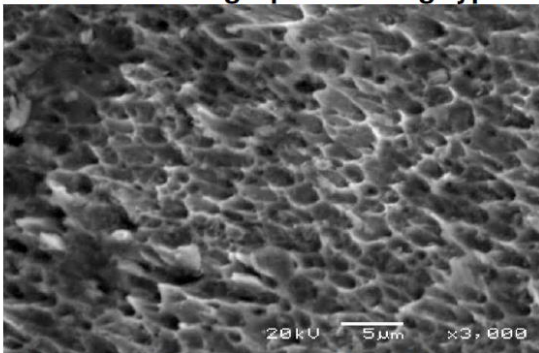
Photo 10: Fractograph showing core wire ductile fracture geometry (x3000, SEM)

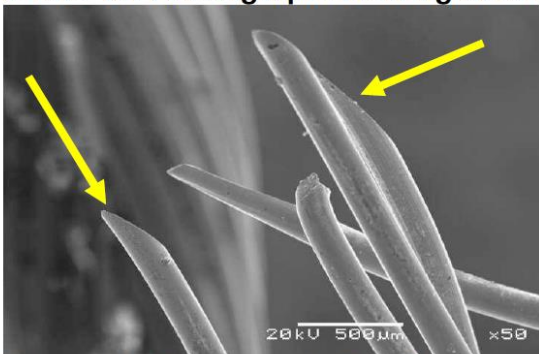
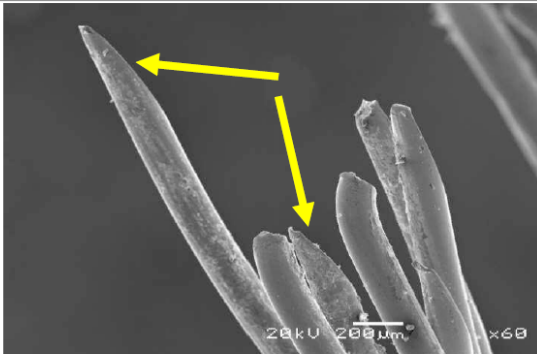
The fractographs from the outer strand wires revealed extensive mechanical abrasive wear damages (Photo's 11, 12 and 13, yellow arrows). Selected wires showed failures due to the mechanical wear only (Photo's 13 and 14, yellow arrows) while others revealed small fracture surfaces of a ductile nature (Photo's 15 and 16, red arrow).

Photo 11: Fractograph showing outer strand wire fractures (x50, SEM)

Photo 12: Fractograph showing outer strand wire fractures (x60, SEM)

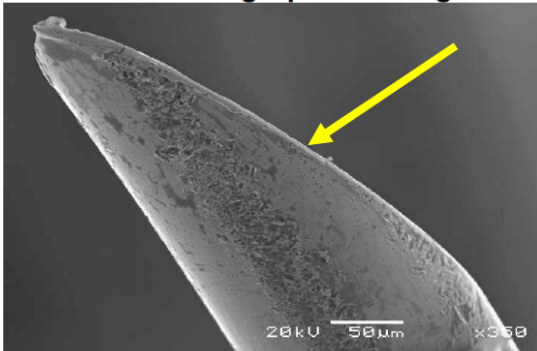
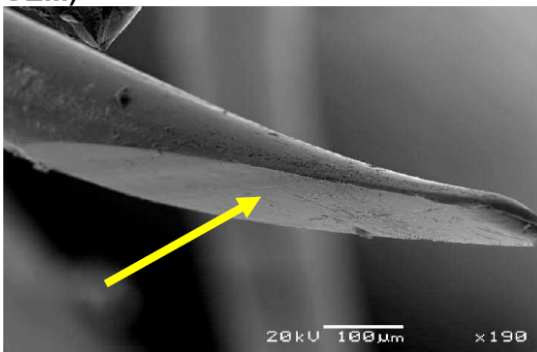
Photo 13: Fractograph showing typical outer strand wire fracture geometry (x550, SEM)

Photo 14: Fractograph showing typical outer strand wire fracture geometry (x190, SEM)

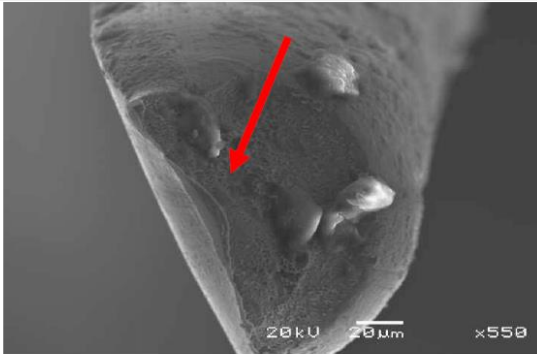
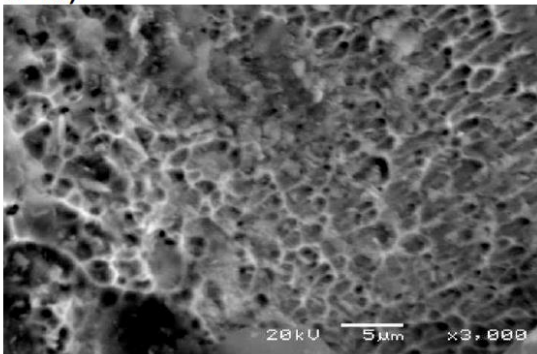
Photo 15: Fractograph showing typical outer strand wire fracture geometry (x550, SEM)

Photo 16: Fractograph showing typical outer strand wire ductile final fracture geometry (x3000, SEM)

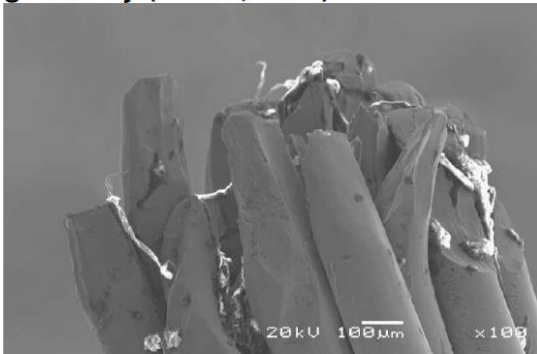
Photo 17 depicts the same cable exposed to a mechanical (side-cutter) incise for comparison purposes.

Photo 17: Fractograph showing fracture geometry of a mechanically severed cable (x100, SEM)
