AIRCRAFT ACCIDENT REPORT AND EXECUTIVE SUMMARY

Reference:	CA18/2/3/9269	
Aircraft Registration	ZU-FXI	Date of Accident	5 January 2014		Time of Accident	0630Z
Type of Aircraft	Bat Hawk (Aeroplane)		Type of Operation	Private		
Pilot-in-command Licence Type	NPL Airplane		Age	55	Licence Valid	Valid
Pilot-in-command Experience	Flying	Total Hours	Flying	935,48	Hours on Type	202,0
Last point of departure	Andrew's Field (FAAF)- Western Cape					
Next point of intended landing	Andrew's Field (FAAF)- Western Cape					
Location of the accident site with reference to easily defined geographical points (GPS readings if possible)						
Suiderstrand near Struis Bay (fynbos) at GPS position: S 34°49'02.65", E 019°57'28.38"						
Meteorological Information	Wind direction: SWS, Wind speed: 6 knots, Visibility: Good. Temperature: 19 °C, Cloud base: 2 000 ft					
Number of people on board	1+1	No. of people injured	0	No. of people killed	0	
Synopsis	<p>An aircraft with two occupants on board experienced an engine failure during a scenic flight. The pilot initiated a glide to execute a forced landing onto the beach, which was approximately 49,2 feet (ft.) from the bush. During the glide, the pilot was

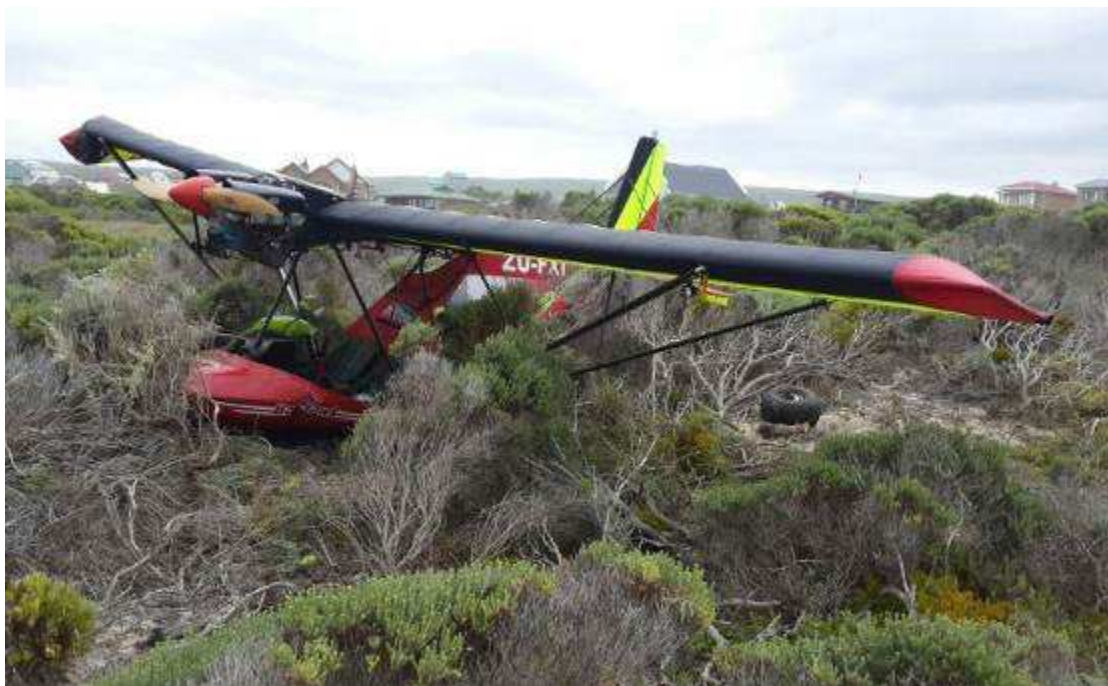
1.3.1 The aircraft sustained substantial damage to the airframe nose section, right wing and undercarriage.

Figure 1: Damage to aircraft

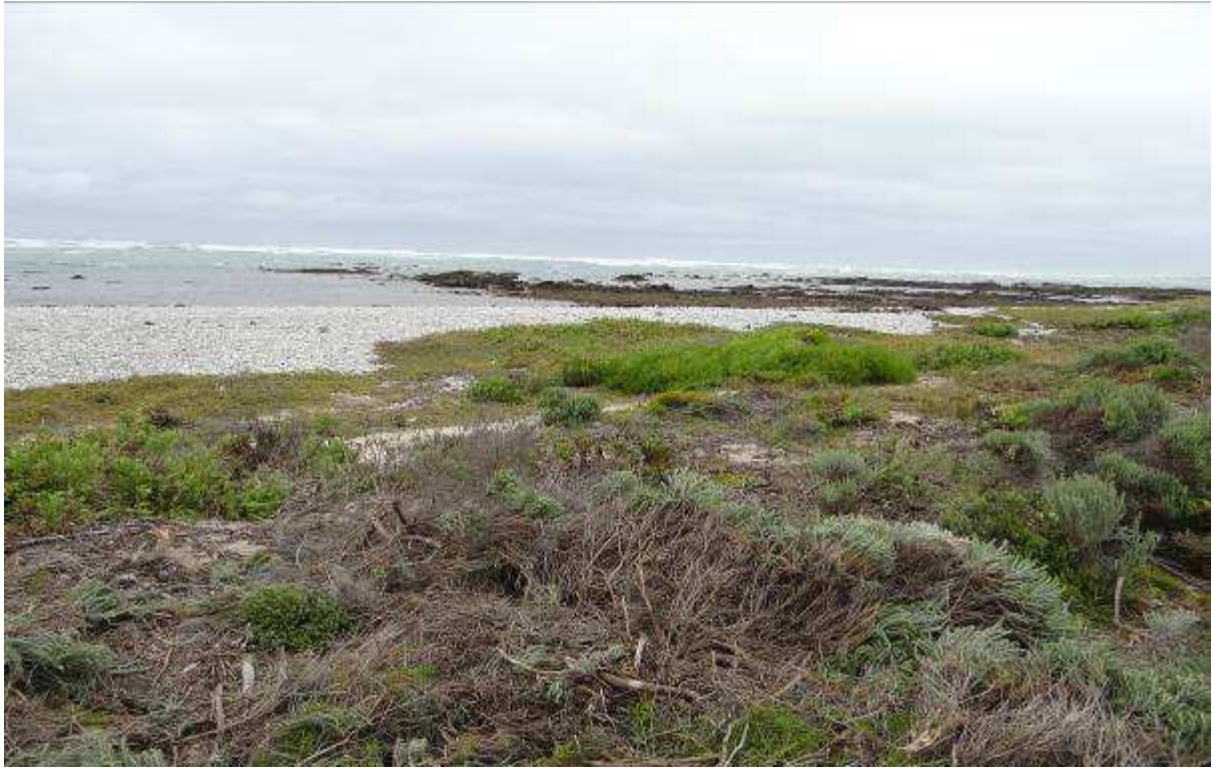
1.12.1 The place at which the aircraft crashed was a bushy environment. The accident site is not suitable for landing.

Figure 3: View of exact location of accident terrain

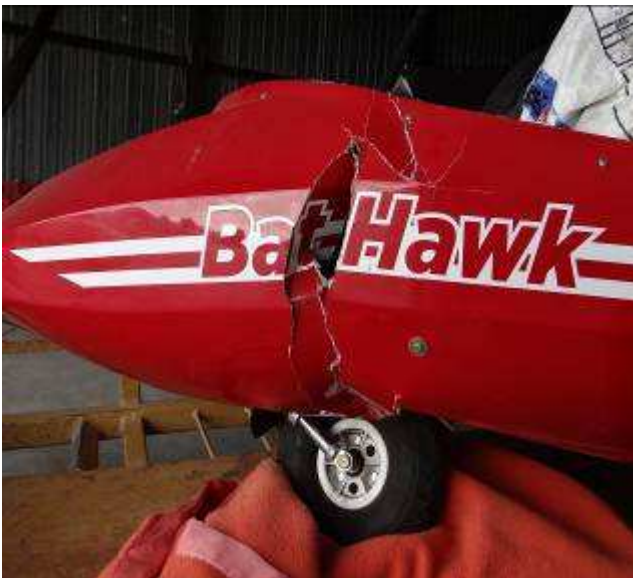
1.12.2 The observation of the impact of the aircraft with the terrain was at a slightly high angle of descent and low speed. During impact with the terrain, the aircraft sustained damage to the nose section, landing gears, right wing tip and the keel pipe.

Figure 4: Damage to nose landing gear

1.12.3 All damage is attributed to impact forces experienced by the aircraft.

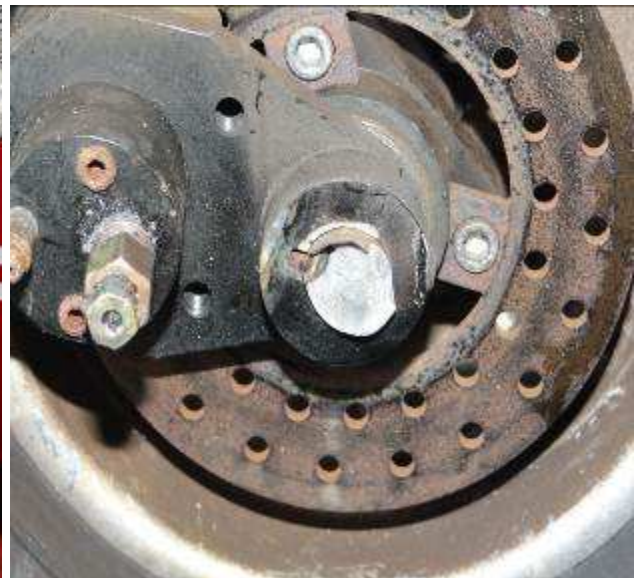
Figure 5: Left main wheel broken off

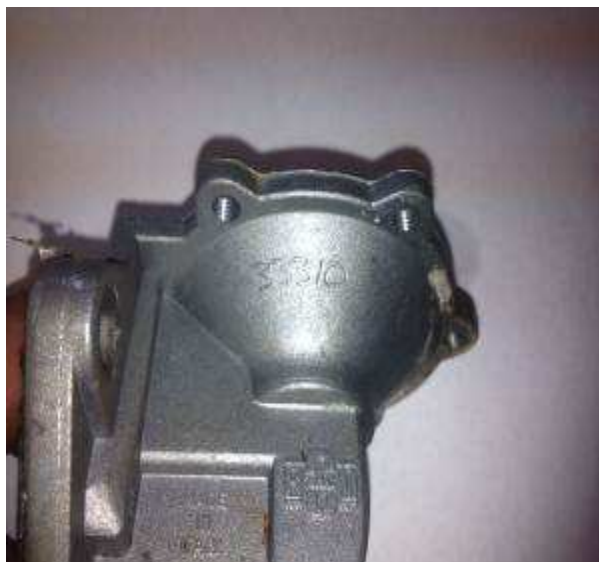
Figure 6: Mechanical pump

1.16.2 With both fuel pumps engaged, the engine functioned at all power setting ranges. As soon as the electrical (back-up) booster fuel pump was switched "OFF", the engine failed after 20 to 30 seconds depending on the power settings.

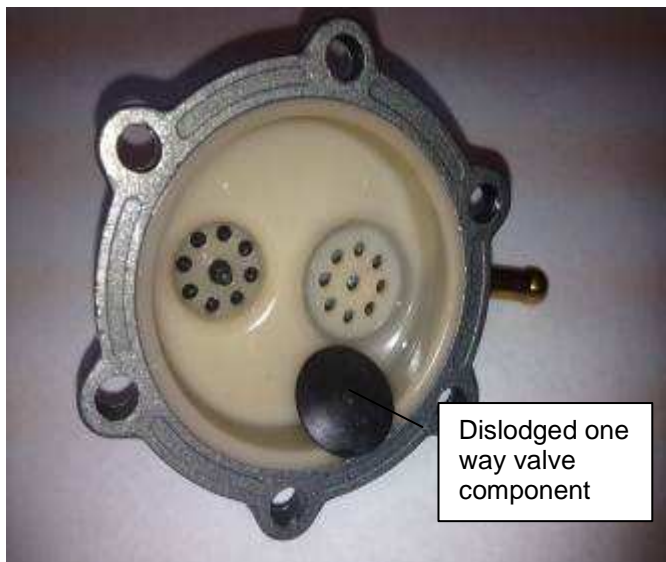
Figure 7: Dislodges one-way valve

1.16.3 The pump was removed and dismantled. It was discovered that the one-way valve was dislodged, causing fuel flow disruption during operation.

- 2.1 The aircraft owner carried out general maintenance on the aircraft. Although it is indicated that a qualified person conducted the annual inspection, it was concluded that the mechanical fuel pump's dislodged one-way valve could only have occurred during an improper assembly during the 100-hour inspection or initial installation. The pilot was not qualified to carry out maintenance in accordance with existing regulatory procedures.

- 3.1.7 All control surfaces were accounted for, and all damage to the aircraft was attributable to the severe impact force.
- 3.1.8 The fuel pump's one way-valve was dislodged.
