| <b>AIRCRAFT ACCIDENT REPORT AND EXECUTIVE SUMMARY</b> |

| | | | | Reference: | CA18/2/3/9272 | |
| <b>Helicopter Registration</b> | ZS-RIU | <b>Date of Accident</b> | 7 January 2014 | | <b>Time of Accident</b> | 1256Z |
| <b>Type of Aircraft</b> | AS350 B3 (Helicopter) | | <b>Type of Operation</b> | Training | | |

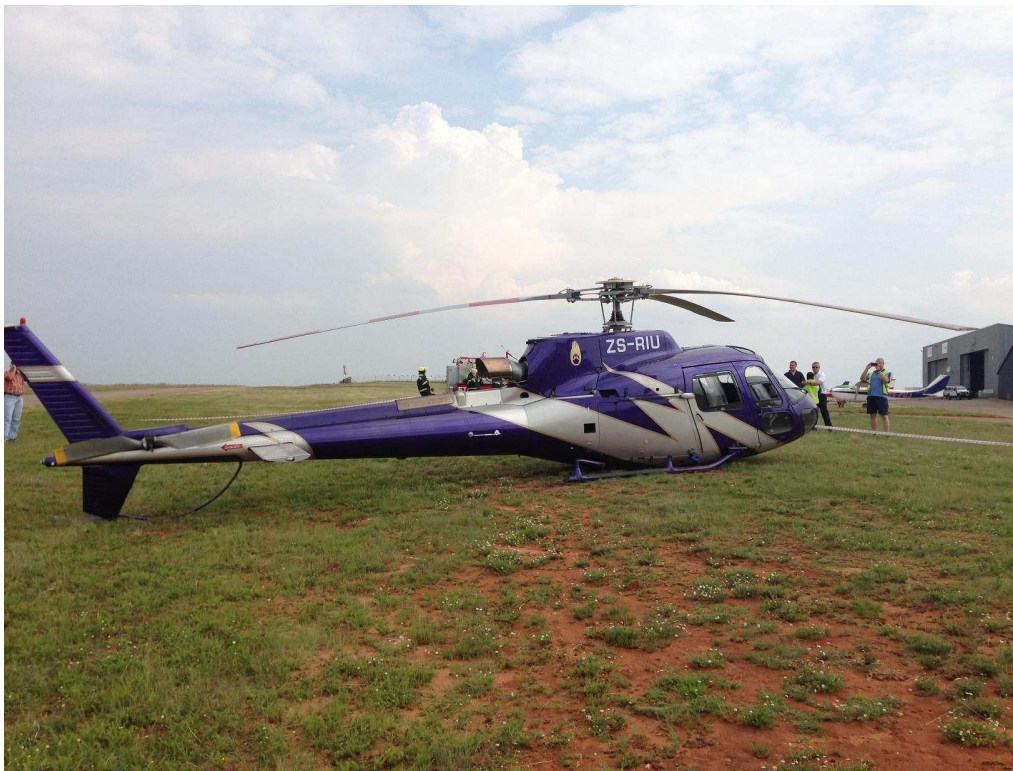
1.12.1 The helicopter descended towards the ground, touched down hard and came to rest 80 metres from the initial impact point in an upright position after turning through 90 degrees.

1.12.2 The helicopter came to rest in a northerly direction adjacent to taxiway 35 at FAGC.

1.12.3 The helicopter sustained substantial damage to the tail boom and skid gear, which broke off during the impact sequence.

**Figure 2:** Helicopter as it came to rest
