## *Final report RL 2014:19e*

**Serious incident at Malmö Airport on January 10, 2014 involving the aircraft SE-LIS of the model Fokker F27 Mark 050, operated by Amapola Flyg AB.**

File number L-04/14

2014-12-16

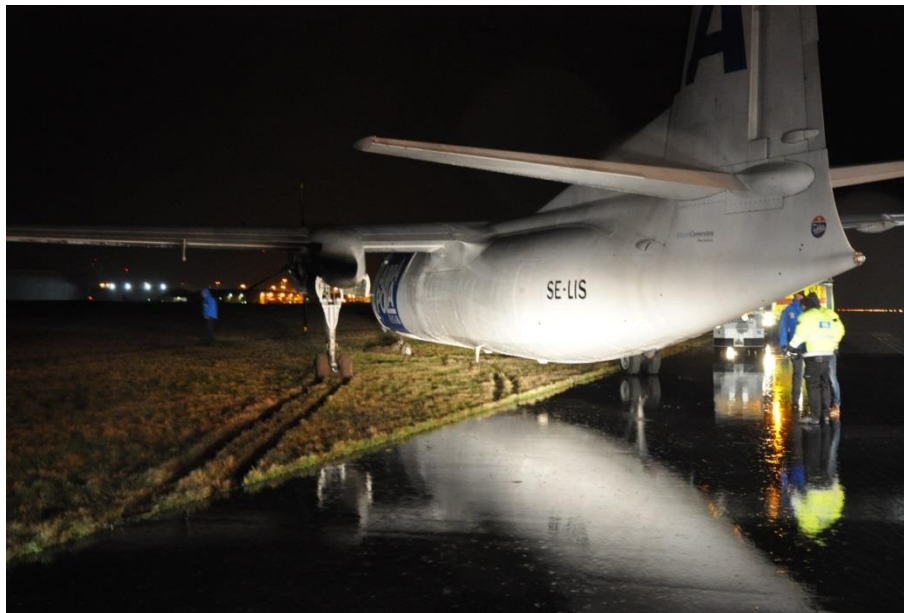
The yaw continued towards the left, and the aircraft left the runway and stopped with the nose wheel and left main gear in the grass, with the right main gear on the asphalted runway shoulder. In connection with the excursion, the nose gear and left main gear each ploughed a furrow in the ground on the grass area with a depth corresponding to just under half the diameter of the wheels. See Figure 1.

Figure 1. The aircraft's position after the excursion. The picture was taken four hours after the incident.

The yaw to the left was probably caused by a combination of a wind gust in connection with the fact that thrust reversal was still activated at a speed far below what was recommended.

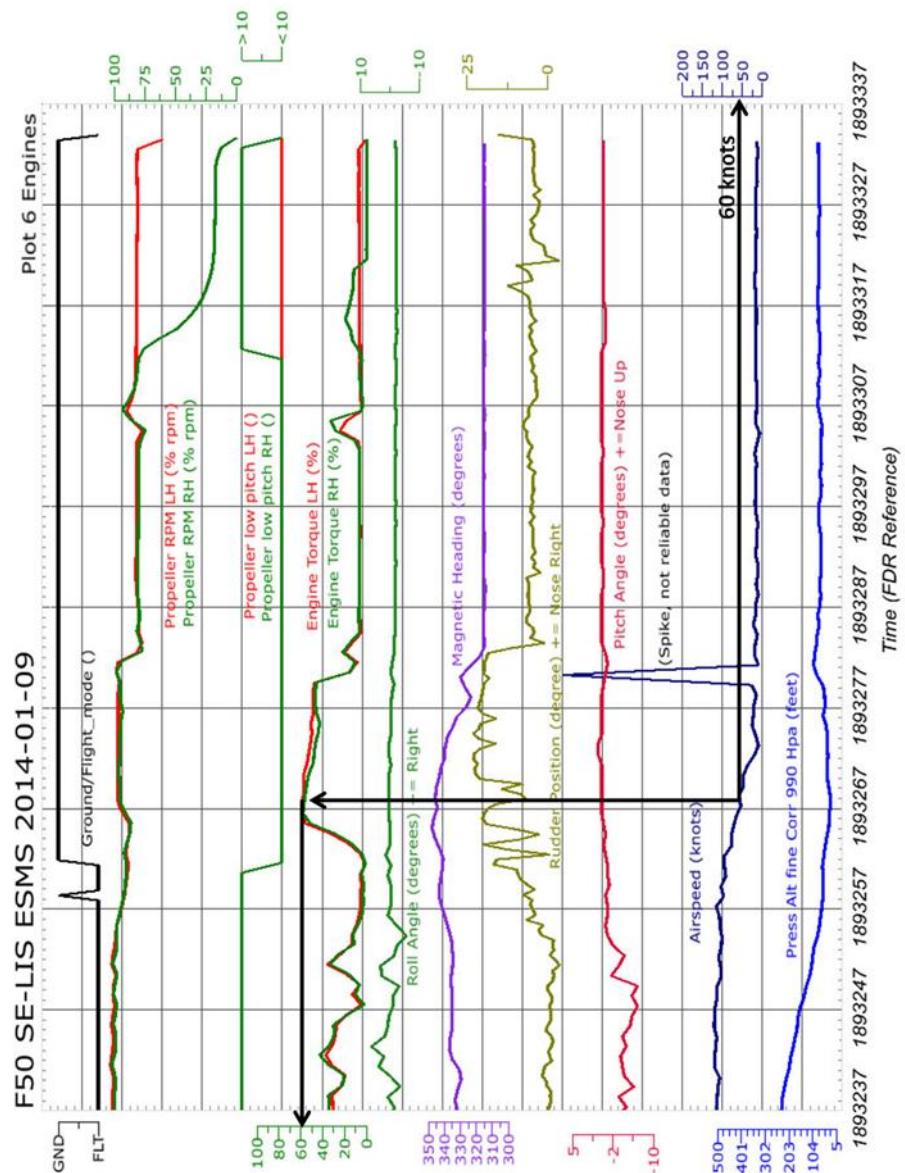
Table data and corresponding plots show that the touchdown and the initial roll-out took place in connection with the centre line with an indicated speed of 95 knots and a heading of about 345 degrees. Thrust reversal was initiated soon thereafter at an indicated speed of 90 knots. At about 60 knots, the highest recorded torque value during thrust reversal was achieved, TRQ 59 % and 58 % for the left and right engines, respectively. See Figure 3 below.

Figure 3. FDR plot during the last 100 seconds of the sequence of events.

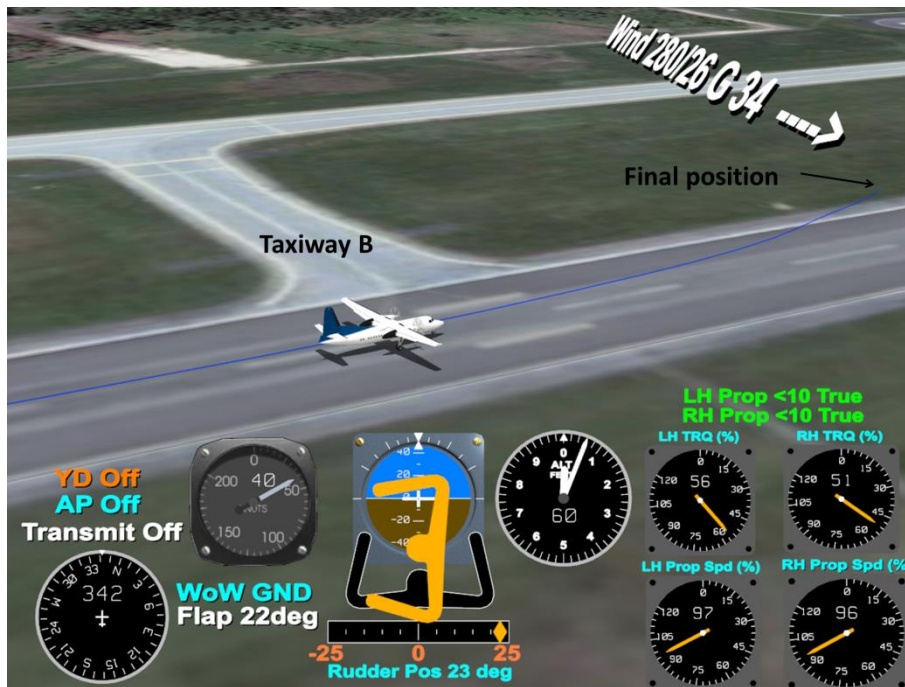
When roughly abeam taxiway B, the heading began to change to the left; the recorded indicated speed was 40 knots, and TRQ during thrust reversal was 56% and 51% respectively - see Figure 4 below. Throughout the sequence of thrust reversal, the rpm of the propellers was just over 95% Np, which according to the manufacturer corresponds to full thrust reversal. In connection with the left yaw, the left engine had about 4 to 7% higher TRQ values than the right engine, which according to the manufacturer leads to the possibility of a noticeable movement occurring in the yaw axis.

Figure 4. Screen dump from animation. With permission from CAE Inc (Flightscape).
