AIRCRAFT ACCIDENT REPORT AND EXECUTIVE SUMMARY

Reference:	CA18/2/3/9278	
Aircraft Registration	ZS-NDY	Date of Accident	24 January 2014		Time of Accident	1258Z	
Type of Aircraft	Cessna A188 (Aeroplane)		Type of Operation	Private			
Pilot-in-command Licence Type	Private Pilot License		Age	24	Licence Valid	Yes	
Pilot-in-command Flying Experience	Total Flying Hours		109.7		Hours on Type	15.5	
Last point of departure		Wonderboom aerodrome (FAWB): Gauteng province.					
Next point of intended landing		Warmbaths aerodrome (FAWA): Limpopo province.					
Location of the accident site with reference to easily defined geographical points (GPS readings if possible)							
Petronella plot number 79 at GPS coordinates determined to be (S 25° 28.986 ' E 028° 11.638') at an elevation of approximately 3 860 feet above mean sea level (AMSL).							
Meteorological Information		Dry bulb temperature, 34°C: Dew point temperature, 7°C: Wind Speed@ 03 Knots.

AIRCRAFT ACCIDENT REPORT

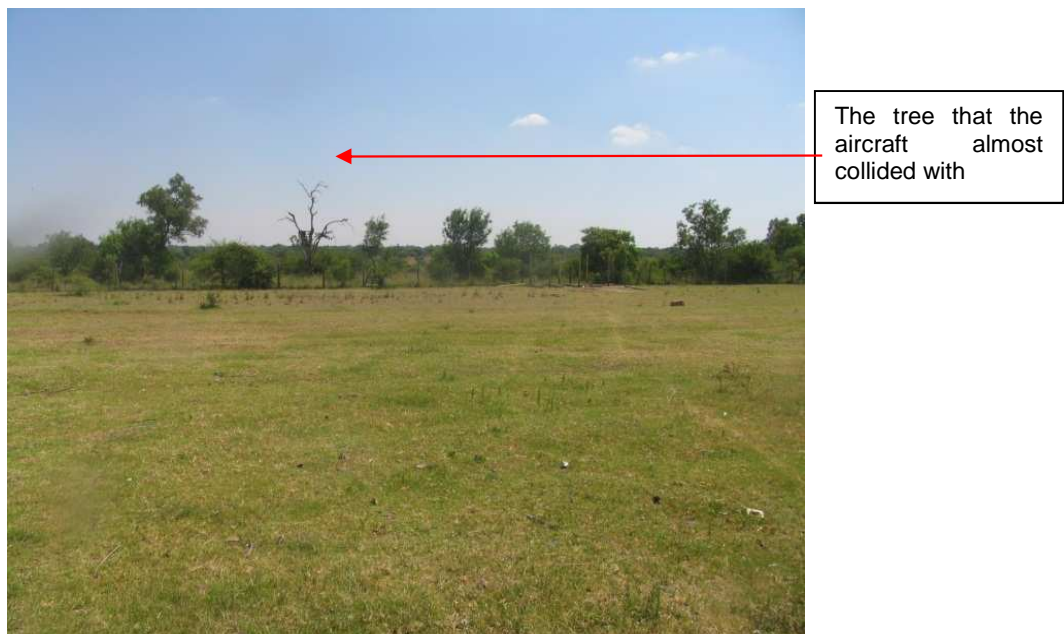
Figure1: The tree on the aircraft flight path.

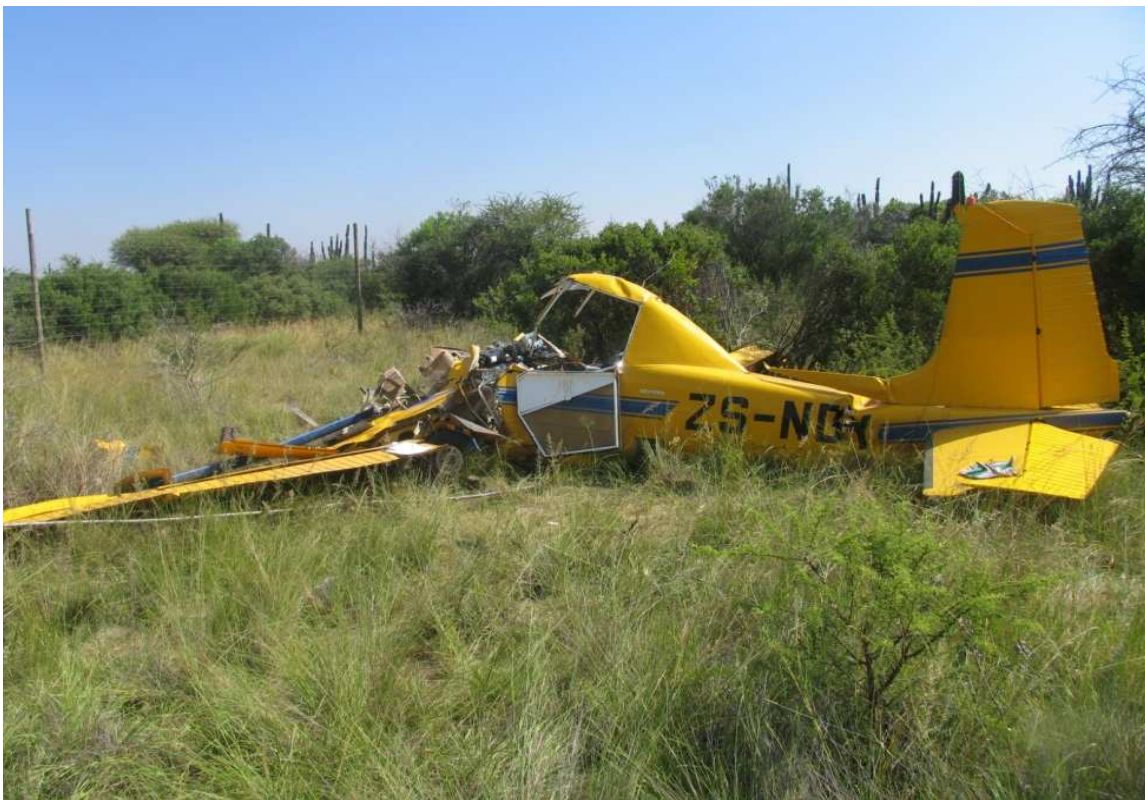
1.3.1 The aircraft was destroyed during the accident sequence.

Figure 3: Side view of the aircraft as found at the accident site.

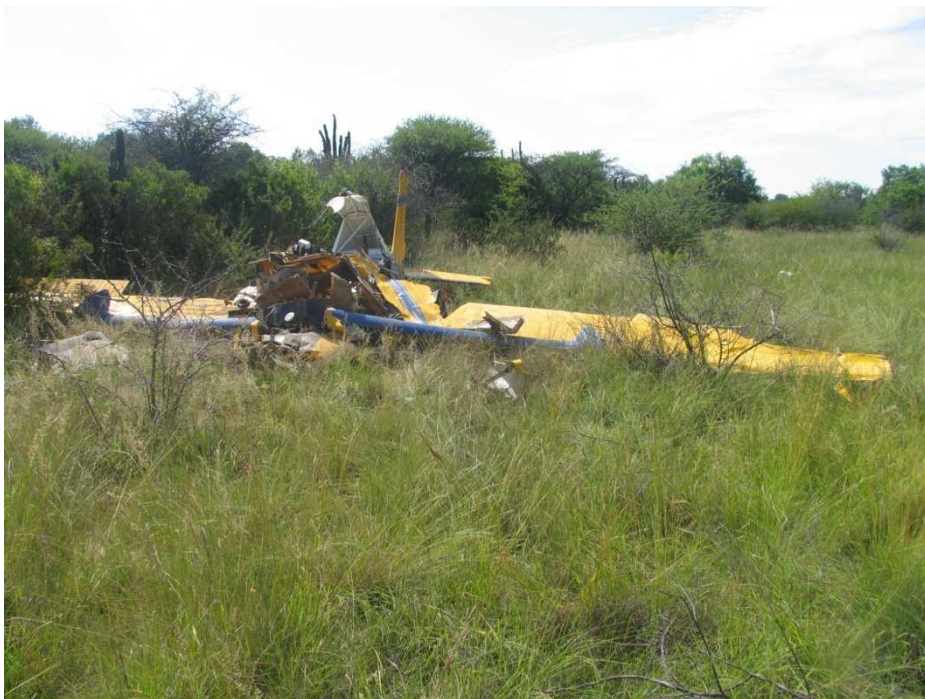
1.12.1 The impact sequence indicates that the aircraft was in a wings level, nose-down attitude when it crashed. Both wings were still found attached to the fuselage at the main spar attachment, but extensively deformed. The undercarriage/main gear failed from overload. The flight controls were substantially damaged with the spray boom mounted under the wings being destroyed. One propeller blade was embedded onto the ground. The propeller instantly detached from the engine severing the crank. The oil sump, oil cooler, fuel tank, fibre glass chemical hopper and the aircraft battery were crushed.

Figure 6: Front view of the aircraft.

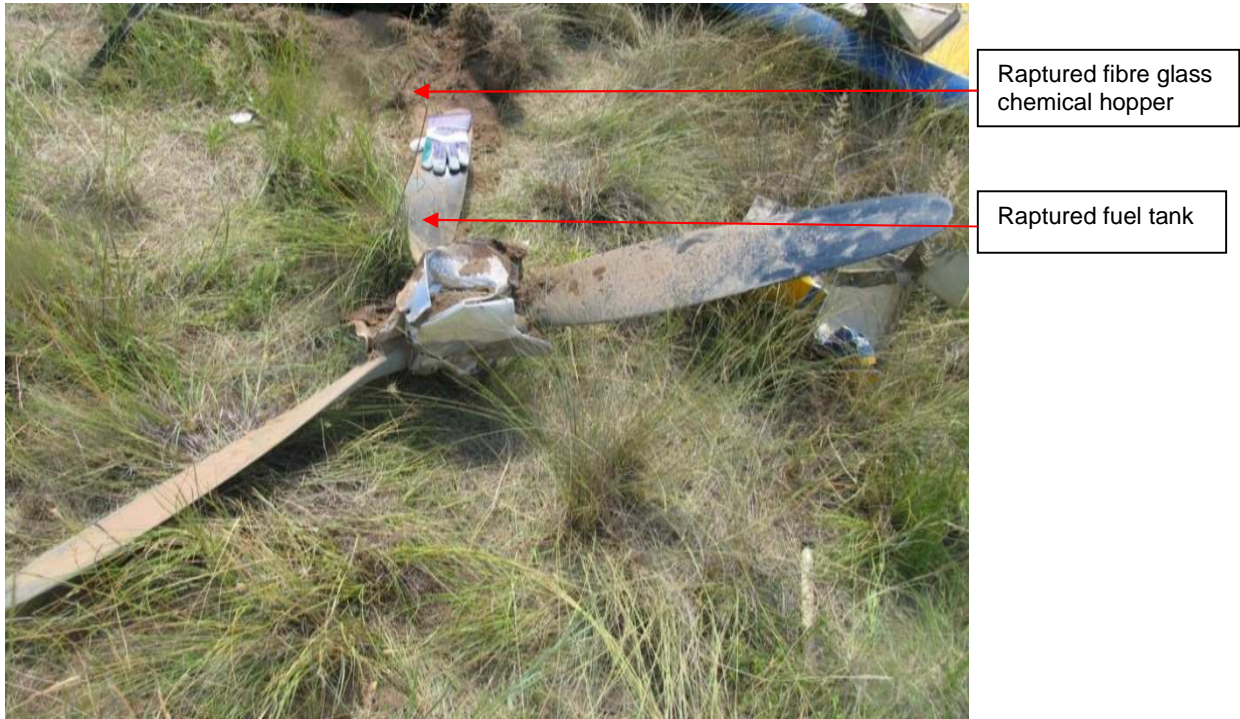
Figure 7: View of the propeller as found at the accident site.

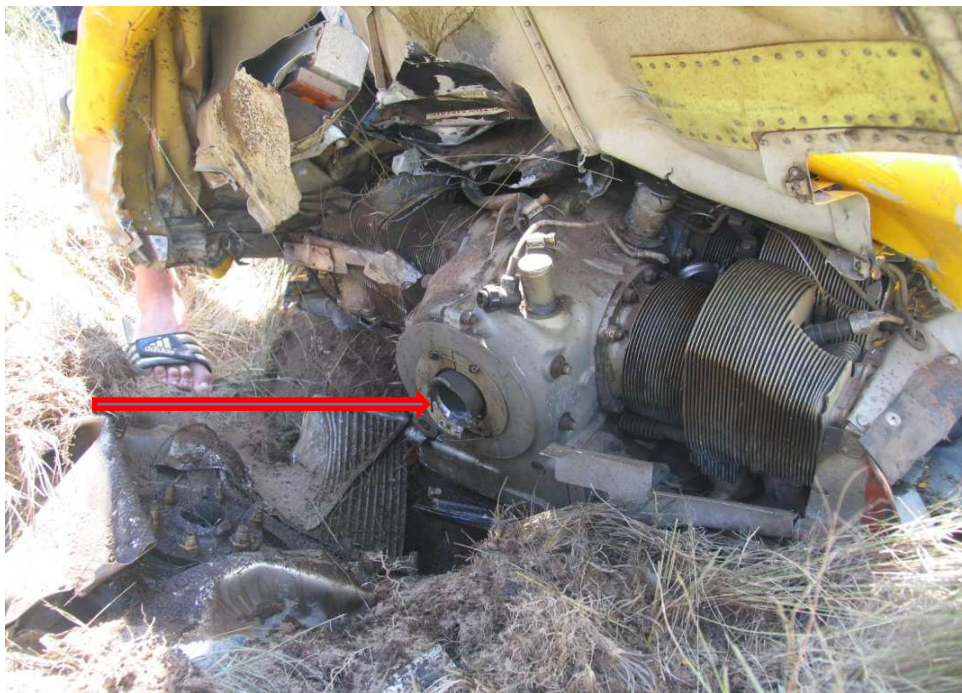
Figure 8: Severed crank.

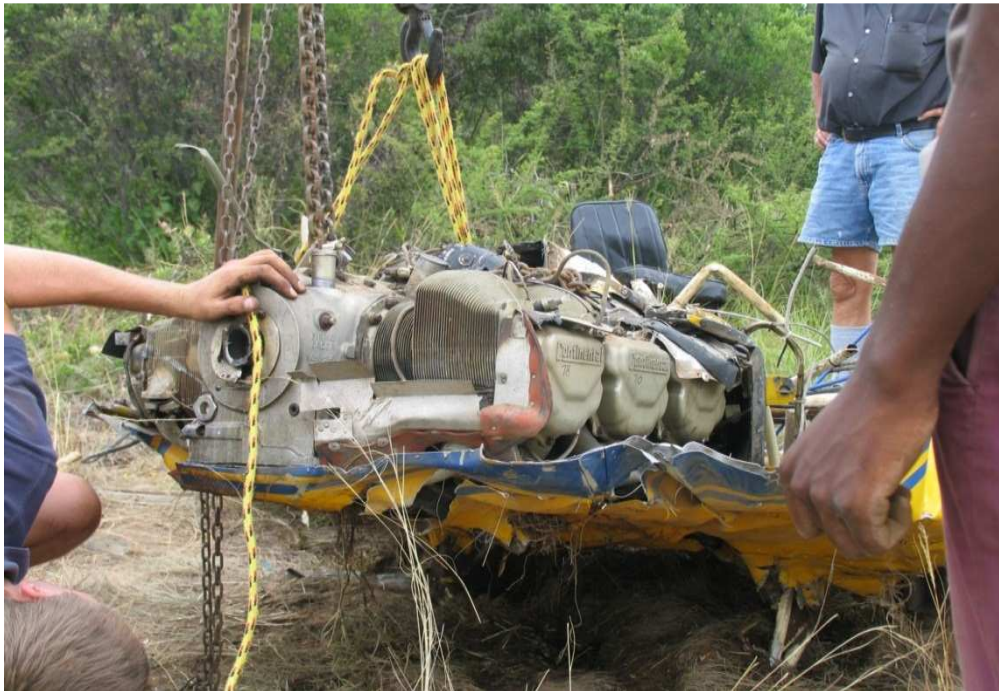
1.16.1 The Investigation revealed no communication or any distress call made by the pilot and on-site examination revealed that the aircraft had impacted the ground in a nose down attitude. On 04 February 2014, a (Continental IO-520L engine, serial number 567907) and a Hartzell propeller, serial number QG461B propeller were recovered from the accident site to an approved maintenance overhaul facility in FAWB aerodrome for examination and tear down inspection under the supervision of the investigating team. Attached is the engine photo shot during the recovery.

Figure 9: The engine at the accident site.

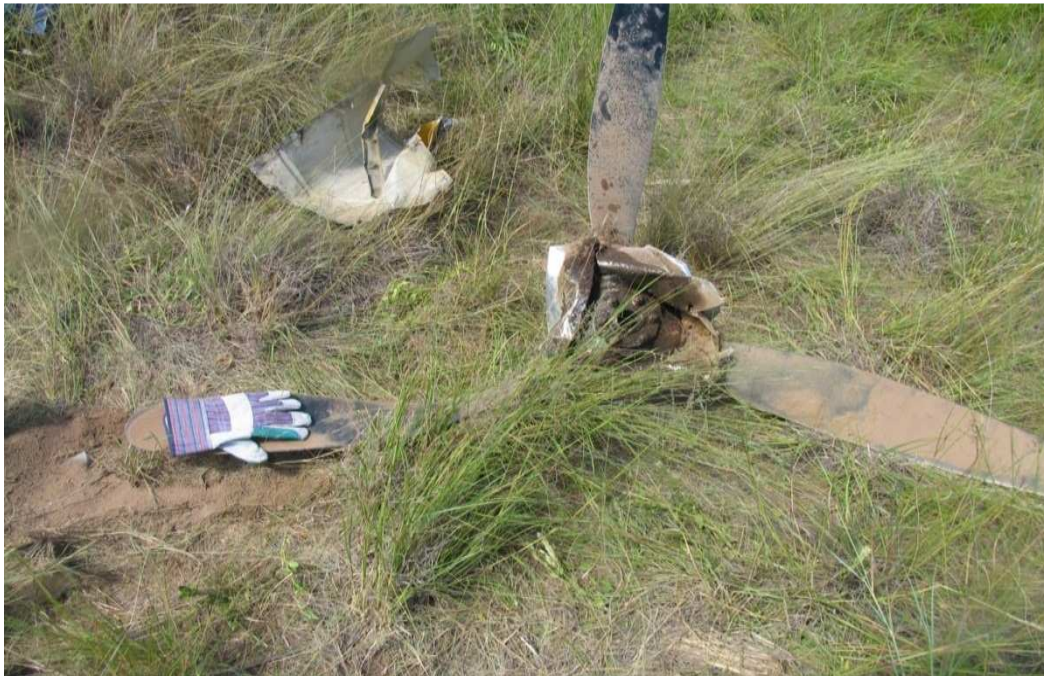
1.16.2 During the investigation, the engine was set up together with the propeller to determine the position of propeller blades relative to the engine at the moment of impact when the propeller detached from the engine. The fracture faces of the fractured crank and the propeller were positioned to fit as closely as possible into each other. At this stage no attempt was made to rotate the crank in the engine, however during the engine strip, it was evident that the crank could still rotate and no anomalies were detected. The severed crank showed evidence that the propeller was still turning on impact however the amount of power it was producing couldn't be determined by visual inspection. Examination of the propeller also suggests that the oil pressure was in fact available to activate the constant speed mechanism as this is the function of the throttle and the other cockpit settings. See figure 10 below.

Figure 10: View of the propeller.
