AIRCRAFT ACCIDENT REPORT AND EXECUTIVE SUMMARY

Reference:	CA18/2/3/1037	
Aircraft Registration	ZU-NTC	Date of Accident	24 January 2014		Time of Accident	1300Z
Type of Aircraft	RV 7A Amateur-build aeroplane		Type of Operation		Private (flying club)	
Pilot-in-command Licence Type		PPL	Age	62	Licence Valid	Valid
Pilot-in-command Flying Experience		Total Flying Hours	315		Hours on Type	27.6
Last point of departure		Cape Town International Airport (FACT), Western Cape				
Next point of intended landing		Cape Town International Airport (FACT),-Western Cape				
Location of the accident site with reference to easily defined geographical points (GPS readings if possible)						
FACT Runway 01 at GPS co-ordinates: S 33°58'45", E018°36'21"						
Meteorological Information		Wind direction: 220°C, temperature: 25, wind speed: 15 kts, visibility: CAVOK Cloud base: 030, cloud cover: SCT030				
Number of people on board	1+0	No. of people injured	0	No. of people killed	0

AIRCRAFT ACCIDENT REPORT

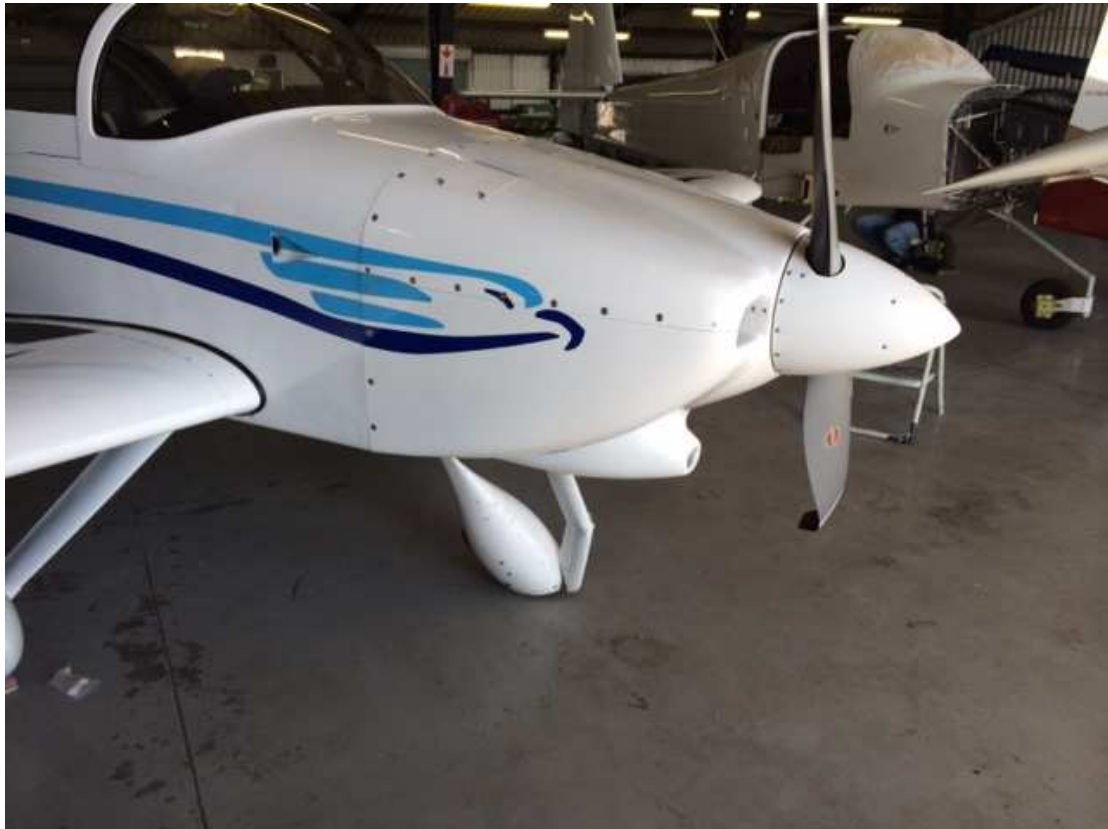
1.3.1 The aircraft sustained substantial damage

Figure 1: Damaged aircraft

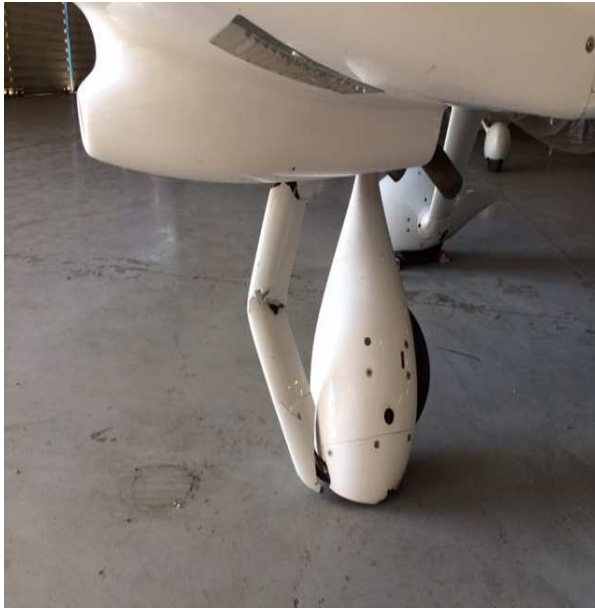
1.12.1 The aircraft landed hard with the nose wheel first and collapsed. Due to the aircraft nose gear damage, the propeller struck the runway and was damaged. The aircraft skidded for approximately 16,4 ft on the nose strut and came to rest next to the left side of the runway.

Figure 3: View of nose gear damage

1.12.2 The aircraft sustained damage to the nose gear and the propeller. All damage was accounted for and was attributed to high impact forces.

1.16.2 The aircraft was recovered to the owner's workshop and repairs were made to the nose gear strut. The engine was subjected to a propeller strike inspection and a new propeller was fitted to the aircraft.

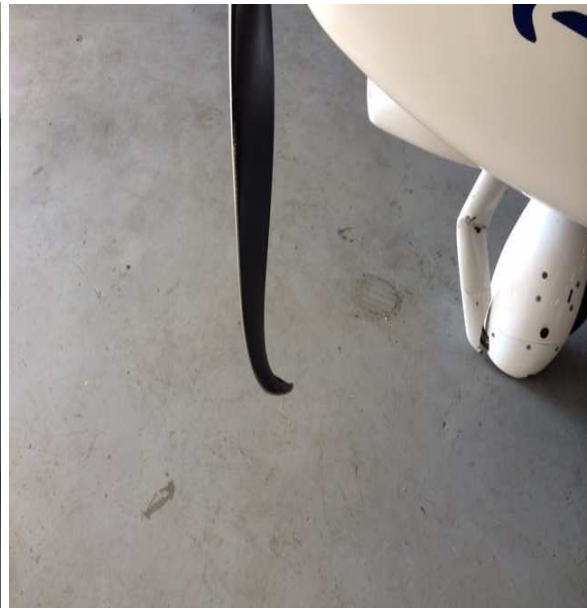
Figure 4: View of propeller damage
