AIRCRAFT ACCIDENT REPORT AND EXECUTIVE SUMMARY

Reference:	CA18/2/3/9281	
Aircraft registration	ZU-TZT	Date of accident	29 January 2014		Time of accident	±1140Z
Type of aircraft	Giles G-202 (Aeroplane)		Type of operation	Private		
Pilot-in-command licence type	Private pilot		Age	50	Licence valid	Yes
Pilot-in-command flying experience	Total flying hours		1 693,0		Hours on type	30,8
Last point of departure	Port Alfred aerodrome (FAPA), Eastern Cape					
Next point of intended landing	Mossel Bay aerodrome (FAMO), Western Cape					
Location of the accident site with reference to easily defined geographical points (GPS readings if possible)						
Addo Elephant National Park (GPS position: 33°36.03 5' South 025°47.229' East, elevation 1010 ft AMSL)						
Meteorological information	Temperature: 22 °C; Dew point: 20 °C; Cloud: 8 okta s in light to moderate rain					
Number of people on board	1 + 0	No. of people injured	0	No. of people killed	1	
Synopsis	<p>Three aircraft took off from runway 10 at Port Alfred aerodrome (FAPA), at 1106Z. After take-off they turned out right, joining up in a loose formation and flying over the town in a westerly direction. ZU-WAN, the lead aircraft, broke aw

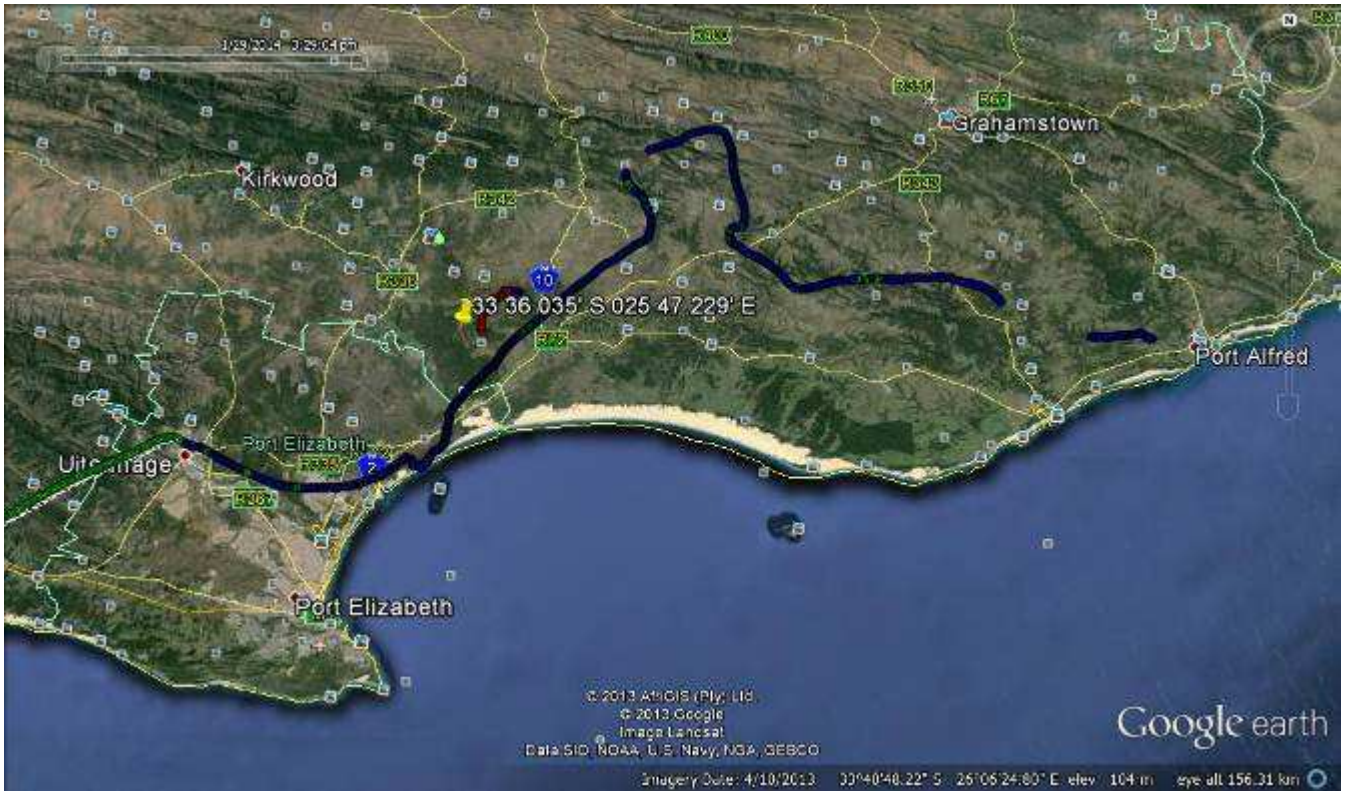
Figure 1: The dark blue line indicates the track ZU-ZOZ was flying from FAPA until abeam of Uitenhage

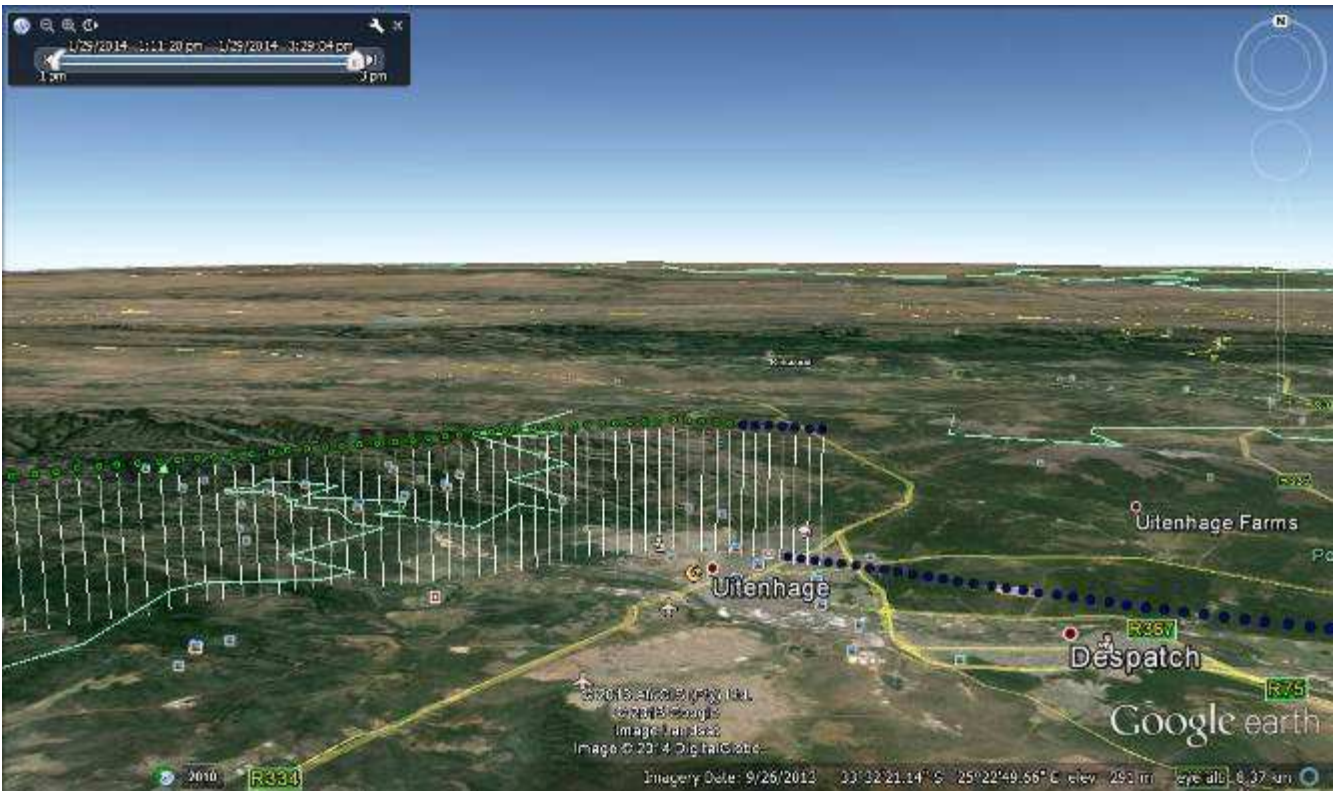
Figure 2: Following activation of mode C on transponder, aircraft ZU-ZOZ was identified on radar at 10 500 ft

The pilot flying ZU-ZOZ requested assistance from ATC once he had broken cloud near Uitenhage, where he was identified on secondary surveillance radar at 10 500 feet after he had entered the given squawk code and activated the mode C function on the transponder. From there he turned in a southwesterly direction towards the coast and was able to proceed along the coastline and landed at FAMO, two hours and twenty minutes after he took off from FAPA.

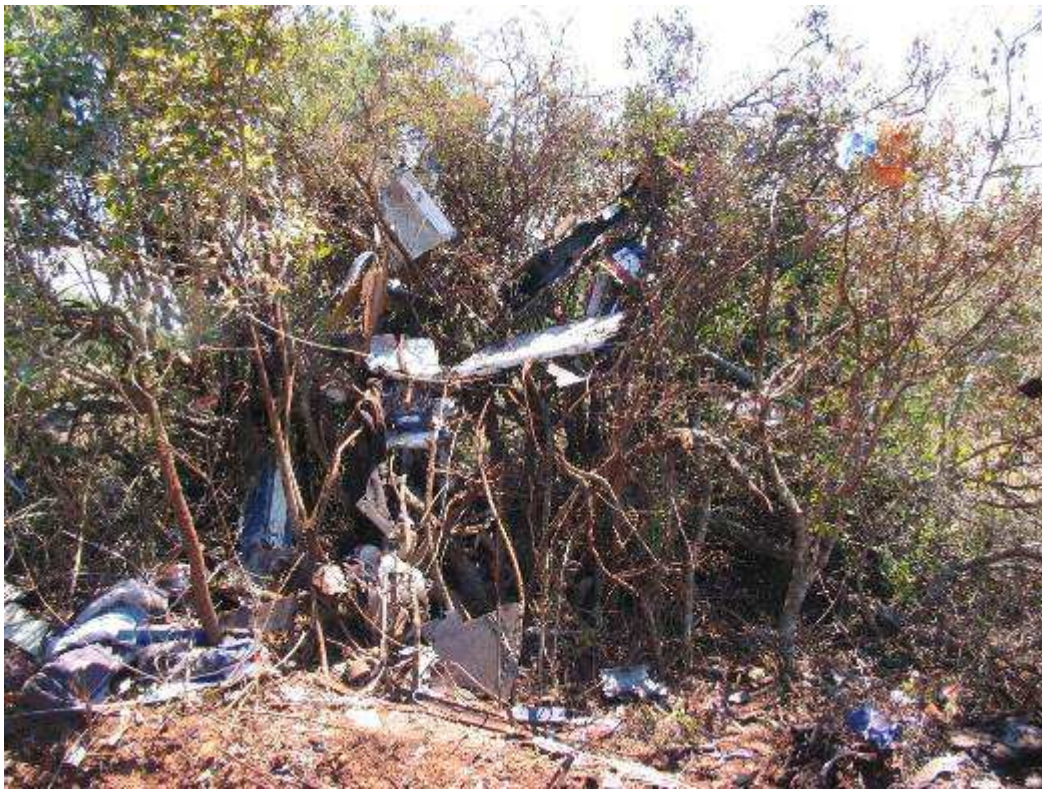
1.3.1 The aircraft was destroyed during the impact sequence.

Figure 3: Photo of wreckage

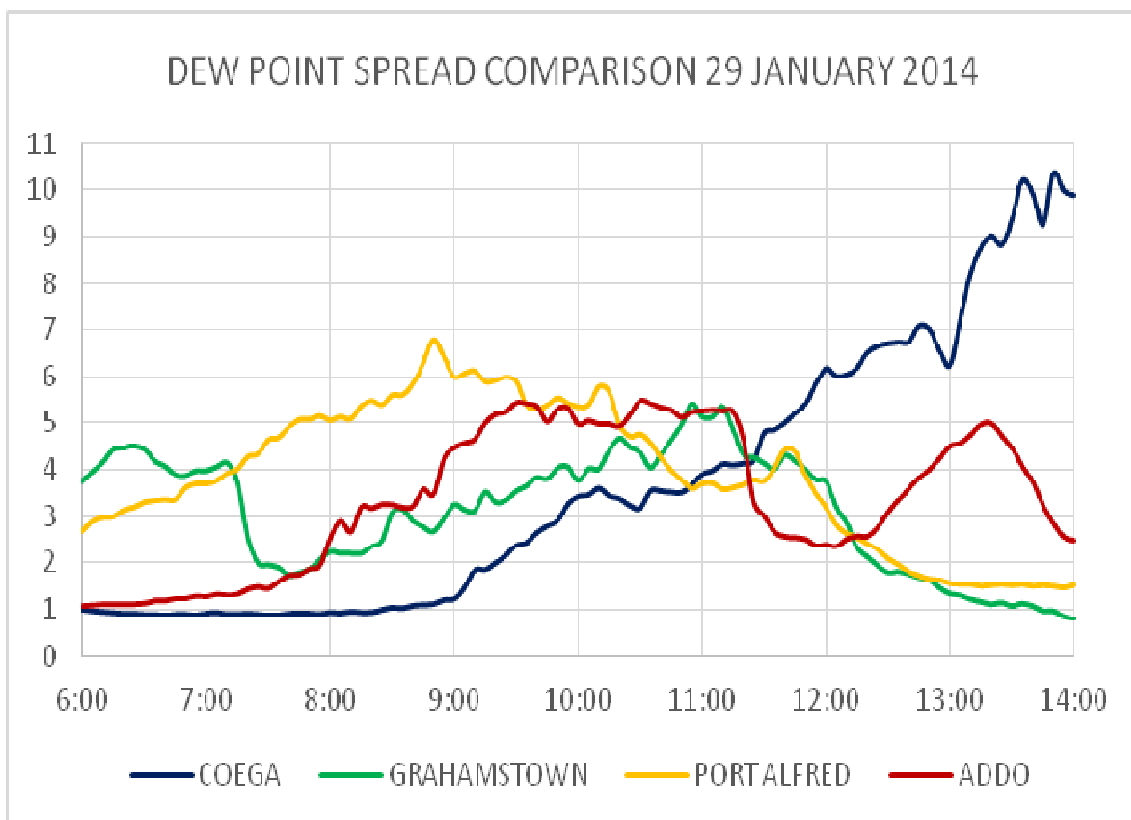
The data analysed in Figure 6 shows a deterioration of the dew point spread and possible lowering of the cloud base in the Port Alfred area between 1000Z and 1100Z (yellow curve). The blue curve shows an increase in the spread towards Port Elizabeth consistent with the trend of increased dew point spread as shown in the METAR summary below. However, between 1115Z and 1130Z a rapid decrease in spread and possible drop in cloud base overhead Addo (red curve) and Grahamstown (green curve) occurs. It appears that the inland cloud base rapidly deteriorated during this period, especially overhead Addo.

Figure 6: Dew point spread comparison for four automatic weather stations

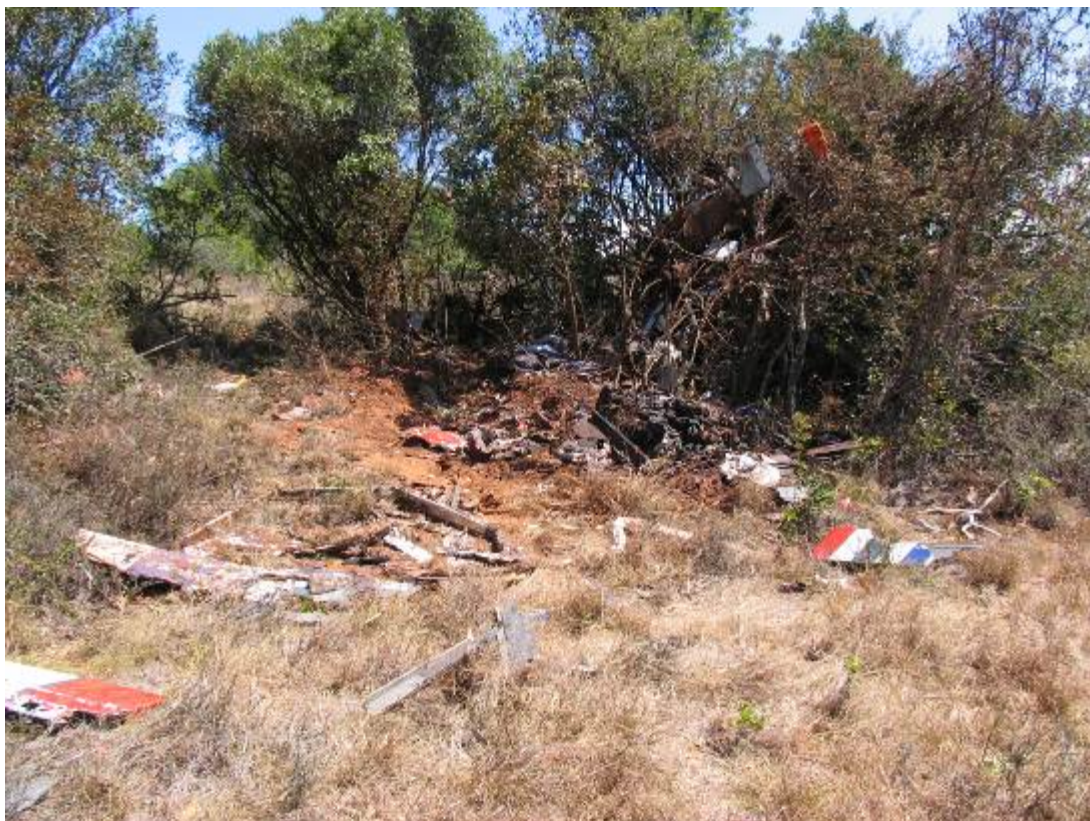
1.12.1 The aircraft hit the ground on a heading of approximately 010° magnetic. The impact sequence indicates that the aircraft was in a vertical nose-down attitude when it crashed in bushy terrain (Figure 15). The nose section, including the propeller, was embedded in a crater approximately one m in depth (Figure 16). The fuselage, which consists mainly of a composite type of material, shattered in a substantial number of pieces.

Figure 15: Crash site

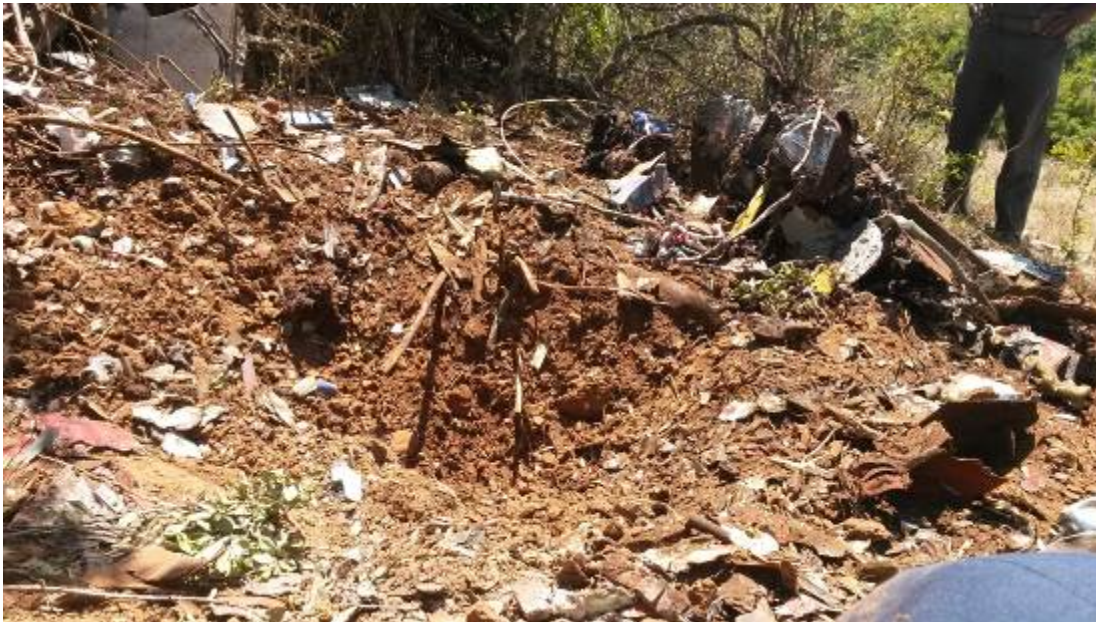
Figure 16: Crater caused during the impact sequence

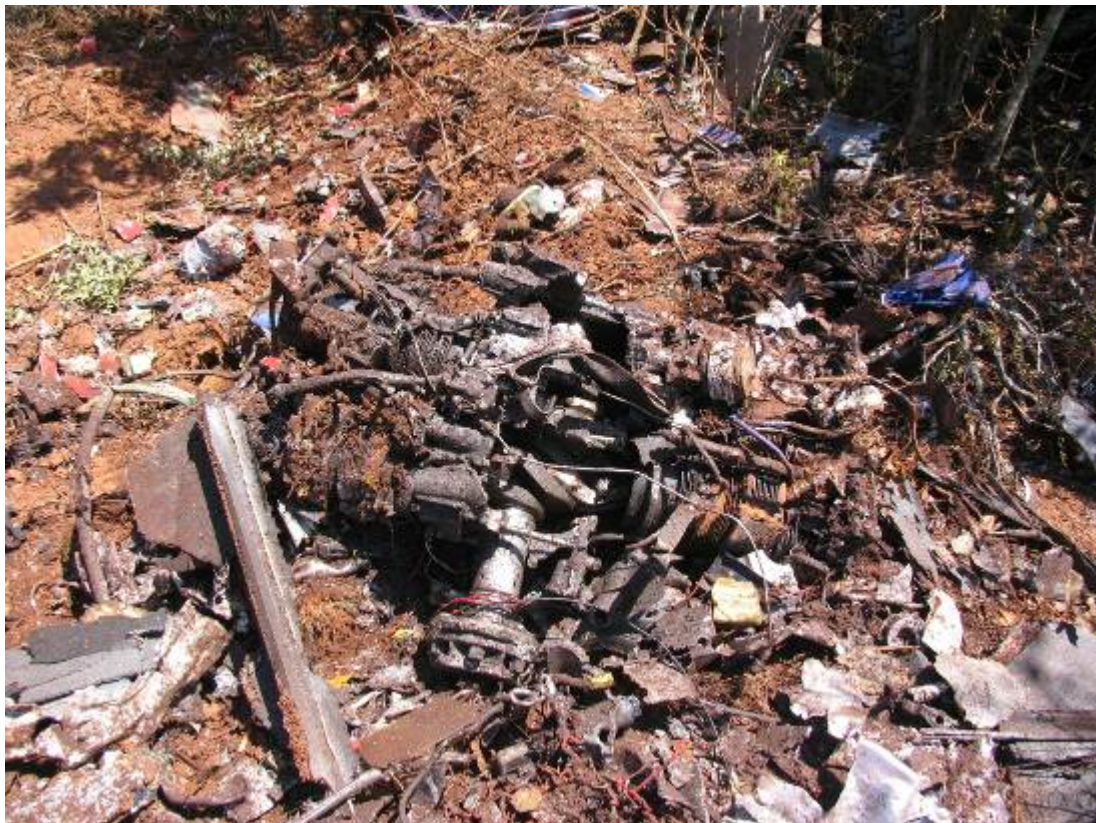
1.12.2 The engine was split diagonally along the crankcase centre with only the propeller hub left attached to the crankshaft flange (Figure 17). The spring steel undercarriage frame was dislodged from the airframe, the two main wheels had separated from the frame assembly and were found some 10 m from the impact crater. The horizontal and the vertical tailplane, including the tail wheel assembly, were entangled in a tree near the impact position. A parachute was found in the same location.

Figure 17: The engine which was severely deformed and split open

dug out of the crater, approximately 15 to 30 cm in length. It was evident from these fractured pieces that the engine was delivering power when the aircraft crashed to the ground. Both wingtips were accounted for, including the aerobatic sight gauge that was fitted to the left wing. The empennage and horizontal stabilisers, including the elevators and tail wheel, were found entangled in a tree. Due to the extent of the damage to the aircraft, it was not possible to reconstruct the wreckage. Because the propeller (sections thereof), the empennage (tail section) and both wingtips were located in the same area, an in-flight structural failure of a major part of the aircraft was eliminated.
