## *Final report RL 2015:10e*

**Serious incident on 31 January 2014  
involving the aircraft ES-PJR of the model  
Bae Jetstream 3200, operated by AS Avies  
at Torsby airport, Värmland county.**

File number L-0018/14

22/06/2015

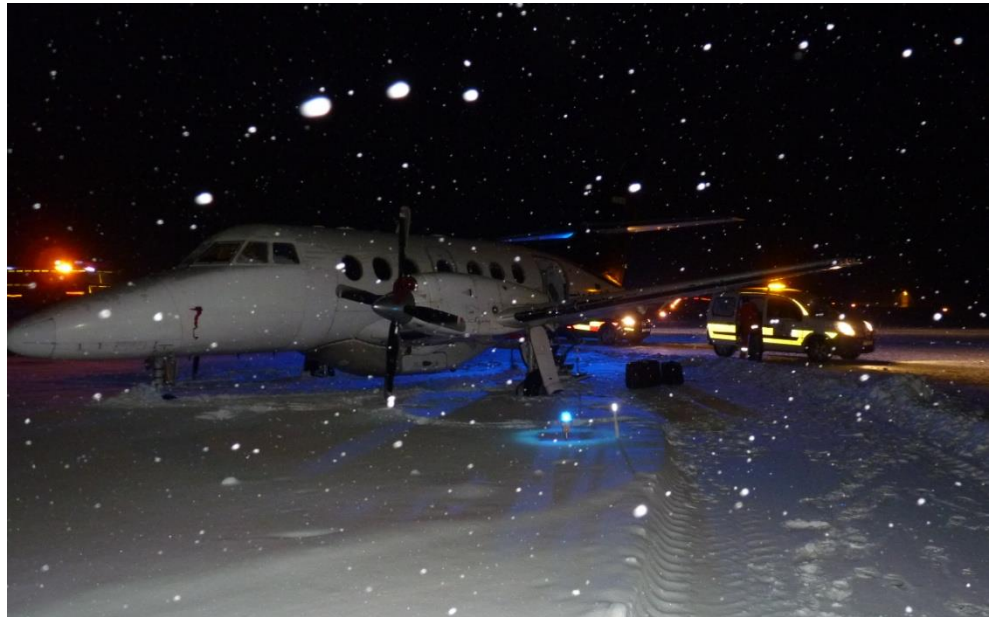
taxiway and came to stand in a snowdrift with the nose 6-7 metres from the edge of the taxiway, see Figure 2.

Figure 2. The aircraft after the excursion. Photo: Torsby Airport.

After having informed the tower, the crew shut off the engines, and the co-pilot assisted with the evacuation of the passengers. No injuries to passengers or damage to the aircraft have been reported.

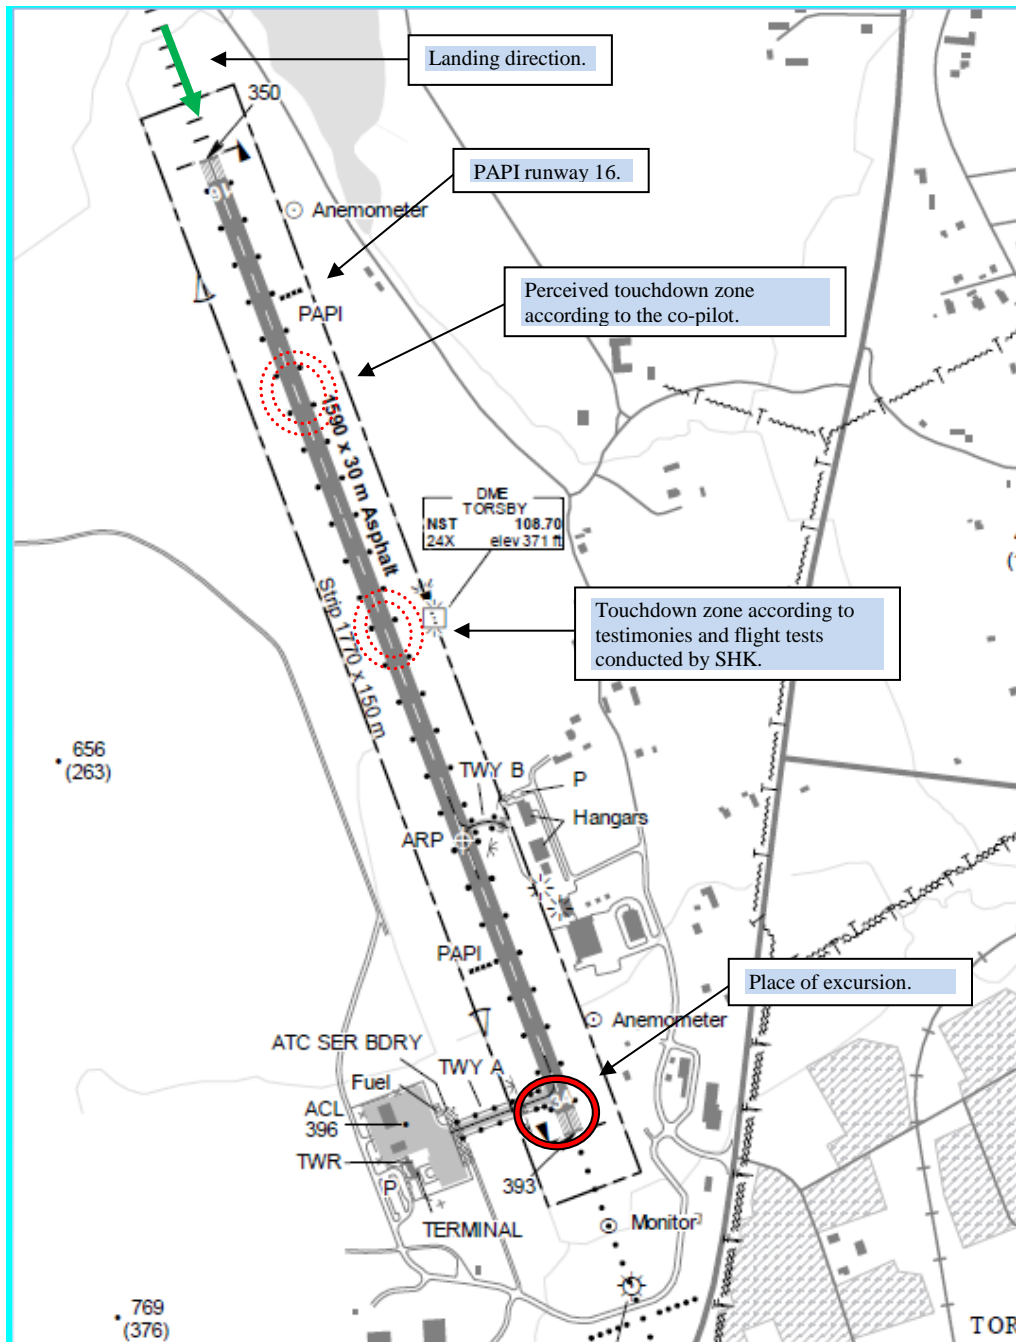
Figure 7. Torsby Airport marked with places relevance for the event.

Figure 7 above shows the zone where the crew perceived the landing to take place, as well as the zone where the touchdown was executed according to the testimonies. The remaining runway length from this touchdown zone is about 800 metres.

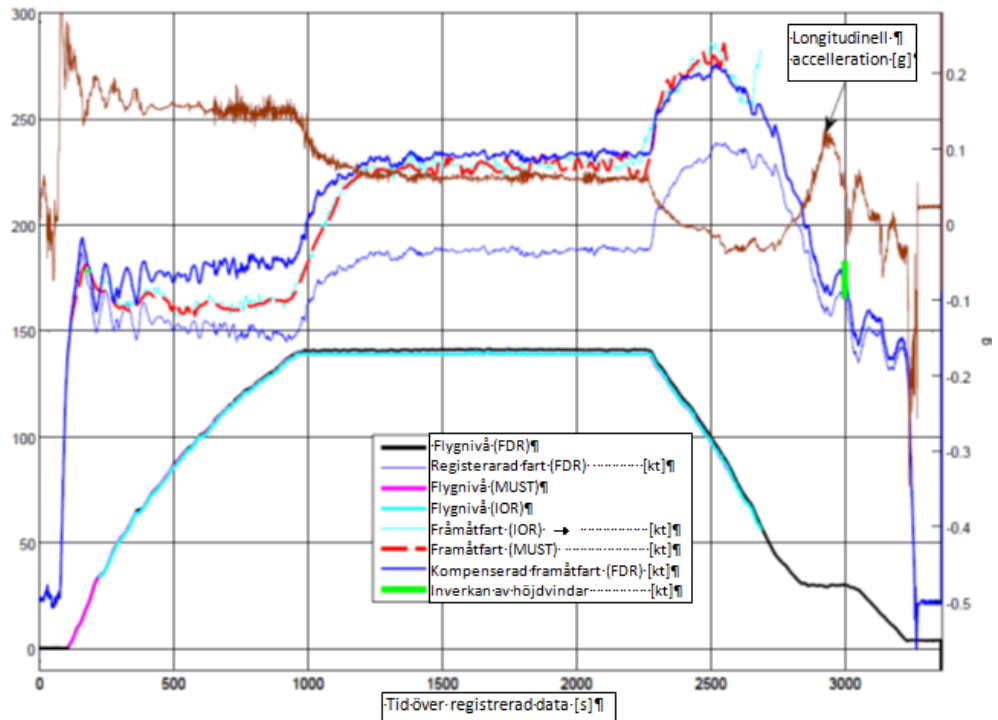
Figure 8. The aircraft's altitude, speed and longitudinal acceleration.

The graph shows that the recorded speed during the last 50 seconds of sequence was 20 knots. However, during that time, the aircraft was standing still on the ground. It is also possible to see that where the retardation transitions to a constant value in the final phase, the forward speed is 0 knots for a short while and thereafter rises to 20 knots. The forward speed can also be calculated by means of the time integral of the acceleration. The constant term formed in integration constitutes a boundary condition and is set to 0 knots where the acceleration becomes constant.

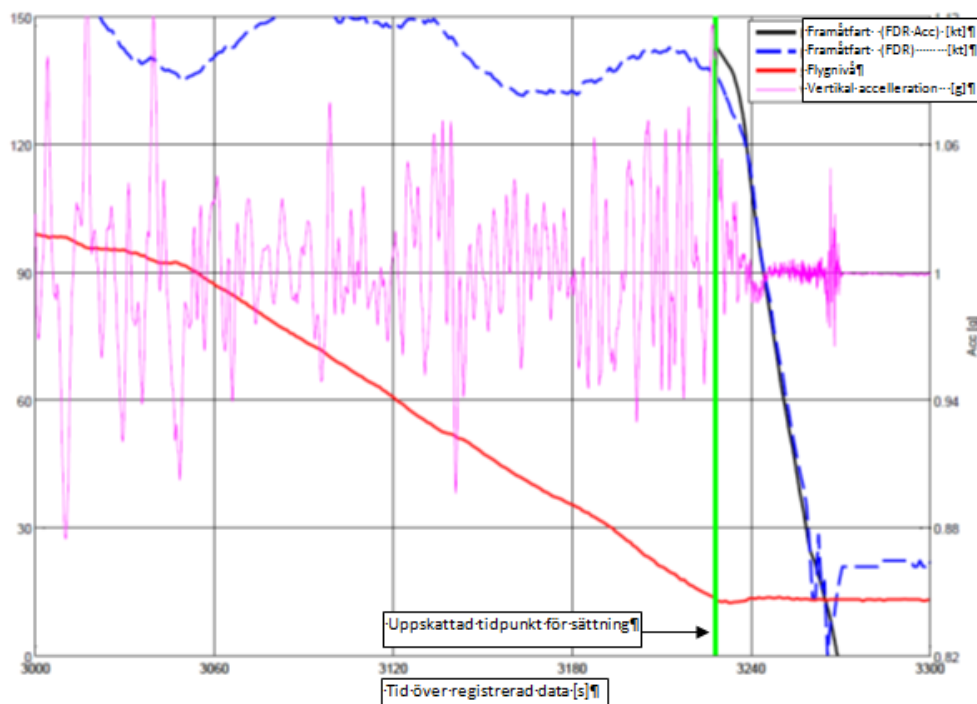
Figure 9. Altitude and speed during the final 3,000 seconds of recorded data. The green line shows an estimated time for touchdown.

The graph shows that during touchdown and rollout, the calculated speed from the accelerometer corresponds well with the recorded speed from the flight data recorder. The assessment of touchdown time is based on values including those from the vertical accelerometer signal recorded by the FDR.

From the graph in Figure 9, it can also be inferred that the speed varied greatly during the final 120 seconds of the approach. About 40 seconds before touchdown, there was a marked speed increase of 10-15 knots that is only broken about 10 seconds before touchdown on the runway.

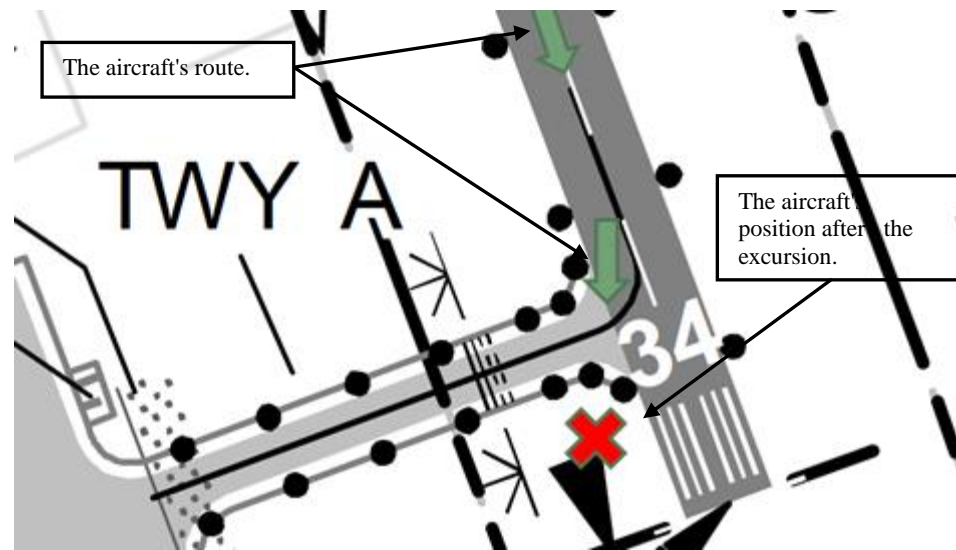
The snow depth at the site in question was about 30-40 cm, for which reason the aircraft was rapidly slowed after the excursion. In the incident, several taxiway lights were passed without being damaged

Figure 10. Subsection of the airport from AIP with the site of occurrence marked.

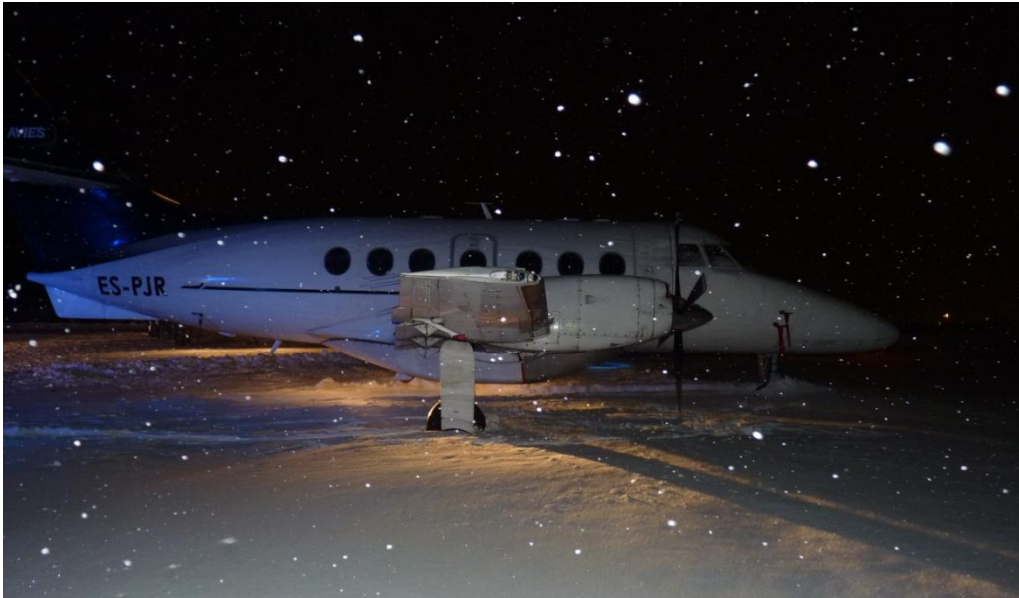
When braking, the surface was perceived as “very slippery”. SHK sees no reason to question this assertion. As previously mentioned, 17 minutes had elapsed since the latest friction measurement, and given the continuous snowfall, it is likely that the friction coefficient had gradually deteriorated.

Figure 13. The aircraft after the excursion. Photo: Torsby Airport

When the commander realised that the aircraft would not be able to be brought to a stop before the runway end, he chose to attempt to turn to the right onto the taxiway, see Figure 13. It has not been evaluated as to whether an excursion straight ahead would have entailed any other consequences, but the excursion that took place in the present case was successful in that no injuries/damage arose, either inside or outside the aircraft.
