AIRCRAFT ACCIDENT REPORT AND EXECUTIVE SUMMARY

Reference:	CA18/2/3/9286	
Aircraft Registration	ZS-NTY	Date of Accident	06 February 2014		Time of Accident	0730Z
Type of Aircraft	Cessna A188B (Aeroplane)		Type of Operation	Commercial		
Pilot-in-command Licence Type	Commercial Pilot Licence		Age	22	Licence Valid	Yes
Pilot-in-command Flying Experience	Total Flying Hours	602.9		Hours on Type	352.0	
Last point of departure	Joubertina aerodrome: Eastern Cape province.					
Next point of intended landing	Joubertina aerodrome: Eastern Cape province.					
Location of the accident site with reference to easily defined geographical points (GPS readings if possible)						
On the mountain lee side at GPS coordinates determined to be S 33°47.201 ' E 25°32.618 '.						
Meteorological Information	Dry-bulb temperature, 21°C: Temperature 15°C: Wind speed@ 07 knots: No clouds.					
Number of people on board	1 + 0	No. of people injured	1	No. of people killed	0

AIRCRAFT ACCIDENT REPORT

Name of Owner/Operator : Sand River Crop Protection CC
Manufacturer : Cessna Aircraft Company
Model : Cessna A188B
Nationality : South African
Registration Marks : ZS-NTY
Place : S 33°47.201 ' E 25°32 .618 '
Date : 06

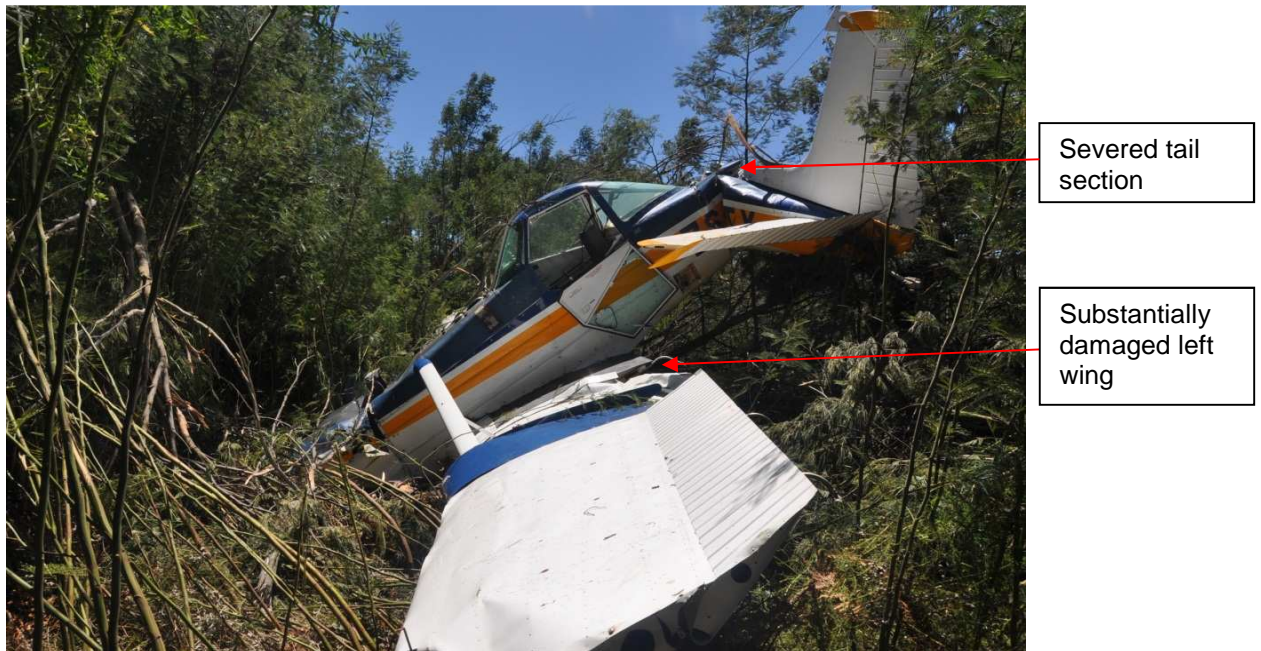
1.3.1 The aircraft was destroyed by impact during the accident sequence.

Figure 2: The wreckage as found at the accident site.

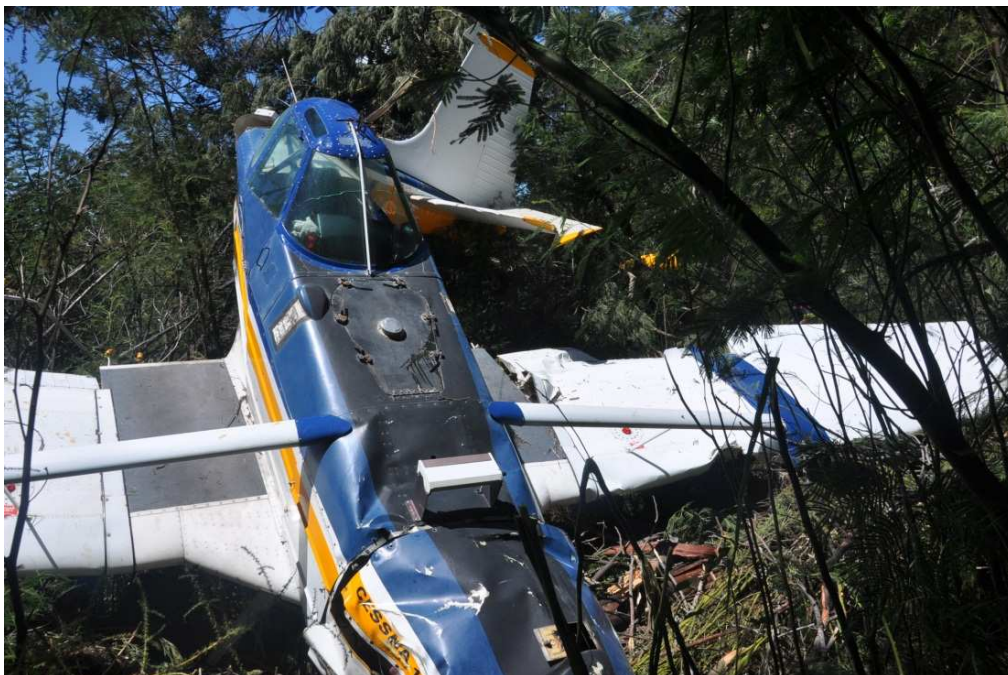
Figure 3: Top view of the wreckage from the front.

1.12.1 The wreckage was located in the bush in a nose down attitude. The left wing was substantially damaged and the tail section severed during the accident sequence. The wing spars were still secured to their respective attachment points and intact. The spinner was still attached to the propeller and the engine was still secured to the cradle. The engine fire wall and cowlings suffered minor damage as a result of the impact. The cockpit area was intact and the pilot seat was still secured to its anchors with the safety harness still intact. Part of the wind shield or wind screen was smashed by the impact but all aircraft instruments were secured to their mounting points and intact. The aircraft landing gear was still intact and the spray boom was destroyed.

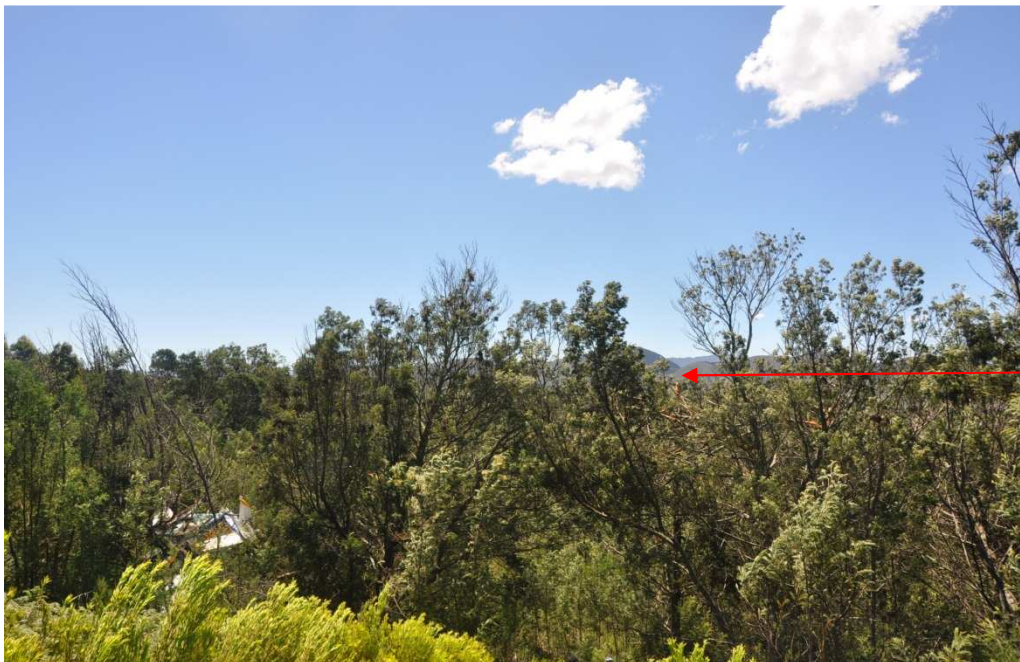
1.16.1 On-site investigation indicated clear visibility at the time of the accident and post-accident examination of the wreckage revealed no pre impact engine or airframe anomalies, which might have affected the aircraft performance. There was no evidence of an in-flight structural failure but flight control continuity could not be established at the accident site due to damaged flight controls surface and control cables. Inspection of the fuel tanks revealed enough fuel for the planned flight and the fuel was free from contamination. According to the available aircraft documentation, no defects were recorded since the last mandatory periodic inspection was conducted. The propeller blades showed evidence of rotation and collision with tall trees prior to impact. Below is the picture of the trees as shown.

Evidence of tree cut by the aircraft propeller prior impact

Figure 6: View of the aircraft flight path prior to the accident.

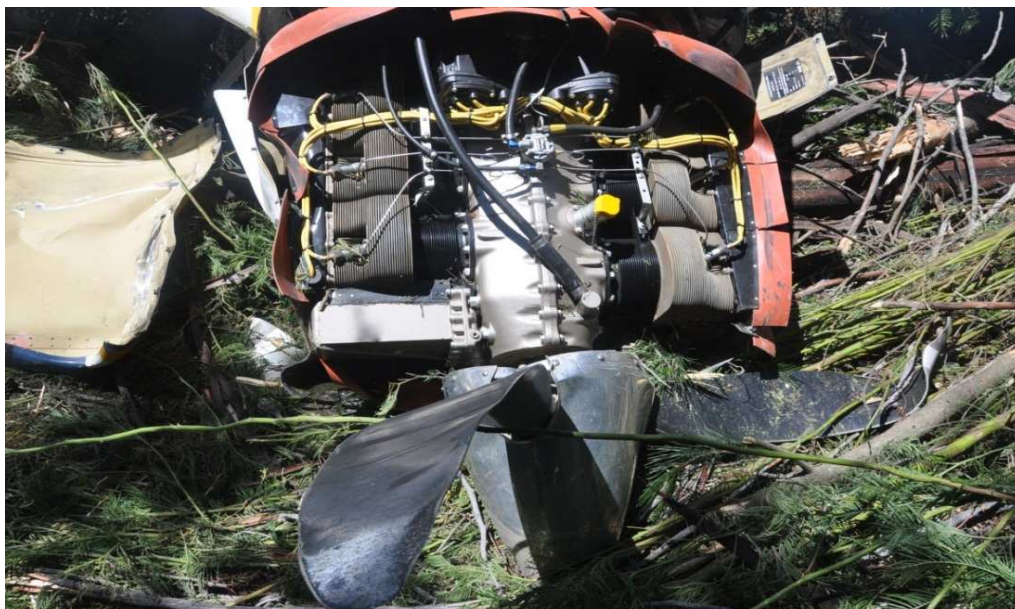
Figure 7: View of the engine and the propeller.

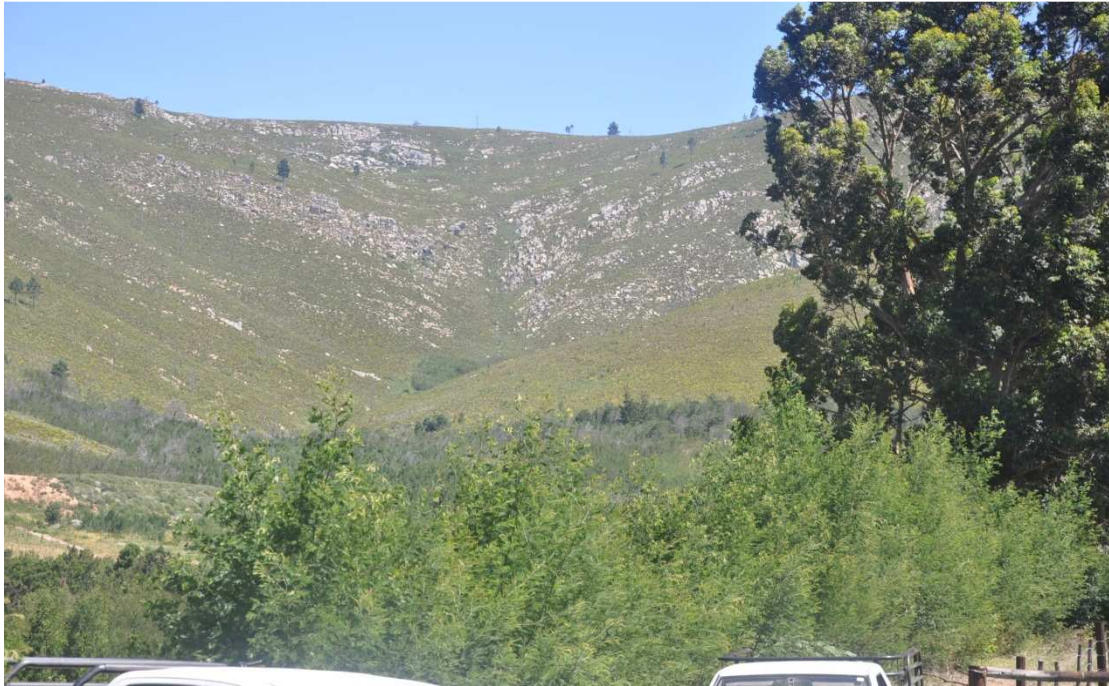
1.16.4 Further analysis and assessment of the accident site by the investigating team revealed mountain wave turbulence “forces of nature exerting a greater influence on aircrafts” from the mountain top, which is believed to have affected the aircraft airspeed and altitude on its flight path and to have rendered ground impact inevitable. *NOTE: Mountain waves are an atmospheric phenomenon in which an obstruction stimulates air currents into a standing wave pattern of up and down vertical flow. It can be visualised as waves downstream of a stone in water. The vertical rates of flow on mountain waves had been reported to reach 8.000 feet per minute, with rates of several thousand feet per minute being common. These rates greatly exceed the climb performance of light aircraft, particularly at the high elevations at which they are encountered. Typical aircraft climb performance in still air at these altitudes, is in the range of 300 to 500 feet per minute.

These aircraft are therefore incapable of climbing or even maintaining altitude while flying in a strong mountain wave (down flowing air). It can present a flight hazard to all aircraft, but the hazard is particularly severe for aircraft of limited performance, which includes almost all light aircraft. Below are pictures of the terrain at the accident site and effects of mountain wave turbulence on aircraft.

Figure 9: Terrain at the accident site.

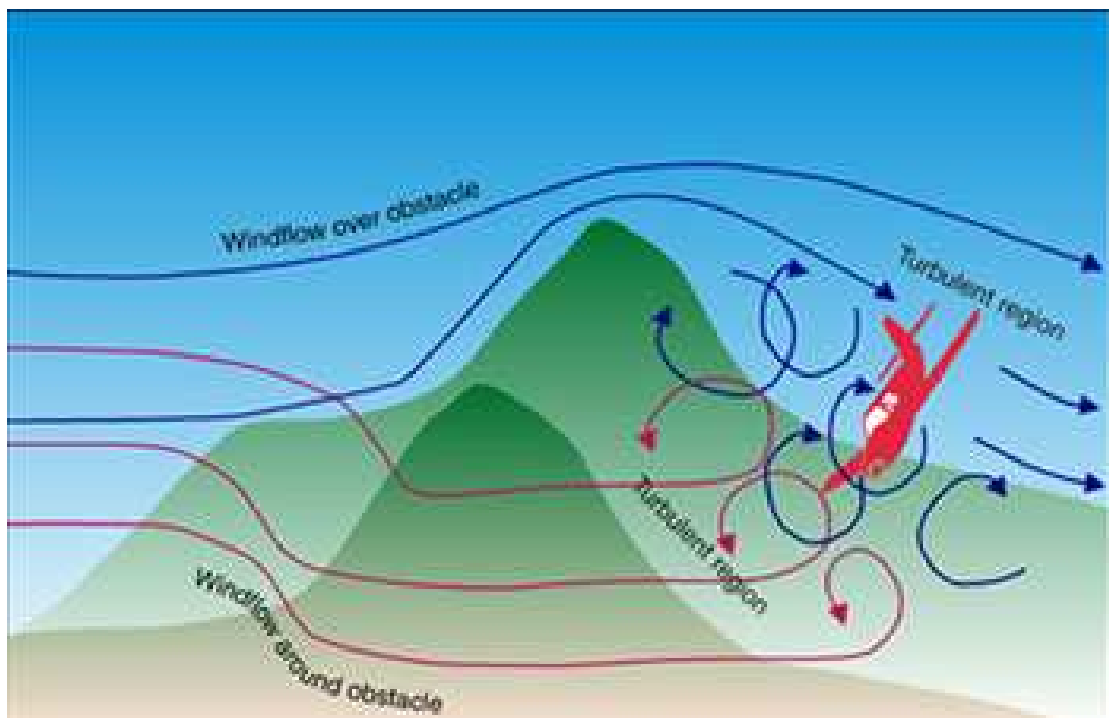
Figure 10: Effects of mountain wave turbulence on the aircraft.

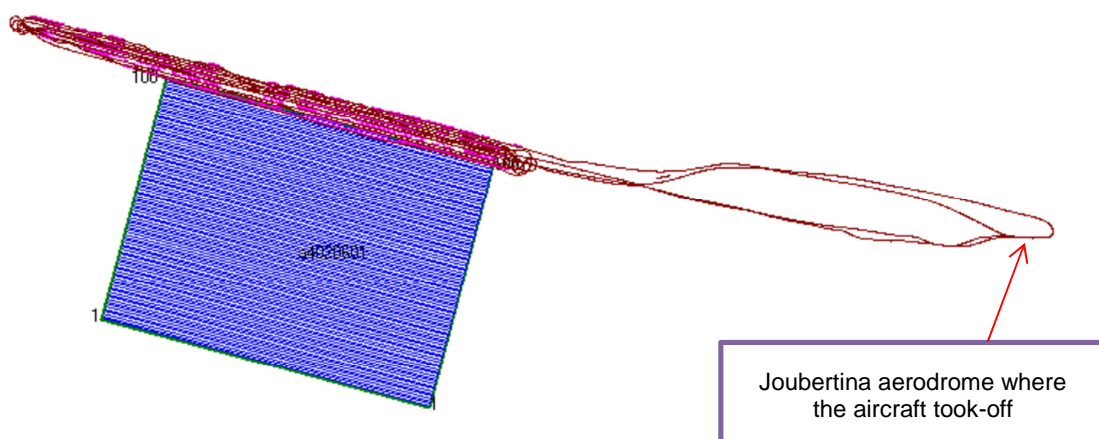
1.16.3 It also enables the pilot to fly and spray precise or accurate patterns using constant or variable rate flow control and spraying costs. During the investigation this device was retrieved from the wreckage and downloaded. The data showed multiple passes being flown above the first field and sprays being performed after which two successful landings were executed. After the third take off the aircraft proceeded or headed towards the second field where it performed the first pass and spray, and in an attempt to execute a 180 degree turn to the right the aircraft collided with the terrain. Just before the accident, the GPS data showed a sign of decrease in aircraft airspeed and abrupt changes in deviations on aircraft flight path most probably due to the pilot trying to recover the aircraft. GPS data is attached in the Appendices to the report. Picture of the GPS installed on the aircraft is shown below.

Figure 11: Aircraft flight path downloaded from the GPS.

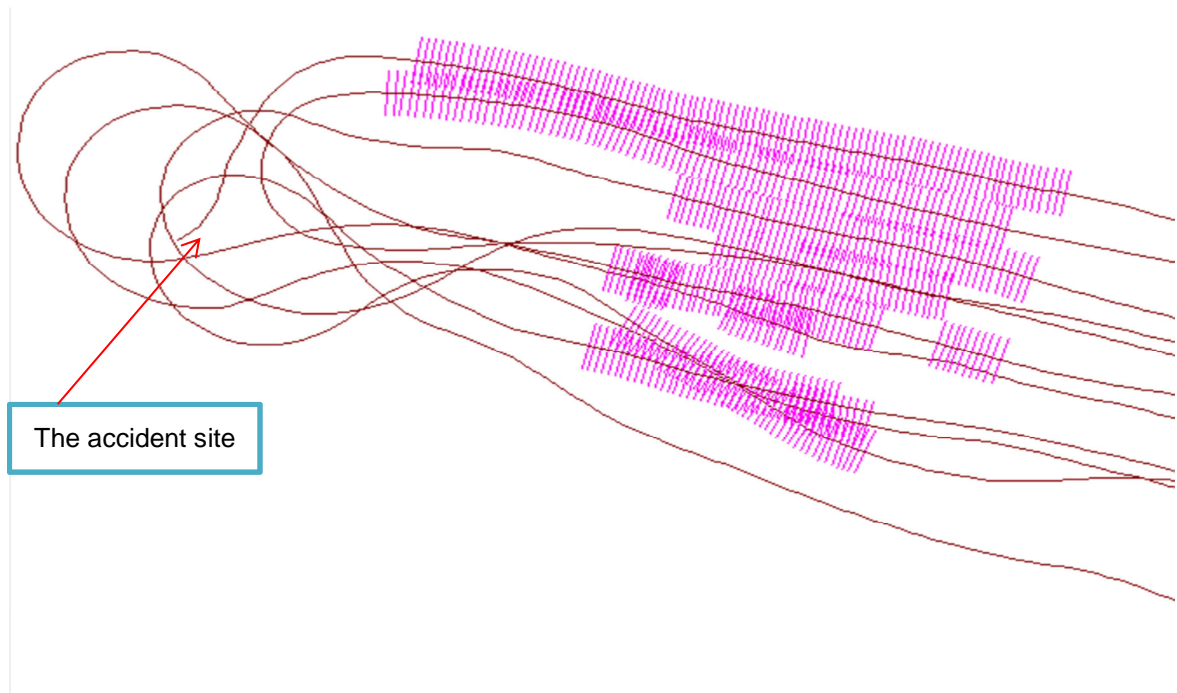
Figure 12: Expanded view of the flight passes and sprays performed by the aircraft and the accident site.
