AIRCRAFT ACCIDENT REPORT AND EXECUTIVE SUMMARY

Reference:	CA18/2/3/9287	
Aircraft Registration	ZS-JTW	Date of Accident	6 February 2014		Time of Accident	17:20Z
Type of Aircraft	PA-25-260 (Aeroplane)		Type of Operation	Agricultural		
Pilot-in-command Licence Type		Commercial	Age	52	Licence Valid	Yes
Pilot-in-command Flying Experience		Total Flying Hours	5 345,8		Hours on Type	47
Last point of departure		Parys Aerodrome, Free State (FAPY)				
Next point of intended landing		Parys Aerodrome, Free State (FAPY)				
Location of the accident site with reference to easily defined geographical points (GPS readings if possible)						
At the geographical coordinates S26 53,538 E027 29,567. Elevation 1407m.						
Meteorological Information		Surface wind: easterly at 10kt. Visibility: good. Cloud base: 1 000 ft				
Number of people on board	1 + 0	No. of people injured	1	No. of people killed	0	
Synopsis						
<p>The pilot took off from Runway 06 at Parys Aerodrome at 17:20Z for a night crop-spraying exercise. During take-off, and while at approximately 100 feet above ground level, the pilot experienced turbulences, due to a thunderstorm in the area, which caused the airspeed to decay in a stall

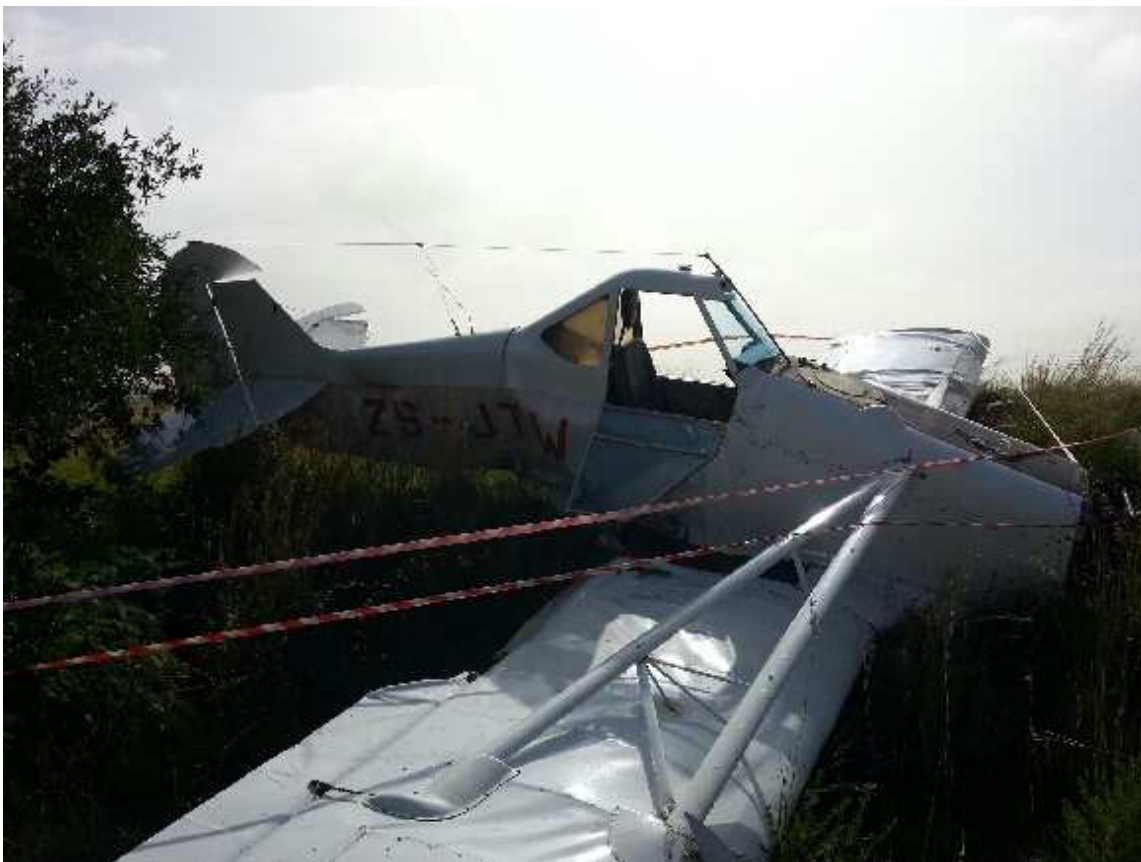
1.3.1 The aircraft sustained extensive damage to the propeller, fuselage and wings. The undercarriage broke off.

Figure 1: Damage to the aircraft.

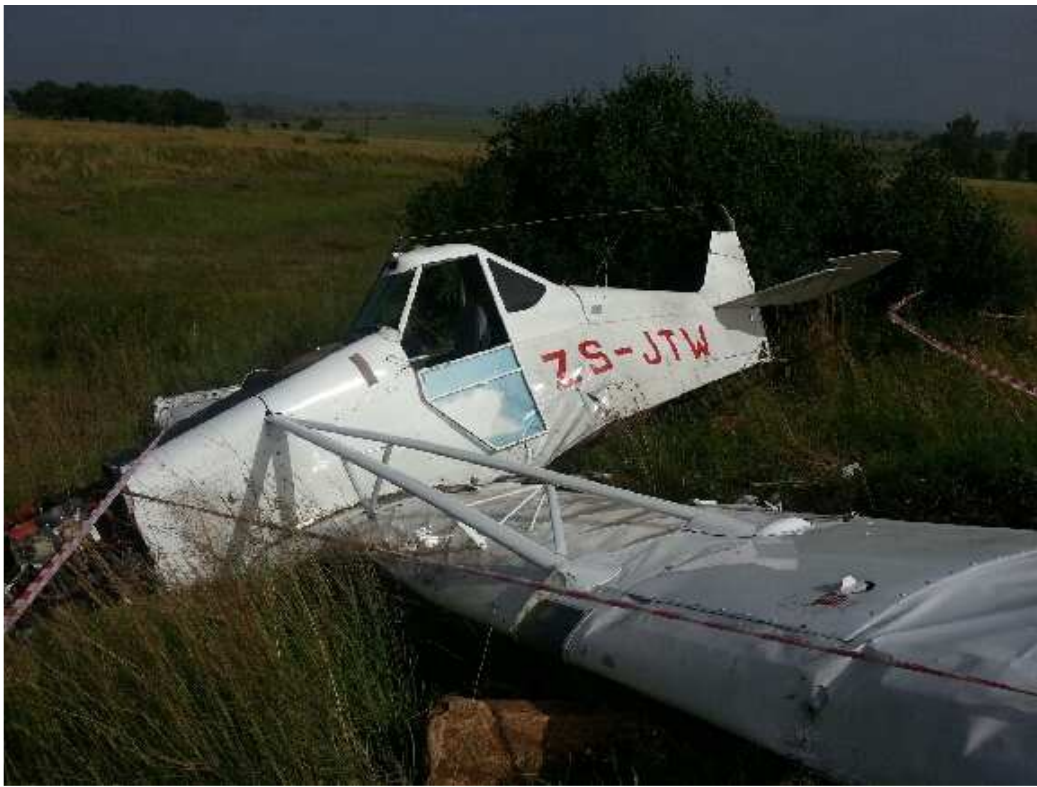
1.12.1 The airspeed decayed and the aircraft impacted with the ground approximately 800m from the runway threshold. The wreckage of the aircraft remained intact following the accident.

Figure 3: The wreckage of the aircraft.

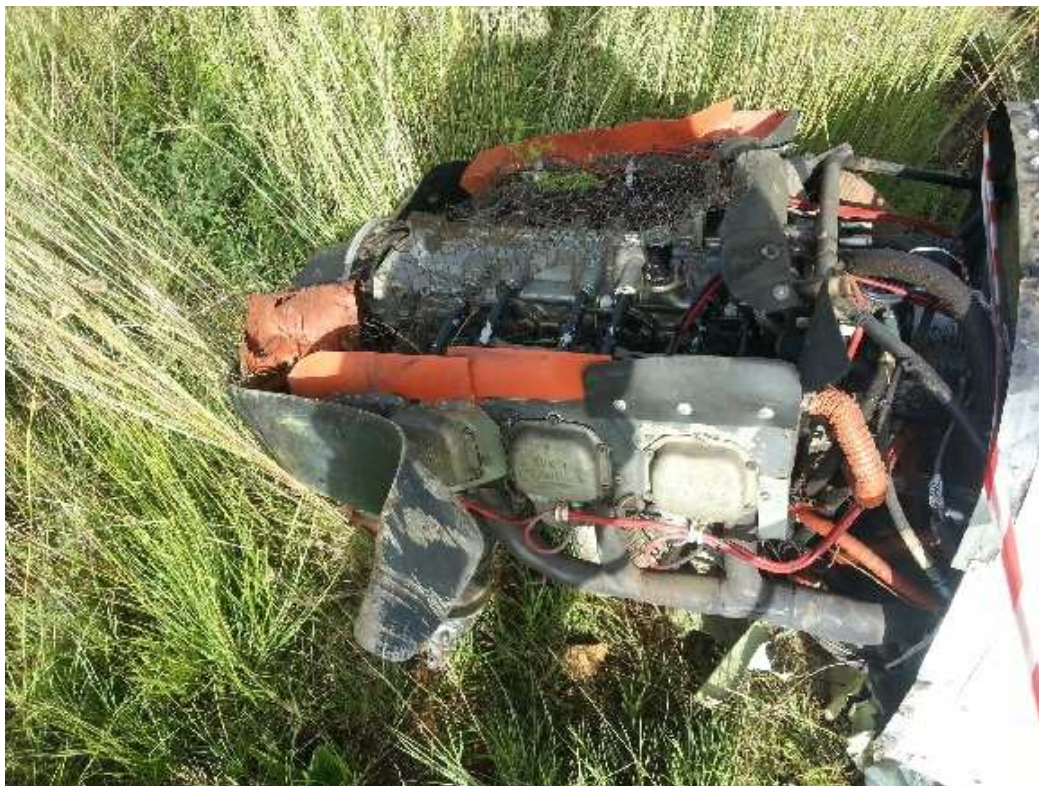
1.12.2 The marks on the propeller perpendicular to its axis suggest that the engine had power prior to the accident.

Figure 4: Picture of the engine

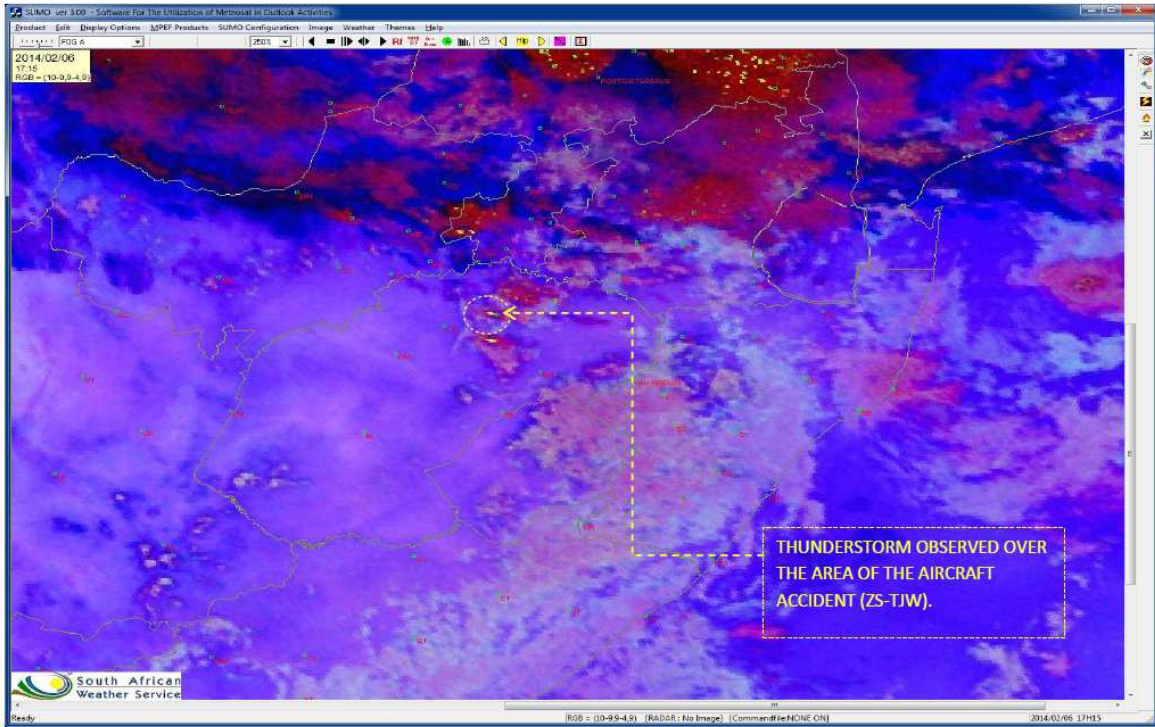
ATTACHMENT A: Satellite image for 1715Z on the 06th February 2014

Thunderstorms clouds were observed in the vicinity of the aircraft accident site provided in the form of GPS coordinates ([see Attachment A](#)).
