AIRCRAFT ACCIDENT REPORT AND EXECUTIVE SUMMARY

Reference:	CA18/2/3/9292	
Aircraft Registration	ZS-LIO	Date of Accident	13 February 2014		Time of Accident	0820Z
Type of Aircraft	Beech Baron 58		Type of Operation		Private	
Pilot-in-command Licence Type		Commercial Aeroplane	Age	51	Licence Valid	Yes
Pilot-in-command Flying Experience		Total Flying Hours	5 151,4		Hours on Type	10
Last point of departure		Rustenburg Aerodrome (FARG), North West Province				
Next point of intended landing		Lanseria Aerodrome (FALA), Gauteng Province				
Location of the accident site with reference to easily defined geographical points (GPS readings if possible)						
The accident occurred on runway 07R at Lanseria aerodrome (GPS position: S25°56'22.89" E027°55'32.07", GL elevation 4 517 ft A)						
Meteorological Information		The pilot reported that the weather was CAVOK at the time of the accident: Wind direction: 140°–160°; Wind speed: 6–7 knots; Visibility: 10 km; Temperature: 20 °C; Dew point: Unknown; Cloud cover: Scattered; Cloud base: 2 000–2 500 feet.

AIRCRAFT ACCIDENT REPORT

Name of Owner/Operator : Jynco Farming Consultants CC
Manufacturer : Beech Aircraft Corporation
Model : Beech Baron 58

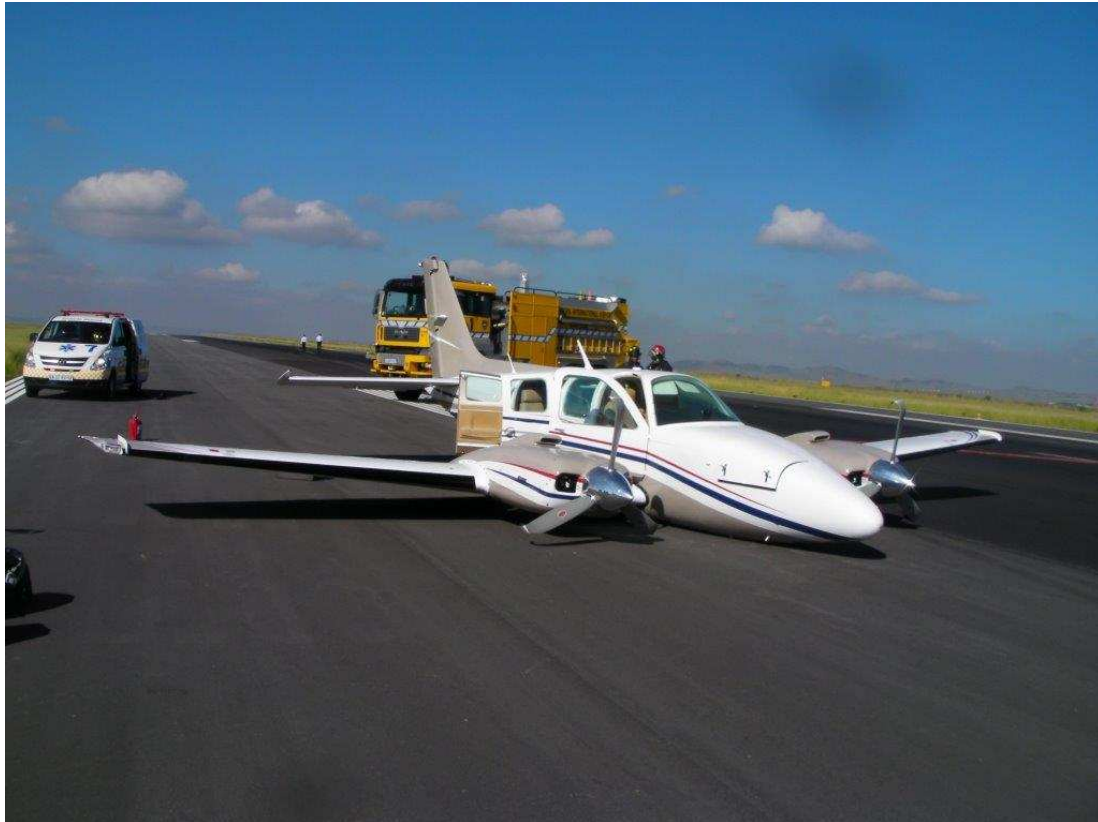
- 1.1.1 On 13 February 2014, the pilot and three passengers undertook a private flight from Rustenburg aerodrome to Lanseria aerodrome (FALA). The intention of the flight was to drop the passengers off at FALA for a connecting flight to Cape Town.
- 1.1.2 The pilot reported that they were cleared to land by air traffic control (ATC) on runway 07R at FALA and at approximately 08h15 they were on final approach to land. The front passenger, the owner of the aircraft, also confirmed three greens. A normal landing approach was carried out and after touchdown, at approximately 300 metres into landing rolls, the landing gear collapsed. The pilot kept the aircraft going as straight as possible with the runway centre line and it skidded on its belly until coming to a halt, damaging the bottom skin, the engines and the propeller blades.

1.3.1 The aircraft sustained substantial damage on its belly.

Figure 1: Damage to aircraft

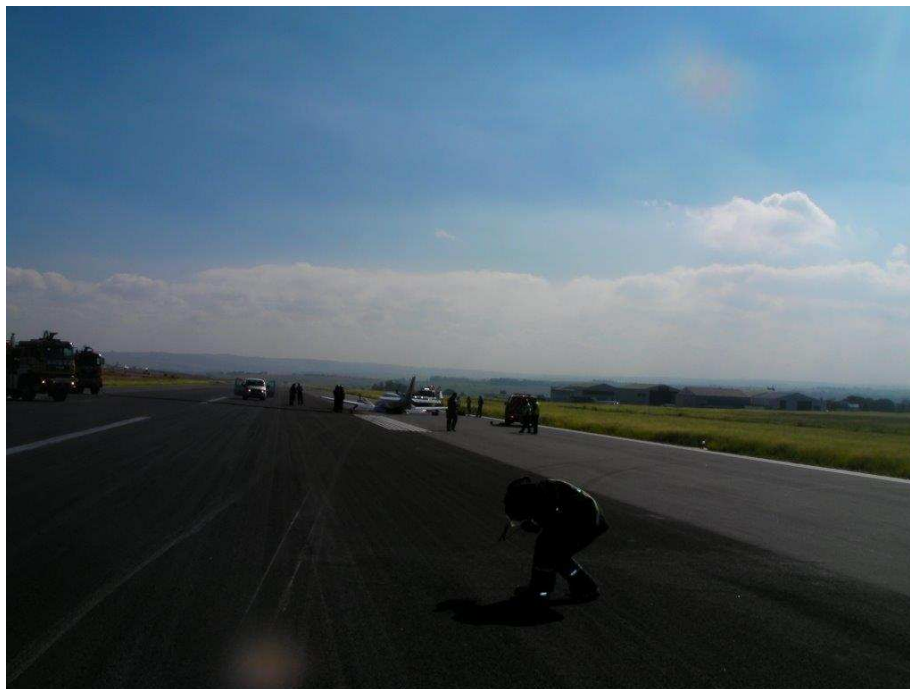
1.12.2 The aircraft skidded a few metres from the touchdown point and veered to the right of the runway before coming to a halt. The bottom skin, engines and propeller blades were damaged in the skid.

1.12.3 During inspections by the pilot and NAC recovery crew it was found that the undercarriage selector lever in the cockpit was in the up position and the flap lever was on the lower position.

Figure 2: Aircraft after coming to a stop

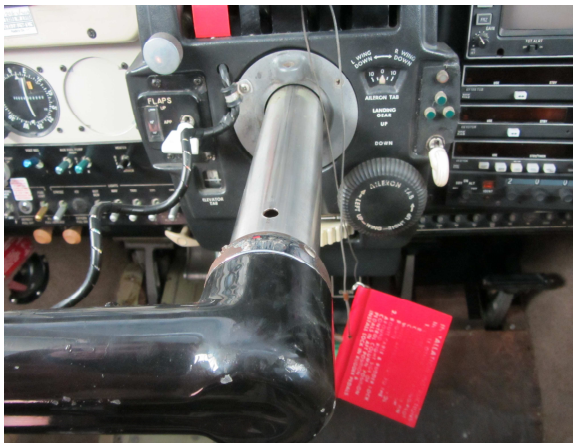
Figure 3: Position of levers in incident aircraft **Figure 4:** Position of controls in Beech Baron 58

2.1.3 It is therefore concluded that this accident occurred because the pilot was attempting to put the flaps control "UP" after landing while taxiing, and moved the landing gear control instead. The inadvertent movement of the landing gear control was attributed to the pilot's being more accustomed to flying aircraft in which these two controls were in exactly opposite locations. It is possible that the pilot might have mistaken the undercarriage selector lever for the flap lever as he had already landed and the aircraft was taxiing. It is also possible that the pilot might not have visually checked which lever he was supposed to select before selecting it.

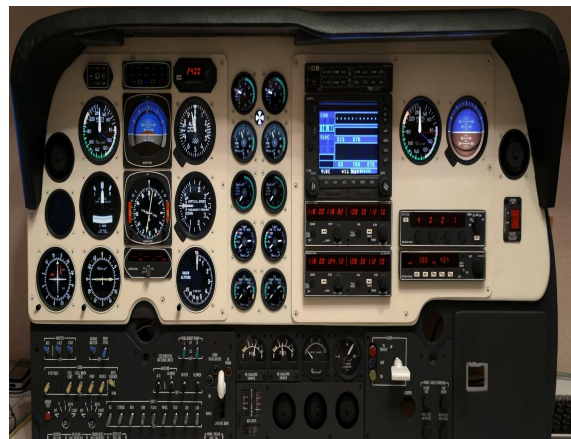
1.16.3 The investigation compared the details of Bonanza and Baron cockpit features to those of other contemporary light aircraft. The comparison indicated that the cockpit design of the various models of Bonanzas and Barons differed from those of most other contemporary light aircraft, for instance the locations for the landing gear and flap controls.

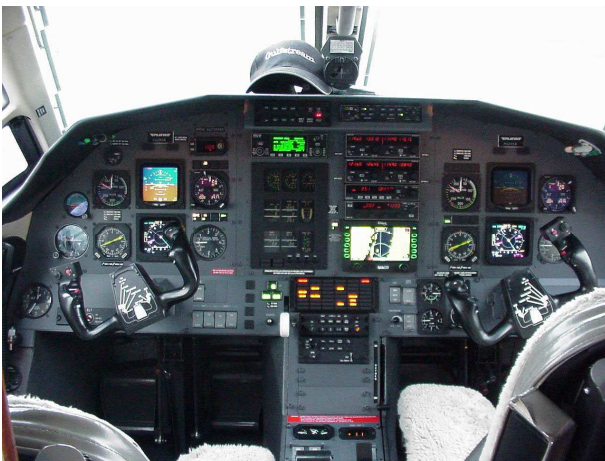
Figure 5: Positions of controls in Pilatus 12

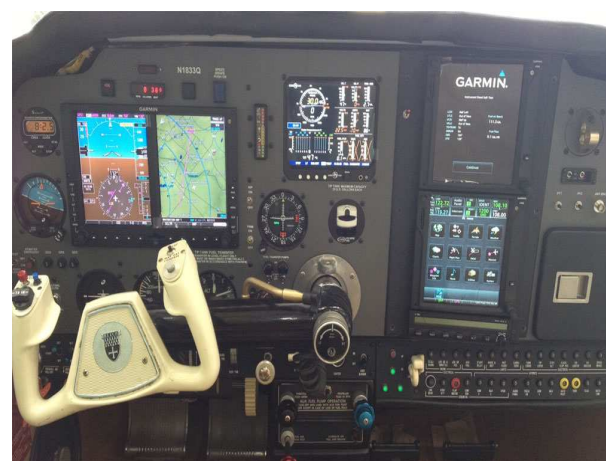
Figure 6: Positions of controls in Beech Baron
