<b>AIRCRAFT ACCIDENT REPORT AND EXECUTIVE SUMMARY</b>
---

Reference:	CA18/2/3/9301	
<b>Aircraft Registration</b>	ZS-KCP	<b>Date of Accident</b>	18 March 2014		<b>Time of Accident</b>	1550Z
<b>Type of Aircraft</b>	Beech Baron BE55 (Aeroplane)		<b>Type of Operation</b>	Private		
<b>Pilot-in-command Licence Type</b>		CPL	<b>Age</b>	23	<b>Licence Valid</b>	Yes
<b>Pilot-in-command Flying Experience</b>		Total Flying Hours	521.3		Hours on Type	211.6
<b>Last point of departure</b>		Vryheid Aerodrome (FAVY):KwaZulu Natal				
<b>Next point of intended landing</b>		Vryheid Aerodrome (FAVY): KwaZulu Natal				
<b>Location of the accident site with reference to easily defined geographical points (GPS readings if possible)</b>						
On the grass at right-hand side of Runway 11. GPS co-ordinates: S 27°47'13.71", E030°47'37.17"						
<b>Meteorological Information</b>		Wind direction: 320°; Wind speed: 9kts; Visibility: CAVOC; Air temp: 23°C				
<b>Number of people on board</b>	1+4	<b>No. of people injured</b>	0	<b>No. of people killed</b>	0

## AIRCRAFT ACCIDENT REPORT

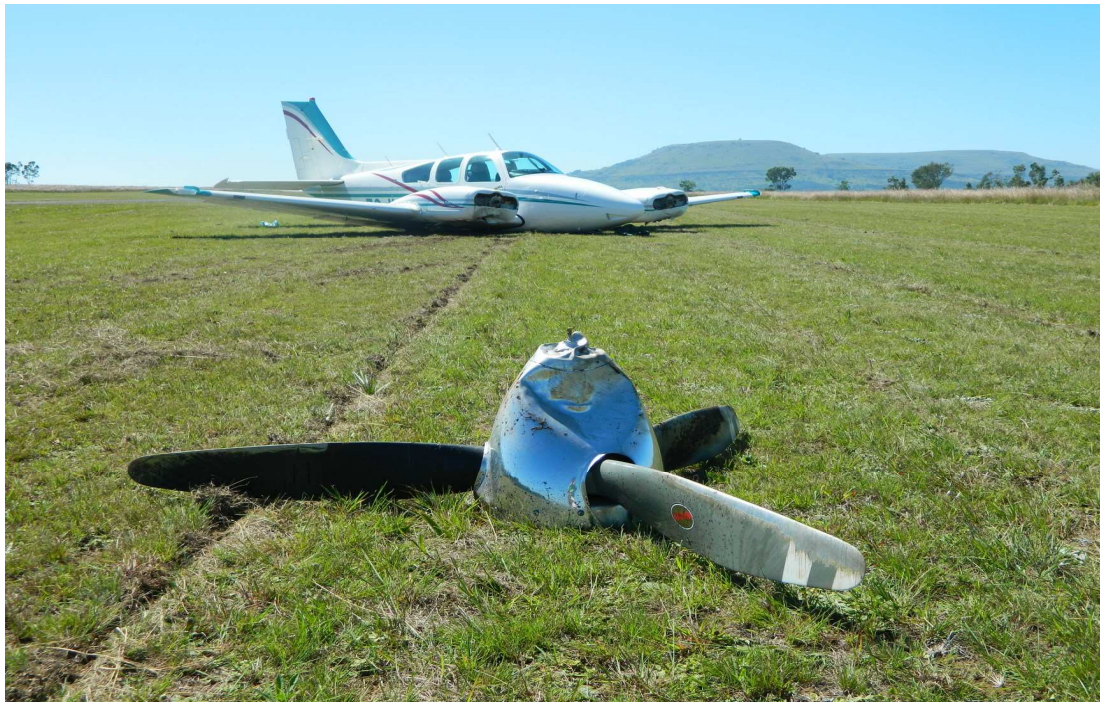
1.3.1 The aircraft sustained substantial damage to propellers, engines and fuselage belly.

**Figure 1:** The aircraft as it came to rest

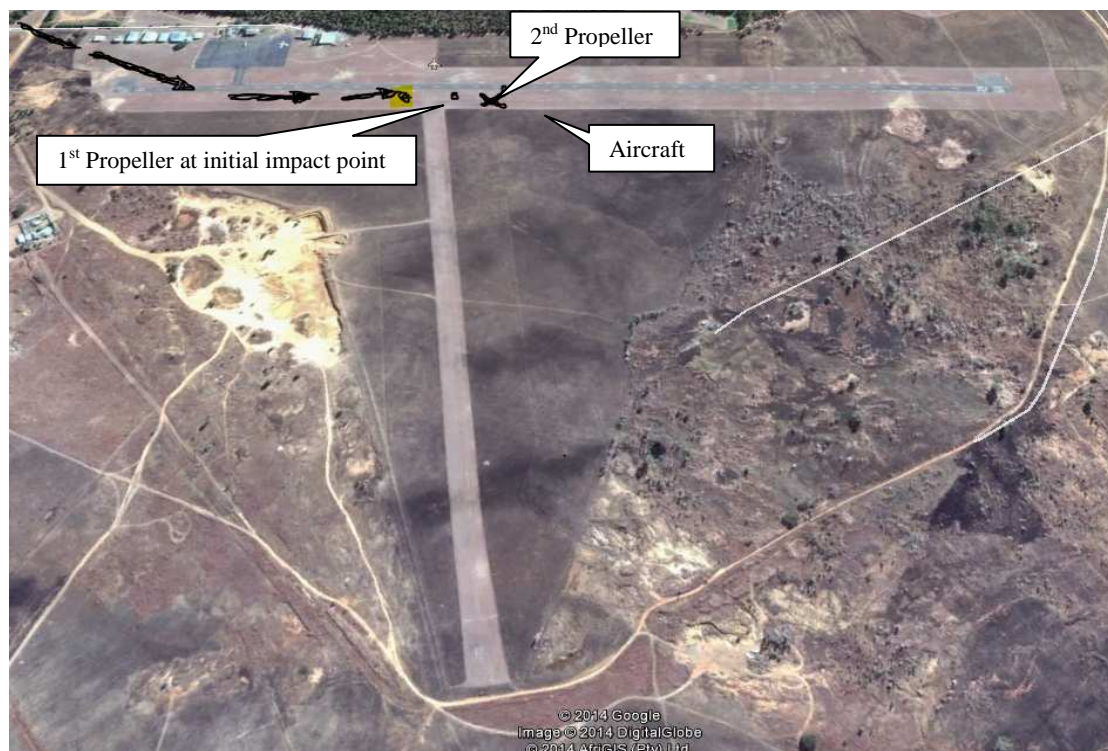
**Figure 3:** Impact sequence of the aircraft

1.12.1 During a wheels-up landing on a grass surface alongside of Runway 11, the aircraft impacted and both propellers broke off on impact. The belly followed and skidded to the point of hold. The aircraft turned to the right and came to a halt at a direction approximately 150 degrees to the right-hand side of the initial landing direction. The wreckage distribution was located within a radius of 10m from the main wreckage. The aircraft sustained substantial damage to the propeller, engine and the fuselage belly.

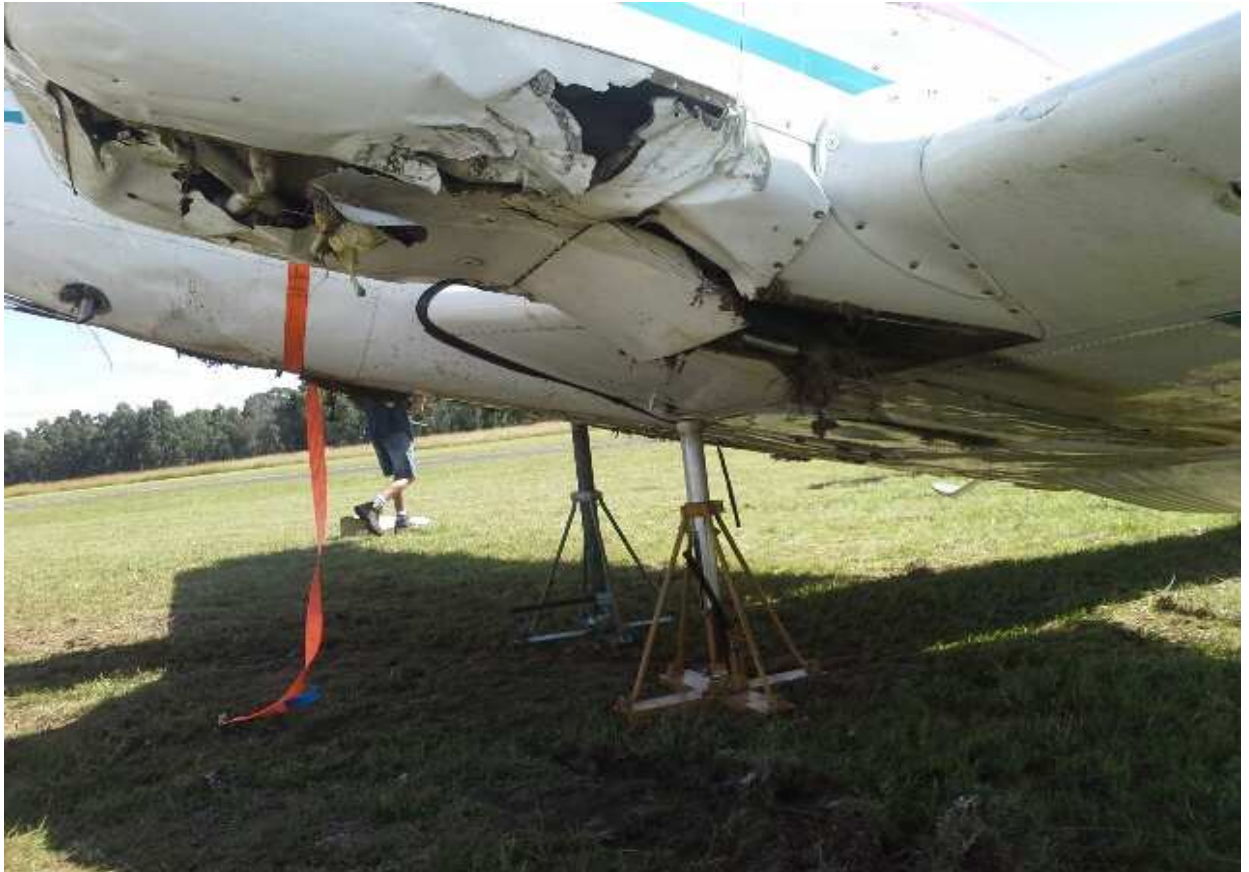
**Figure 4:** The damage to the aircraft surface

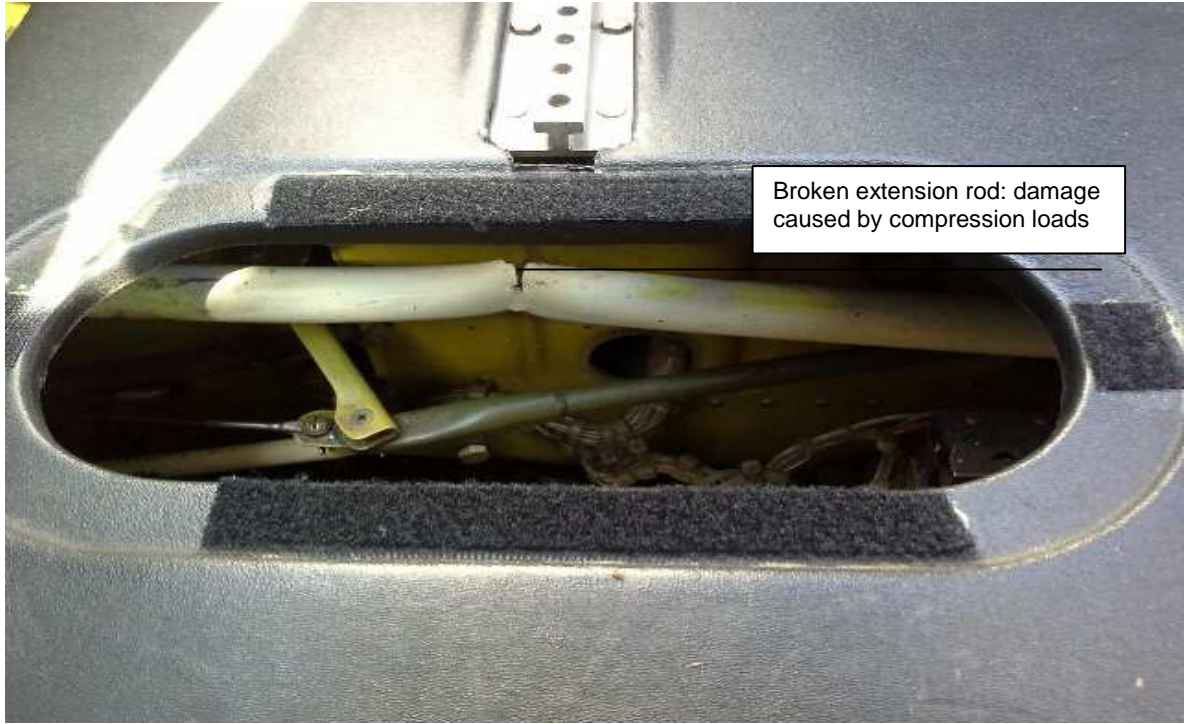
1.12.2 The recovery team informed the investigator that during their post-accident inspection they noticed that the left landing gear up-lock was jammed. The main gear extension rod (figure 5) was damaged because of compression overload as shown in Figure 6 below. The team also mentioned that they observed that the up-lock (figure 6) on the main gear brace assembly had stopped on the wrong side.

**Figure 5:** Damage to the landing gear extension rod

- 2.5 The landing gear extension/retraction rod was found to be damaged. That damage was caused by the compression and tensile forces imposed on it. During the initial attempt to land, both the right hand main landing gear and the nose gear were extended with only the left main landing gear not extended. This implies that the left main landing gear extension rod was broken either prior or during an attempt to land. The following three possibilities exist to account for damage to the landing gear extension rod:

Nevertheless, the damage to the extension rod was consistent with an object which has been subjected to compression and tensile forces for a considerable period of time: during that time the aircraft had been in operation with the damage gradually becoming worse.

3.3.1 Extension rod failure attributable to compression forces during extension.

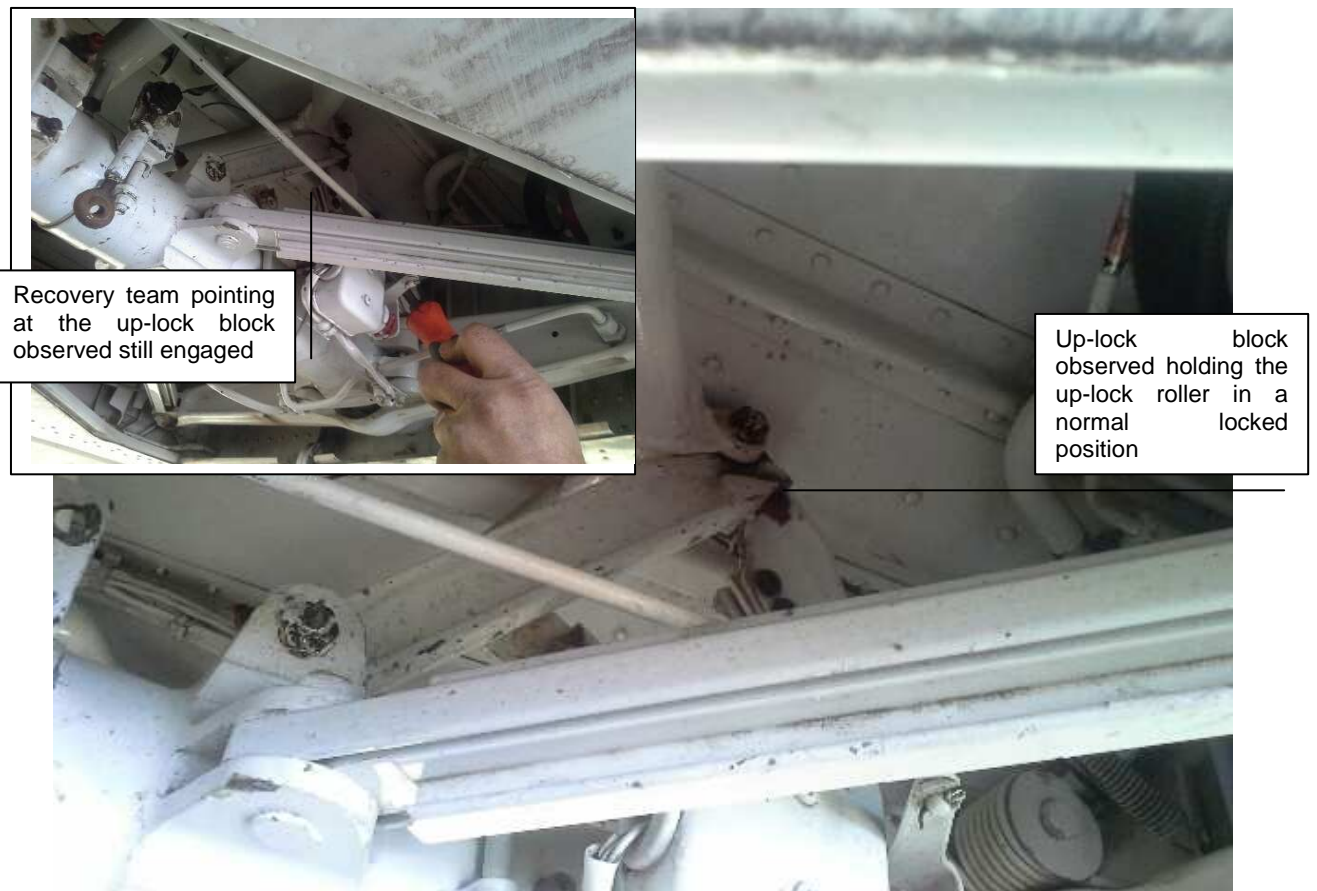
**Figure 6:** Up-lock stop bracket bolt installed from front to back

- 2.4 According to the recovery team, the up-lock block was also found jammed on the wrong side of the up-lock roller. Because of the design and method used to mount the up-lock block, it is not possible for the up-lock block to be at the wrong side of the roller unless the up-block stop has not been fitted. If the up-lock block was indeed on the wrong side of the up-lock roller, then it would not have been possible for the recovery team to release the landing gear without removing the up-lock roller first.

Given this background, it can be stated with certainty that the up-lock block was just holding the landing gear in a locked position. Also if the up-lock roller seized because of a lack of greasing and clearance, this could have caused the up-lock block to jam on the roller preventing the landing gear from extending. However the pilot stated that during the landing gear extension only the left landing gear could not extend. The rigging recordings made by the AMO were in line with the manufacturer’s recommendations. It should be noted that the aircraft was flown for 27.7 hours after maintenance but prior to the accident.

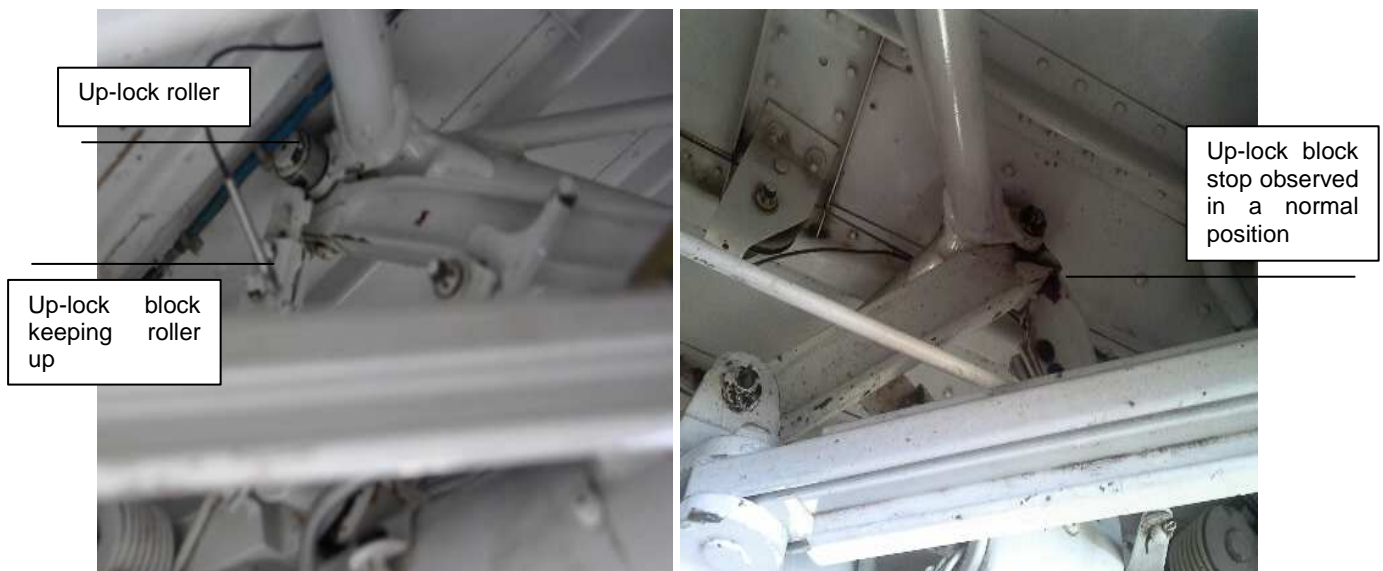
**Figure 8:** Up-lock block at locked positions

**Figure 9:** Up-lock block of the accident aircraft

As part of the follow-up investigation, a test demonstration was conducted on an aircraft with a landing gear system similar to that of the aircraft involved in the accident. The position at which the up-lock block mechanism was observed on the aircraft in the accident was the same as in the demonstration aircraft. The up-lock block was at a normal position when compared to the demonstration aircraft's up-lock block. The method used to mount the up-lock block generally reduces any possibility of sideways play unless the bolt or pin used is of the wrong specification and size. The up-lock block stop prevents further movement of the leg brace as the up-lock block settles under the up-lock roller.

3.1.3 The aircraft up-lock block could not release.

A Service Instruction was released as follows: Instruction No. 0448-211: In order to prevent a wheels-up landing due to the possibility of seizure of the main landing gear up-lock rollers, one should accomplish the following:

1. Inspect the MLG up-lock rollers, per Beechcraft Service Instruction No. 0448-211.

Replace non-greasable up-lock rollers with the greasable type and install hollow zerk-ended mounting bolts on the up-lock rollers, as per Beechcraft Service Instruction (SI) No. 0448-211, before further flight.

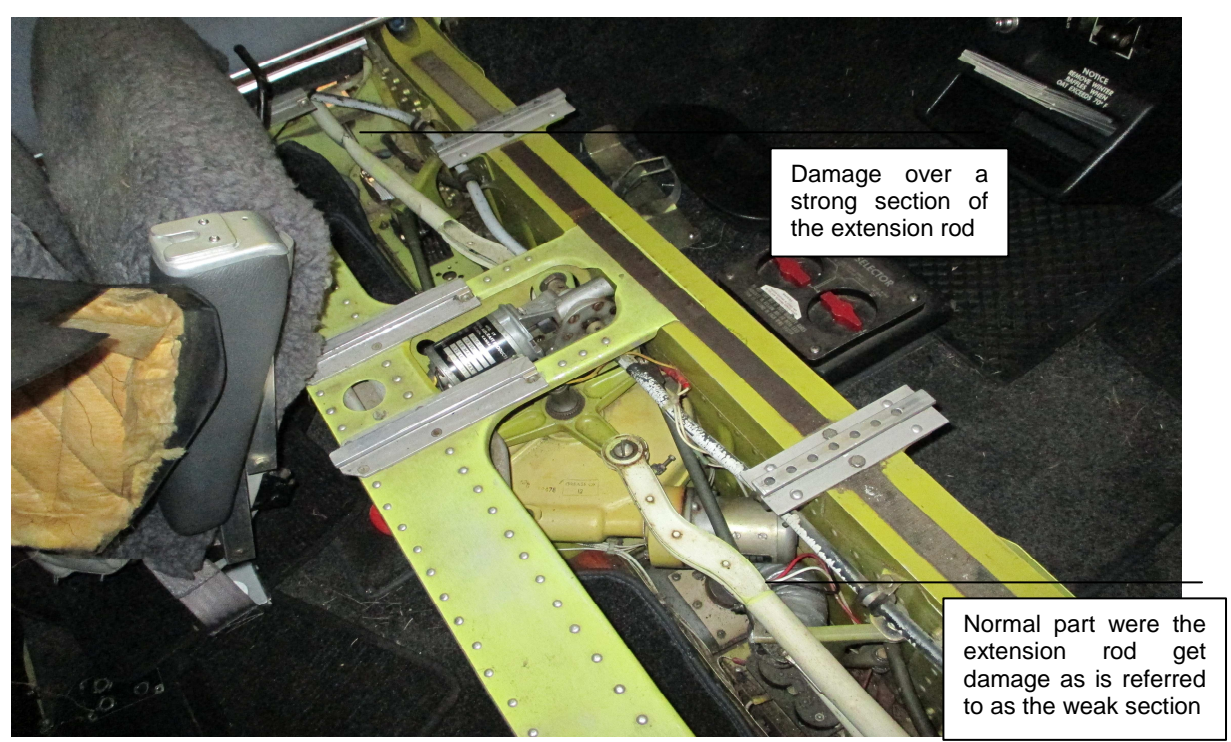
**Figure 10:** The retraction rod connection

“When conducting maintenance on the landing gear system, the aircraft must be put on jacks. Care must be taken with aircraft jacking to allow enough clearance space for landing gears, to enable travel during extension and retraction tests. If the landing gear should be restricted by any objects during system extension and retraction tests, then the result will be the bending or breaking of the extension rod,

most probably at its weak point near the gear box connection (flat area) although any position is possible.”
