DUTCH
SAFETY BOARD

Crashed during aerobatic flight

Bussloo, 19 March 2014

The Hague, June 2016

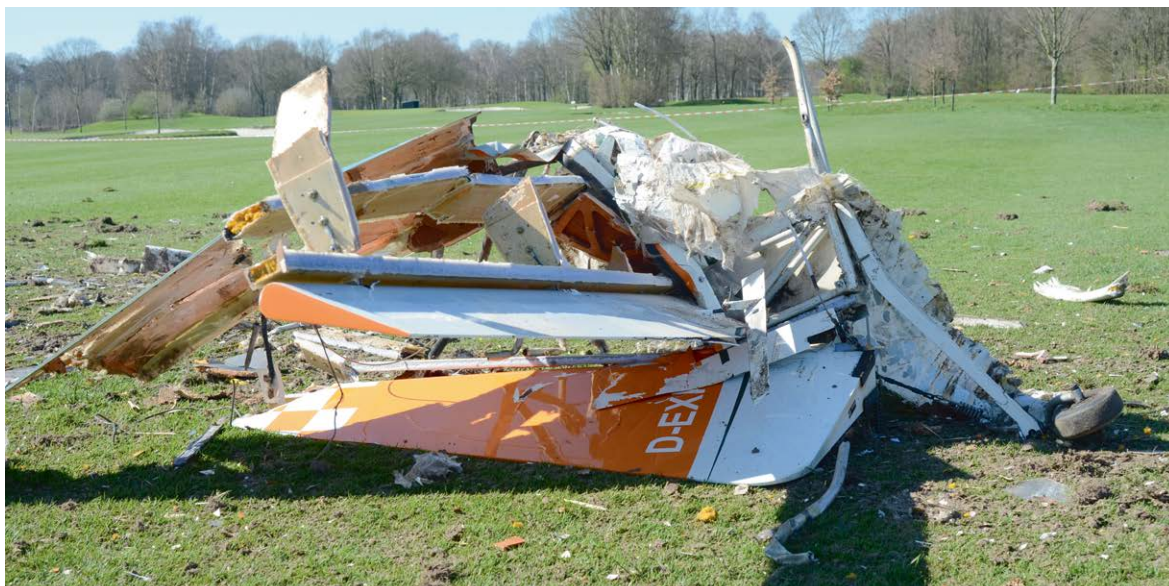
Figure 1: Accident site D-EXIR. (Photo: Dutch Safety Board)

The aeroplane crashed on a golf course. The place where the aeroplane first hit the ground was clearly visible. An impact pit with impressions from the wings on both sides could be seen. At the ends of the wing impressions, orange metal tubes were visible, each of which stuck into the ground at an angle of approximately 20 to 30 degrees. The aeroplane had completely disintegrated, with the heaviest parts lying closest to the point of impact. From the point of impact, parts of the aeroplane parts had spread out in one direction. The direction in which the parts had spread, was approximately 30° relative to the North. The parts which had scattered furthest, were located about 88 meters from the point of impact.

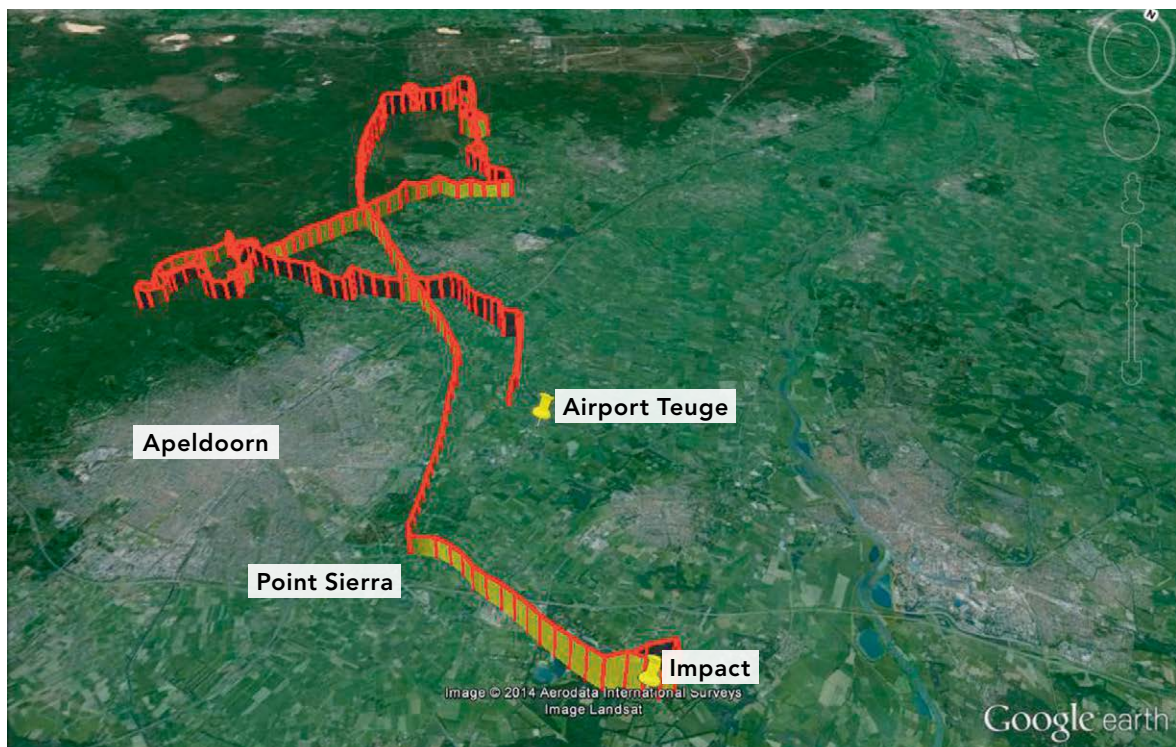
Radar images show that D-EXIR performed several manoeuvres north of Apeldoorn at altitudes between about 1.000 and 3.500 feet. After about fifteen minutes, D-EXIR flew southbound between Apeldoorn and Teuge. When it reached the Sierra reporting point of Teuge airport, it changed course to the southeast. It then gradually climbed to approximately 4.100 feet (see figure 2).

Figure 2: The flight path of D-EXIR. (Photo: Radar images from Air Traffic Control the Netherlands, as visualised in Google earth)

The available radar images were examined and analyzed. Due to the fact that: this radar generates one image per 5 seconds,⁷ the rate of the D-EXIR's movements is very high, the radar does not have coverage all the way to the ground and the system rounds off all altitudes, only a global analysis rather than an accurate analysis could be made based on these radar data. The following table lists the times and the observed altitudes during the last part of the flight.⁸ Based on these, the rate of descent was calculated.

From this data it can be deduced that D-EXIR descended from about 4.100 feet to about 2.500 feet (the last more or less reliable recorded altitude) in 19 seconds. This corresponds to an average rate of descent of 5.052 feet per minute. The rate of descent per five seconds shows that the rate of descent was reduced towards the last part of the manoeuvre.

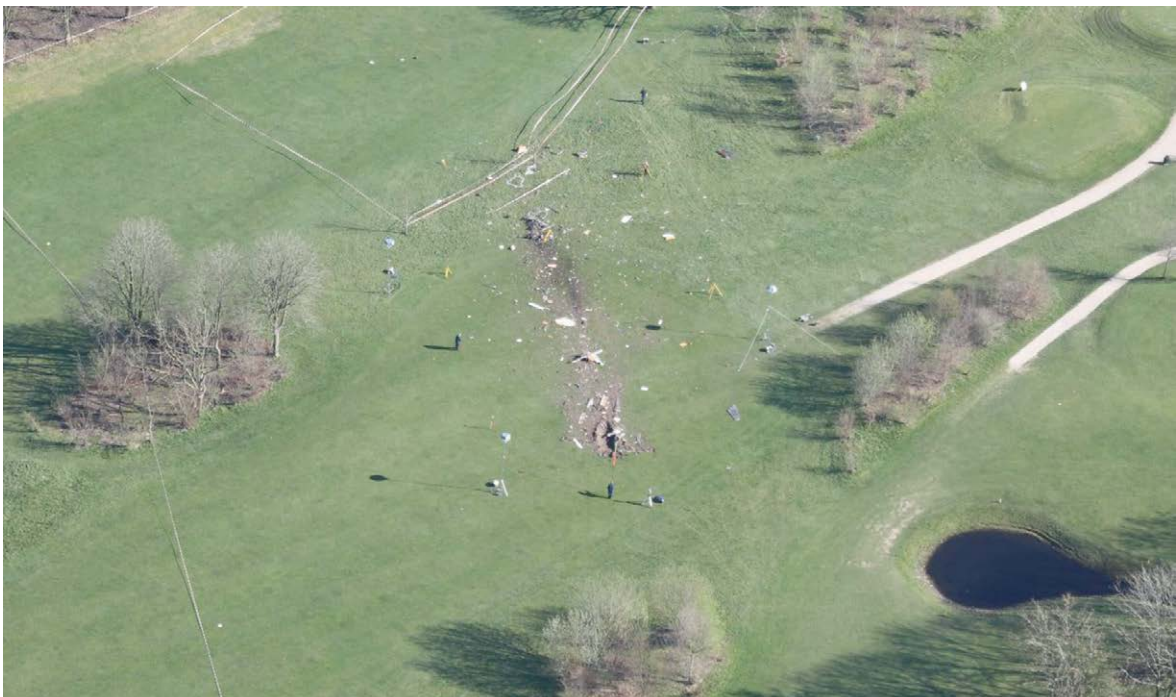
Figure 3: Aerial photograph of the crash site. (Photo: National Police)

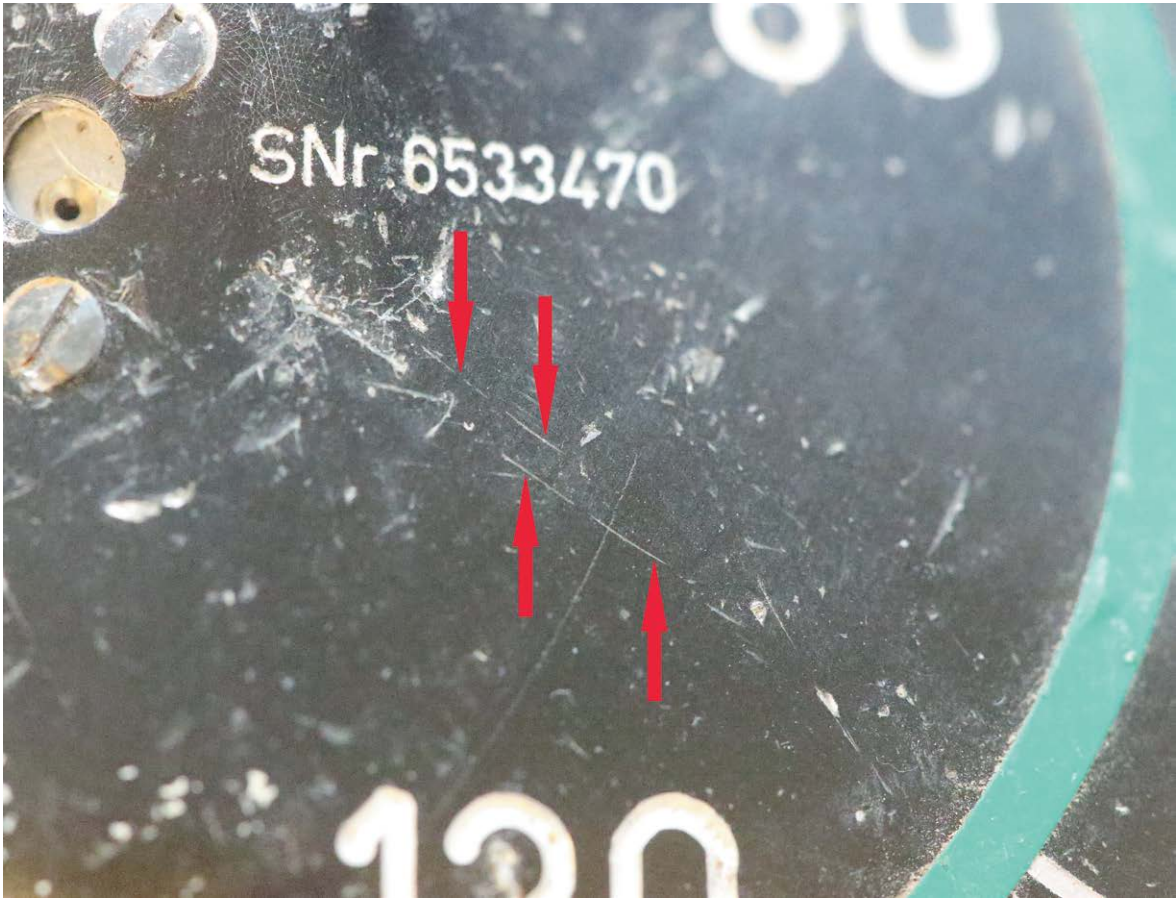
After the accident the Dutch Safety Board conducted a technical examination of the wreckage. Here the aeroplane construction and the components of the control system were examined, but the aeroplane was destroyed to such an extent that this did not yield any useful information. However, an airspeed indicator dial was found. Examination thereof showed a mark that was very likely an impression from the airspeed indicator needle (see figure 7). This impression had apparently been formed at the moment of impact. From the impression it could be concluded that the speed of the aircraft at that time was about 110 knots.⁶ It was also concluded that the safety belts of both the pilot and the passenger were still closed.

Figure 7: Detailed photograph of the airspeed indicator with the impression of the needle. (Photo: Dutch Safety Board)

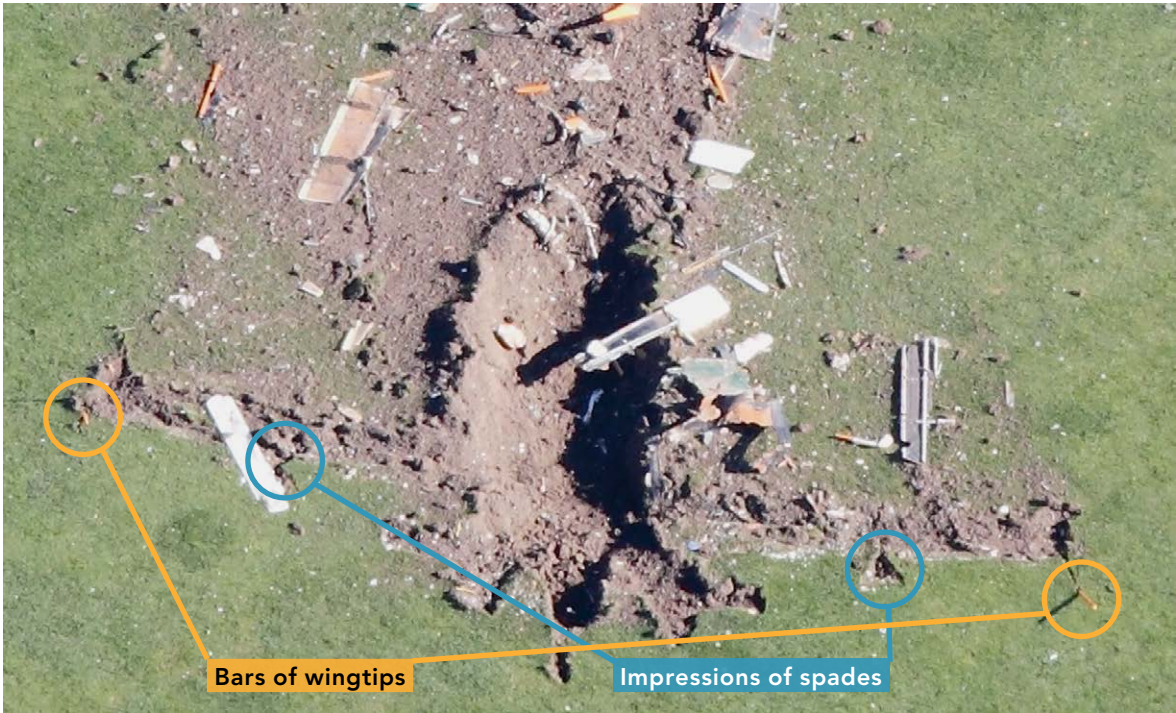
The impression marks of the aeroplane and its wings in the ground indicate that the aeroplane's nose hit the ground first, and that both wings impacted the ground at almost the same time. This is confirmed by the marks that the 'spades' beneath both ailerons left in the ground. At the moment of impact, D-EXIR had little or no bank (see figure 8).

The orange metal tubes, which were found at an angle in the ground, proved to be the reference bars that had been mounted at the wingtips. These bars stuck into the ground at an angle of approximately 20 to 30 degrees. As the bars were mounted parallel to the longitudinal axis of the aeroplane, it can be concluded that D-EXIR impacted the ground at an angle of approximately 20 to 30 degrees.

Figure 8: Impression marks of the aircraft in the ground. (Photo: National Police)
