AIRCRAFT ACCIDENT REPORT AND EXECUTIVE SUMMARY

Reference:	CA18/2/3/9304	
Aircraft Registration	ZS-RHC	Date of Accident	27 March 2014		Time of Accident	1310Z
Type of Aircraft	R22 Beta		Type of Operation	Training		
Instructor Licence Type	Commercial Pilot – Helicopter		Age	26	Licence Valid	Yes
Instructor Flying Experience	Total Flying Hours		1 459,9		Hours on Type	393,5
Last point of departure	Wonderboom airport (FAWB) – Pretoria, Gauteng					
Next point of intended landing	Freeway airport (FAFW) – Private airfield, NE of Wonderboom airport					
Location of the accident site with reference to easily defined geographical points (GPS readings if possible)						
Freeway airport (FAFW) – Private airfield, NE of Wonderboom airport (FAWB) at GPS position S25°28.6' E028°14.4' at an elevation of 3 800 ft.						
Meteorological Information	The instructor reported fine weather conditions with a light and variable wind, temperature of 26°C with 4/8 cloud at 2 000 ft AGL

AIRCRAFT ACCIDENT REPORT

Name of Owner : Brits Pallets CC
Name of Operator : Vortx Aviation Training
Manufacturer : Robinson Helicopter Company
Model : R22 Beta
Nationality : South African
Registration Marks : ZS-RHC
Place : F

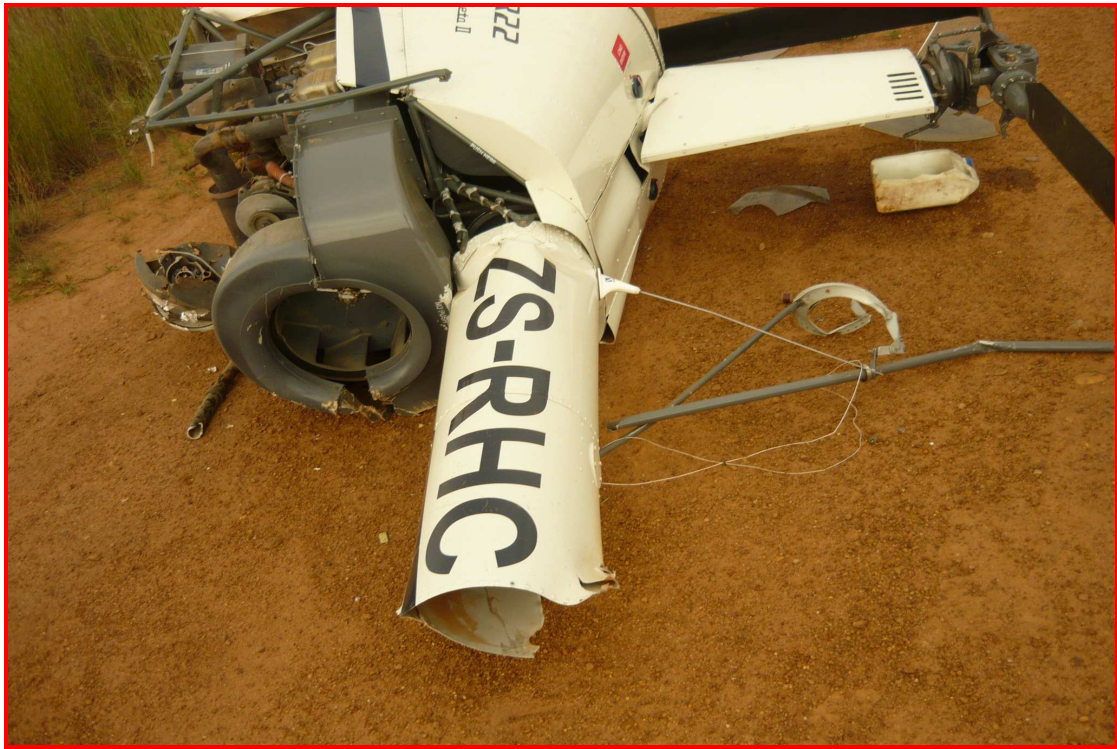
1.3.1 The aircraft sustained extensive damage to the airframe, skids, main rotor and tail rotor.

1.3.2 The tail boom was severed by a combination of impact forces and a strike with the main rotor.

1.3.3 The skids failed as a result of the impact forces exerted on the helicopter during the touchdown.

Figure 1: View of wreckage after accident

1.12.4 During the initial impact, a combination of the impact forces and a strike from the main rotor severed the tail boom.

1.12.5 The skids failed partially due to the high vertical impact forces. The helicopter bounced and finally came to rest on its right side, approximately 45 m from the initial impact point.

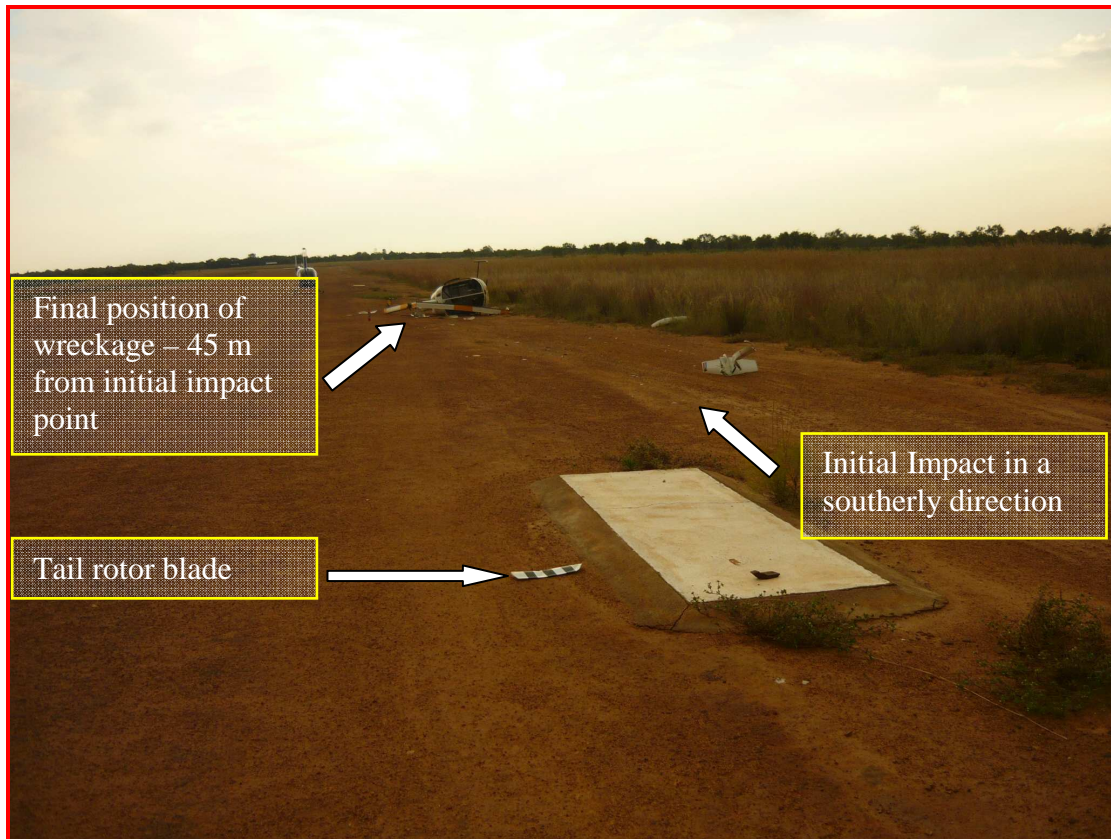
Figure 2: General view of accident site

1.12.2 The helicopter hit the ground in a southerly direction and finally stopped approximately 45 m from the initial impact point.
