KNKT.14.03.09.04

Aircraft Serious Incident Investigation Report

**PT. Wings Abadi Air  
ATR 72-212A; PK-WFR  
Sultan Hasanuddin Airport, Makassar  
Republic of Indonesia  
28 March 2014**

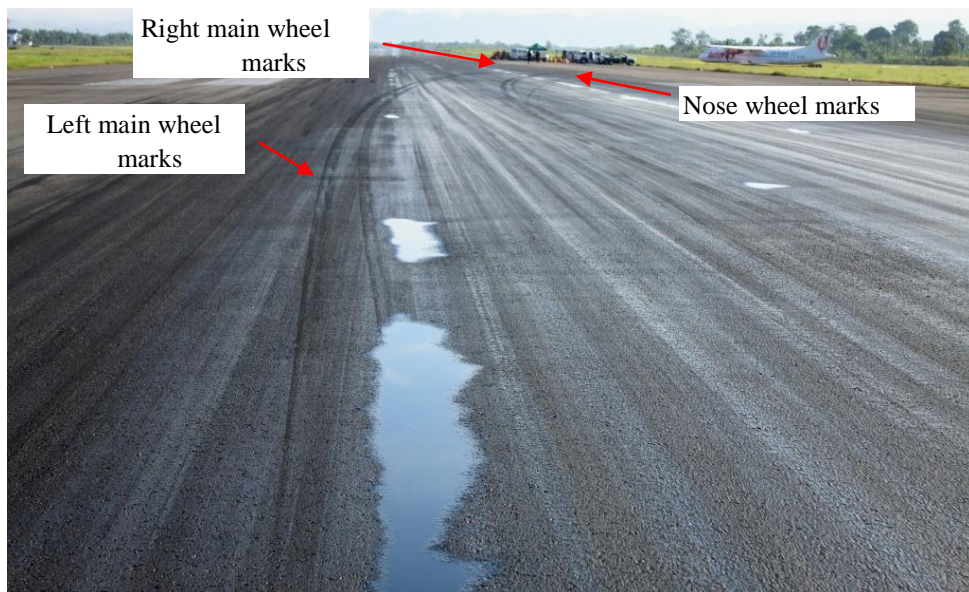
The wheel tracks were found on runway 03, begin on the touchdown and were on the runway centre line. The marks turn to the right at approximately 45° from the runway direction.

**Figure 3: The marks of the wheel where started to turn right**

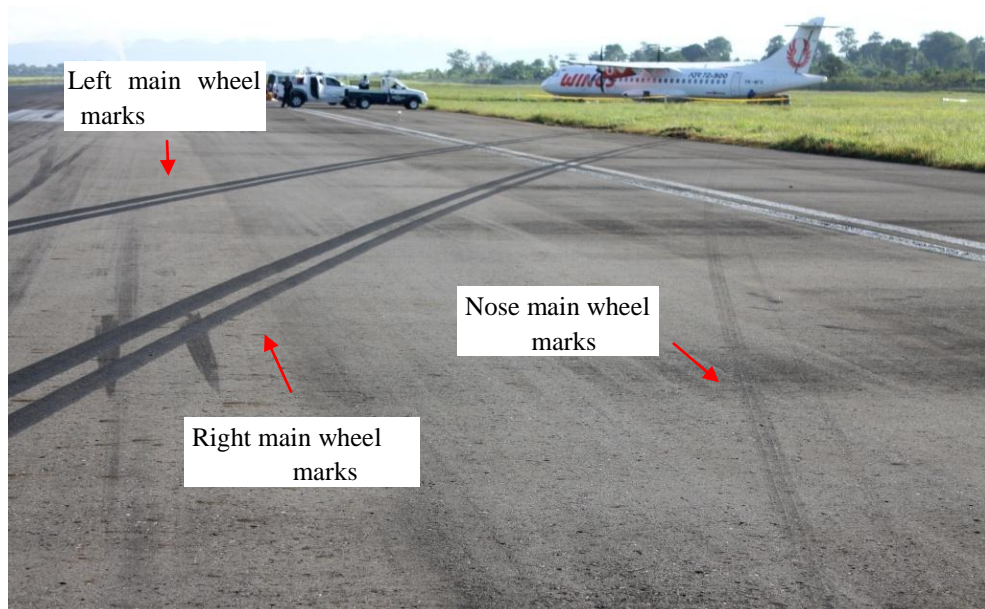
**Figure 4: The marks of the wheel where started left the runway pavement**
