AIRCRAFT ACCIDENT REPORT AND EXECUTIVE SUMMARY

Reference:	CA18/2/3/9313	
Aircraft Registration	ZS-LLD	Date of Accident	22 April 2014		Time of Accident	0921Z
Type of Aircraft	Piper PA-46-310P (Malibu)		Type of Operation	Private (Part 91)		
Pilot-in-command Licence Type		Commercial	Age	35	Licence Valid	Yes
Pilot-in-command Flying Experience		Total Flying Hours	1569.4		Hours on Type	163.2
Last point of departure		Cape Town International Airport (FACT), Western Cape				
Next point of intended landing		Swartwater, in the Limpopo Province				
Location of the accident site with reference to easily defined geographical points (GPS readings if possible)						
Farm Rooisand in the Niekerkshoop area, Northern Cape (GPS S29°26.103 E022°43.722)						
Meteorological Information		Temperature: 25 °C; Dew Point: 06 °C; Wind 300°/167 kt; Visibility: 10 000 m; QNH: 1 016 hPa				
Number of people on board	1 + 1	No. of people injured	0	No. of people killed	2	
Synopsis

AIRCRAFT ACCIDENT REPORT

Name of Owner : L. Botha
Name of Operator : Private
Manufacturer : Piper Aircraft Corporation
Model : PA-46-310P (Malibu)
Nationality : South African
Registration Marks : ZS-LLD
Place : Farm Rooisand, Niekerksh

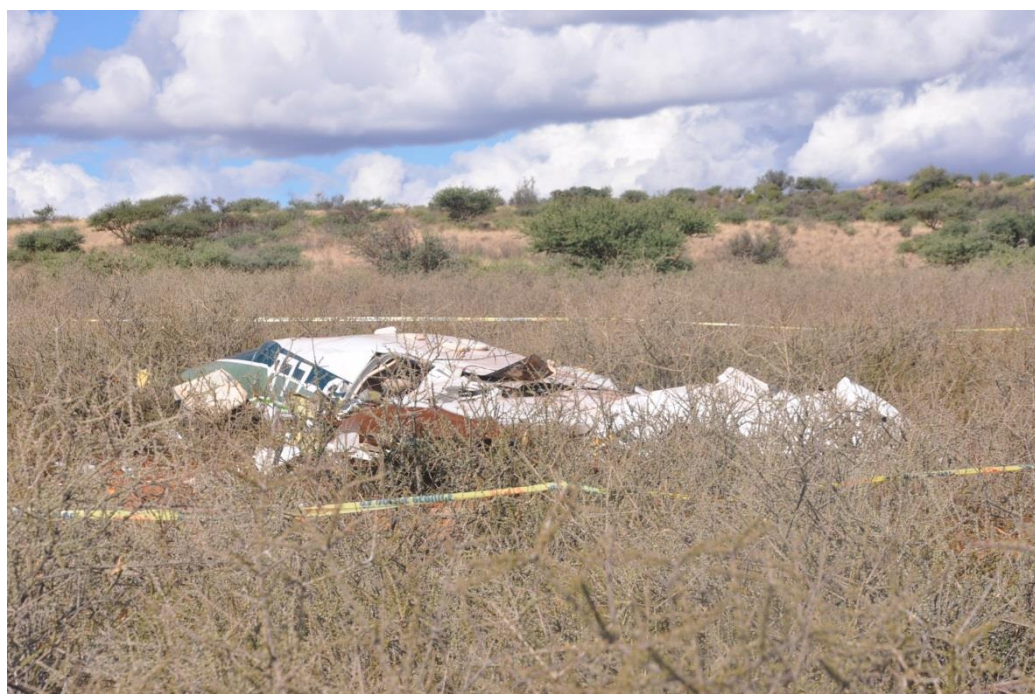
1.3.1 The aircraft experienced a catastrophic in flight failure and was also destroyed during the impact sequence.

**Figure 2:** View of the main wreckage (fuselage)

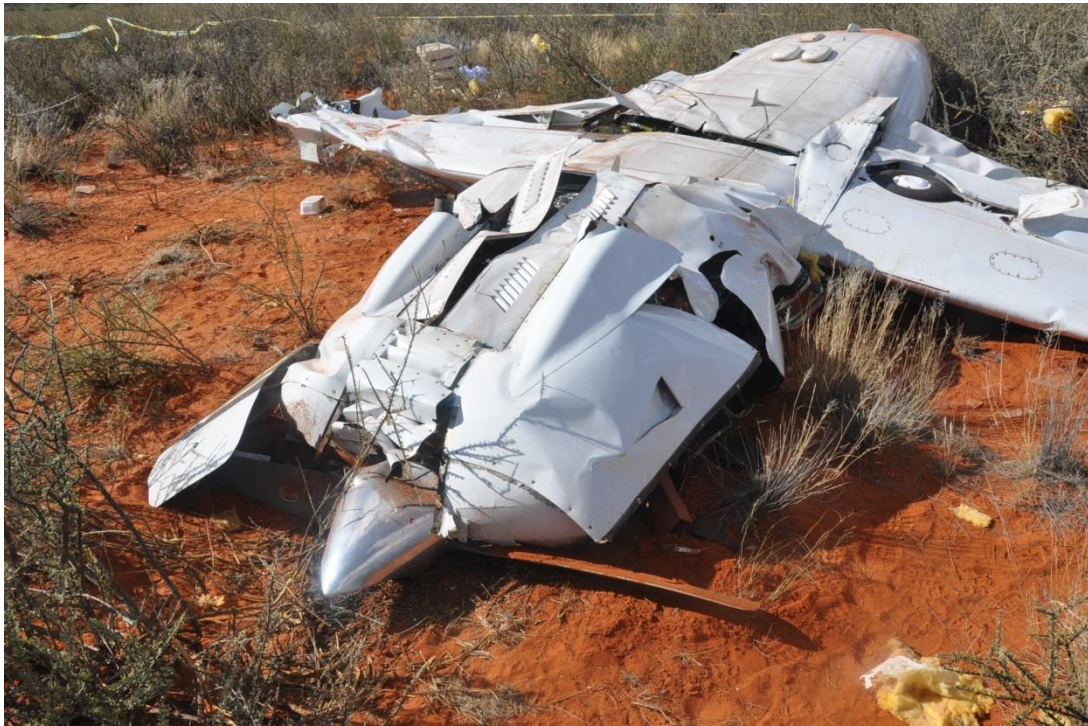
Figure 3: View of the main wreckage

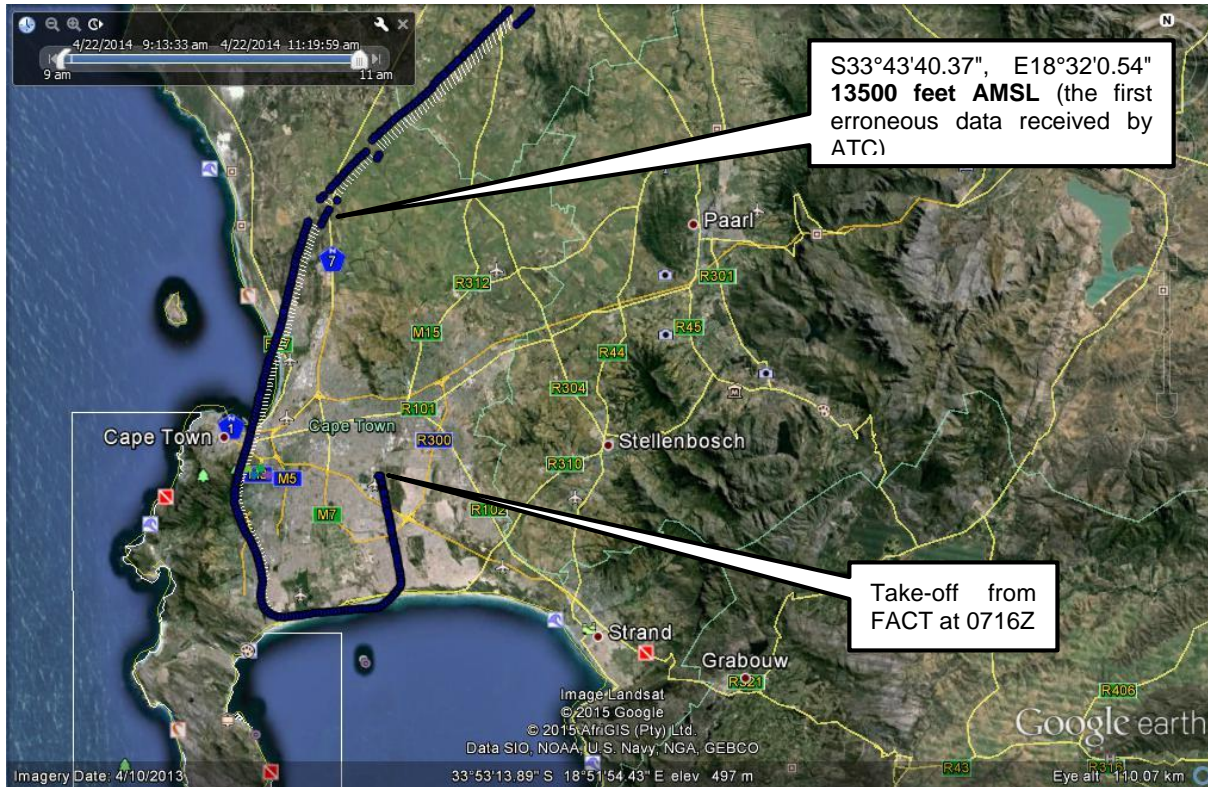
Figure 9: Google Earth view of the area and the first erroneous data received

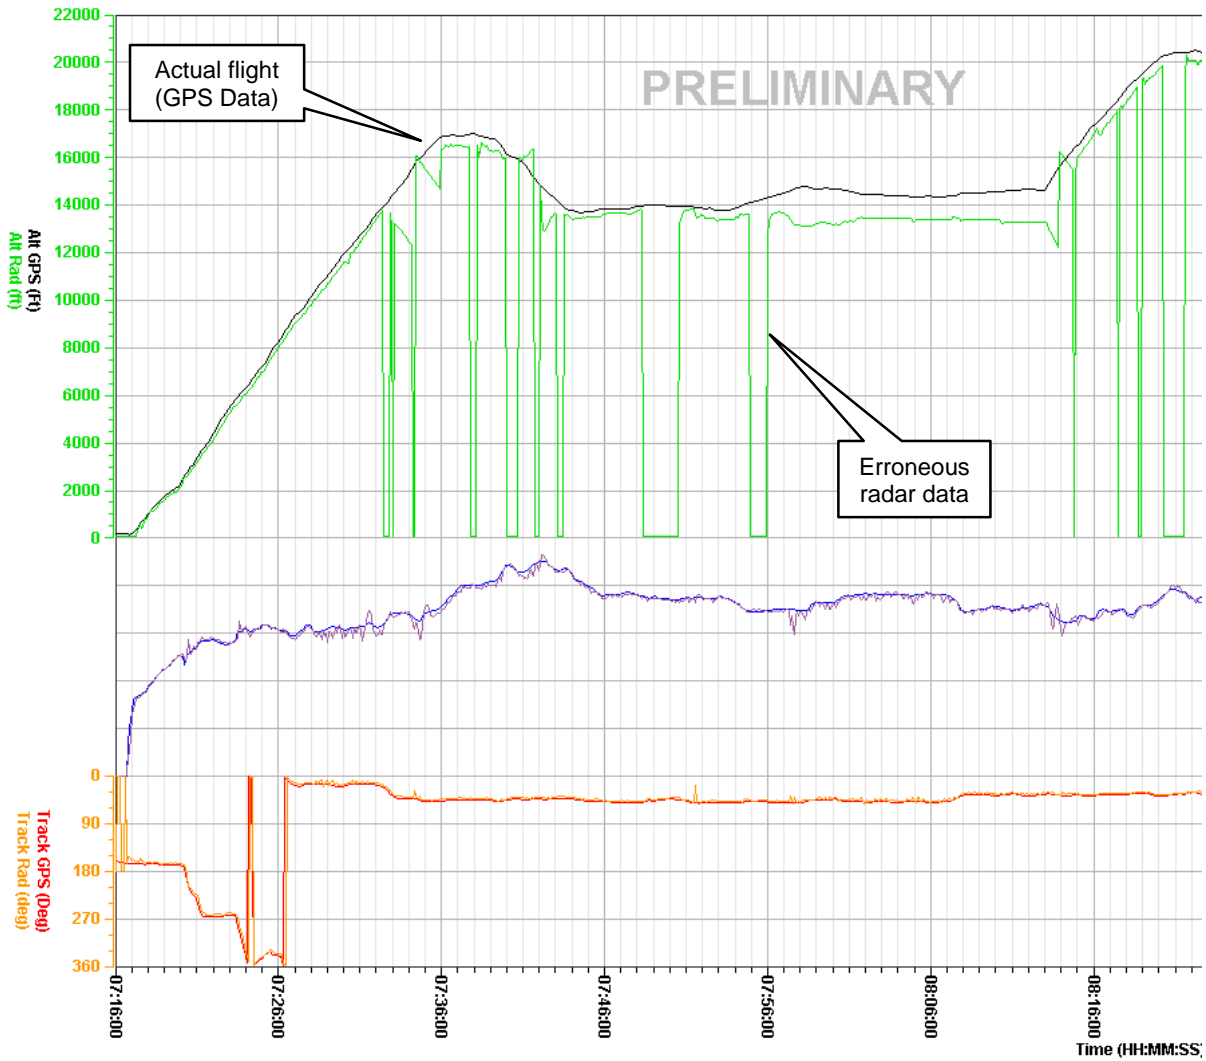
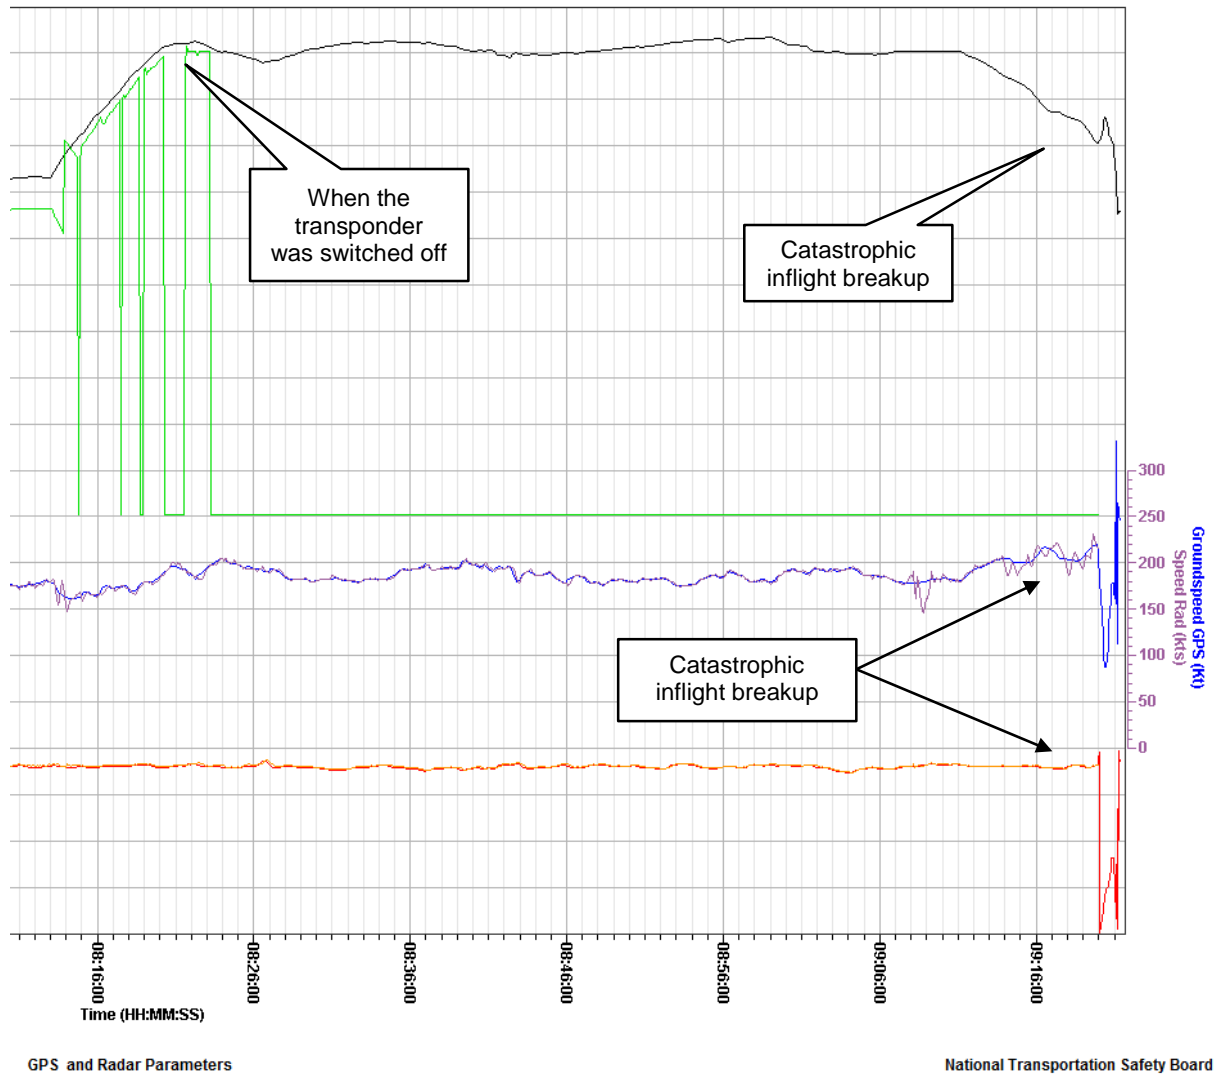
1.11.3 The downloaded GPS data in Figure 10 and Figure 11 was overlaid on the radar data obtained from ATC. This indicates the actual flight with erroneous radar data information ATC received and from the GPS. The aircraft GPS data graph also shows the erroneous data captured at altitude of 13500 ft before the aircraft reached an altitude of 17000 ft and during the flight.

1.11.4 The abovementioned figures illustrate the actual flight path prior and at the point where the aircraft experienced inflight breakup, at figure 10, is evident that the aircraft ascended to an altitude of 17000 ft, the graph indicate that there was definitely a problem with a transponder and the aircraft descended to an altitude of approximately 13500 ft. in figure 11 indicate the aircraft ascending to altitude of 21 000 ft and flew for approximately 52 min before diving and experience inflight breakup of altitude of 17000 ft.

Figure 10: The GPS download and Radar Data overlay as supplied by the NTSB

Figure 11: The GPS download and Radar Data overlay as supplied by the NTSB

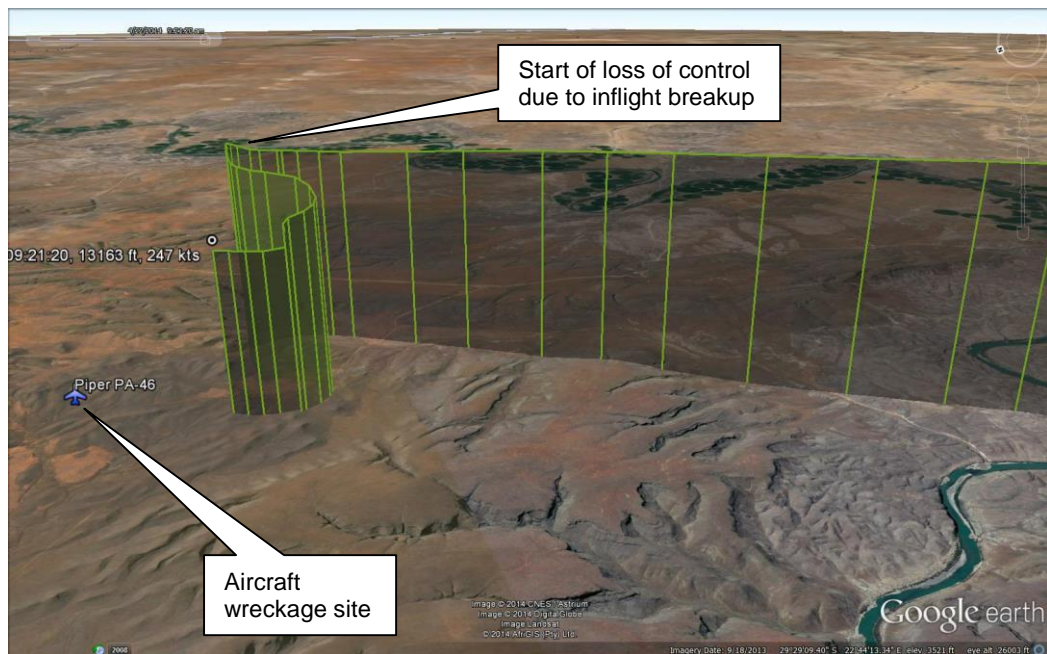
1.12.1 According to the aircraft GPS that was downloaded and radar information the aircraft exceeded the VNO of 173 airspeed and VNE airspeed of 203 airspeed causing a catastrophic inflight failure and destruction of the aircraft during the flight and impact sequence with terrain.

Figure 14: The final three minutes of the flight as recorded by the aircraft on-board GPS

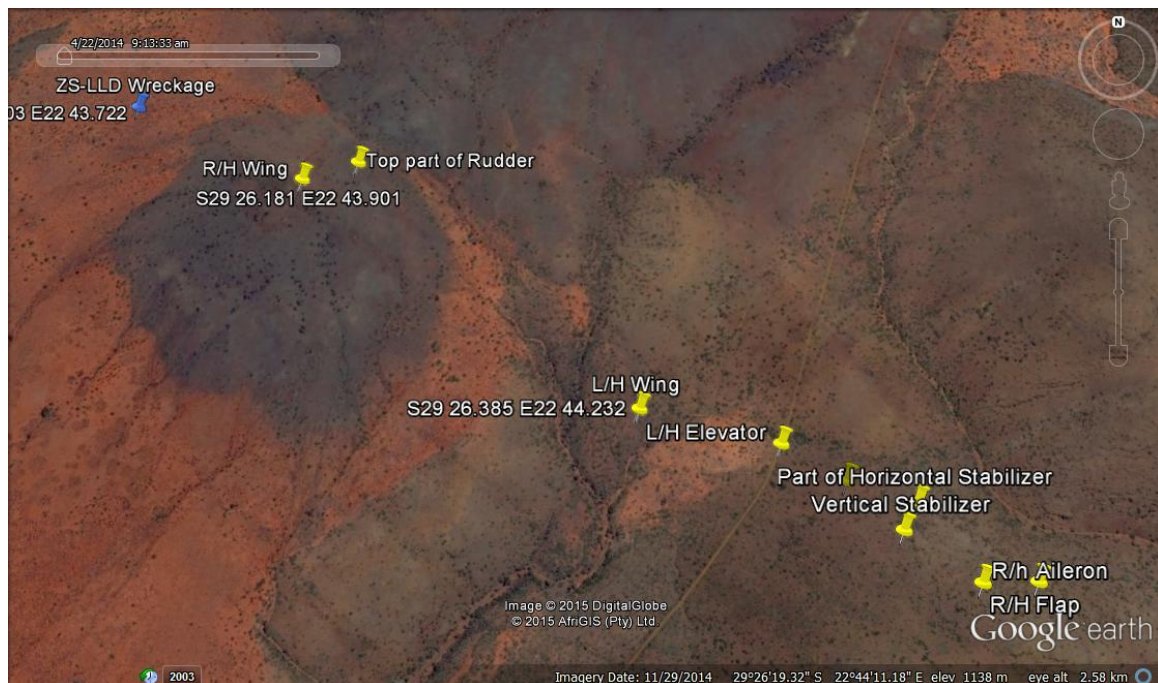
1.12.3 The accident debris path was approximately 45 m wide and 1.58 km long and was oriented on a 299 degree heading. The following wreckage pattern and damage were found:

Figure 15: Wreckage layout of the accident site

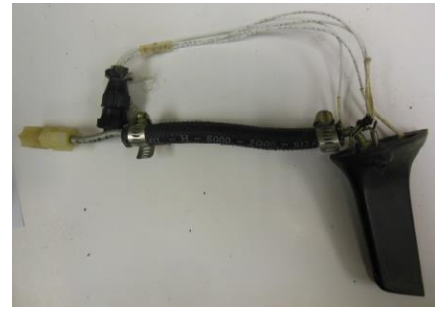
- Although the outboard wings separated during the inflight breakup from the inboard wing, the inboard was still attached to the fuselage. The pitot tube was found in a good condition.

Figure 18: The recovered pitot tube

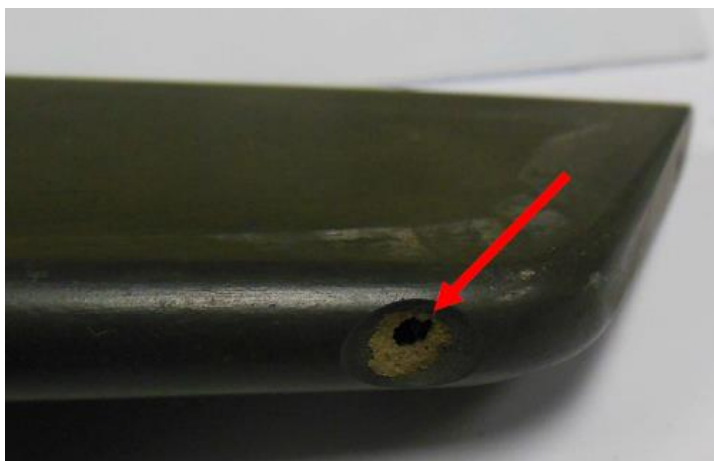
The investigation could not conclusively determine the origin of the contamination due to limited reference samples. Although the indicated air speed test results revealed no clear detrimental effect on the contaminated pitot head's performance, caution should be applied when considering this result as a possible contributing factor, or not, as the original in-flight contamination may have been dislodged during the accident.

Figure 20: Pitot head inlet contamination
