<b>AIRCRAFT ACCIDENT REPORT AND EXECUTIVE SUMMARY</b>
---

Reference:	CA18/2/3/9316	
<b>Aircraft Registration</b>	ZU-IAY	<b>Date of Accident</b>	27 April 2014		<b>Time of Accident</b>	0515Z
<b>Type of Aircraft</b>	Bat Hawk (Amateur Aircraft)		<b>Type of Operation</b>	Private		
<b>Pilot-in-command Licence Type</b>		Commercial Pilot License	<b>Age</b>	46	<b>Licence Valid</b>	Yes
<b>Pilot-in-command Flying Experience</b>		Total Flying Hours	1618.0		Hours on Type	12.1
<b>Last point of departure</b>		Witbank aerodrome (FAWI) Mpumalanga province				
<b>Next point of intended landing</b>		Witbank aerodrome (FAWI) Mpumalanga province				
<b>Location of the accident site with reference to easily defined geographical points (GPS readings if possible)</b>						
To the Right of Runway 04 at Witbank aerodrome (GPS position S25°49'56" E029°11'31")						
Wind: Visibility: Temperature: Dew point: Cloud cover: Cloud base:		Wind: 350°2-6 knots, Visibility: 10000m, Temperature: 12°C, Dew point: Unknown, Cloud cover: None, Cloud base: None.

**Name of Owner** : Drillcon (PTY) LTD  
**Name of Operator** : E Maasdorp  
**Manufacturer** : Micro Aviation SA  
**Model** : Bat Hawk (Amateur Aircraft)  
**Na

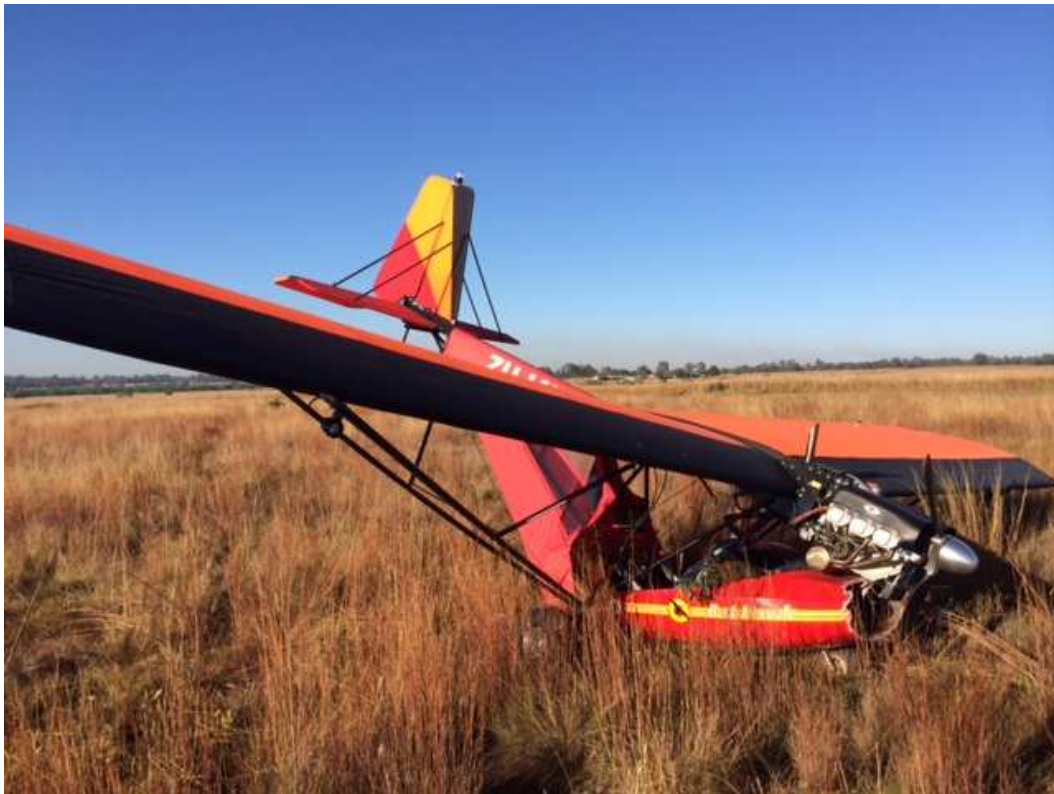
1.3.1 The aircraft was substantially damaged during the sequence of the accident.

**Fig. 1** Damage caused to the aircraft as a result of the accident.

1.3.2 Damage was caused to the propeller, 1<sup>st</sup> riser, wing and nose section of the aircraft.

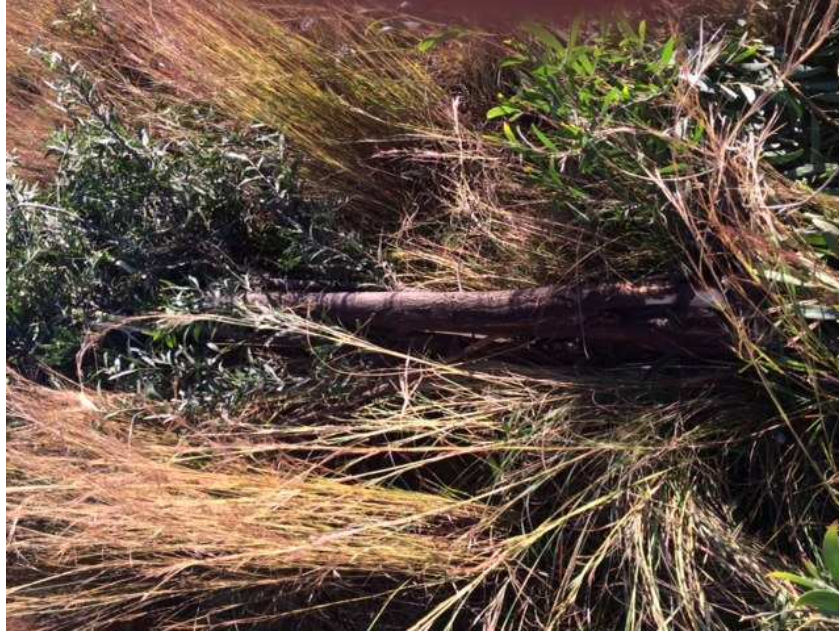
1.4.1 Damage was caused to a shrub bush situated to the right of the runway.

**Fig.2** Damage was caused to shrub bush on the side of the runway.
