AIRCRAFT ACCIDENT REPORT AND EXECUTIVE SUMMARY

Reference:	CA18/2/3/9323	
Aircraft Registration	ZS-GIA	Date of Accident	24 May 2014		Time of Accident	12:20Z	
Type of Aircraft	Glider Schleicher ASK 13		Type of Operation		Private		
Pilot-in-command Licence Type		Glider Pilot's Licence	Age	65	Licence Valid	Yes	
Pilot-in-command Flying Experience		Total Flying Hours	330		Hours on Type	280	
Last point of departure		Howick Airfield (FAHC), KwaZulu-Natal					
Next point of intended landing		Howick Airfield (FAHC), KwaZulu-Natal					
Location of the accident site with reference to easily defined geographical points (GPS readings if possible)							
Next to Howick Airfield, approximately 21km north-west of Pietermaritzburg Airport (coordinates S29° 34q023+E030° 12q266+)							
Meteorological Information		Sky clear, visibility >10km, with a north-easterly wind of 04kt					
Number of people on board	1 + 1	No. of people injured	0	No. of people killed	2

Name of Owner : Howick Flying Club
Name of Operator : Howick Flying Club
Manufacturer : Schleicher
Model : ASK13
Nationality : South African
Registration Marks : ZS-GIA
Place : Howick Airfield (FAHC)
Date : 24 May 2014
Time : 12:20Z

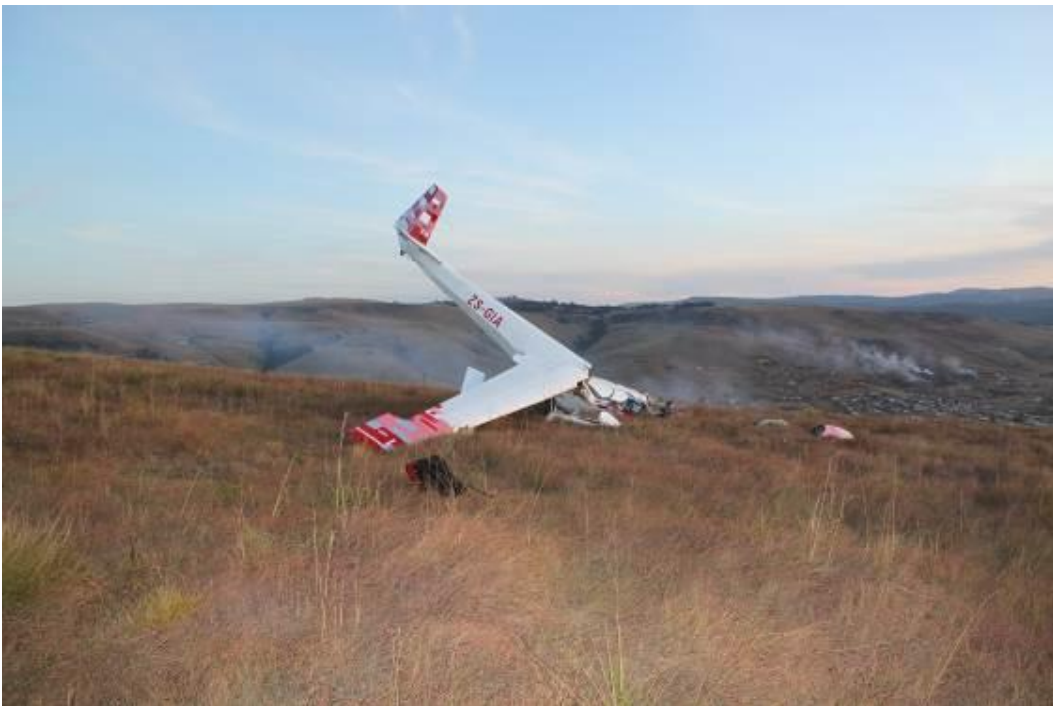
- 1.3.1 The aircraft was destroyed in the impact.

Figure1: The force of the impact destroyed the glider.

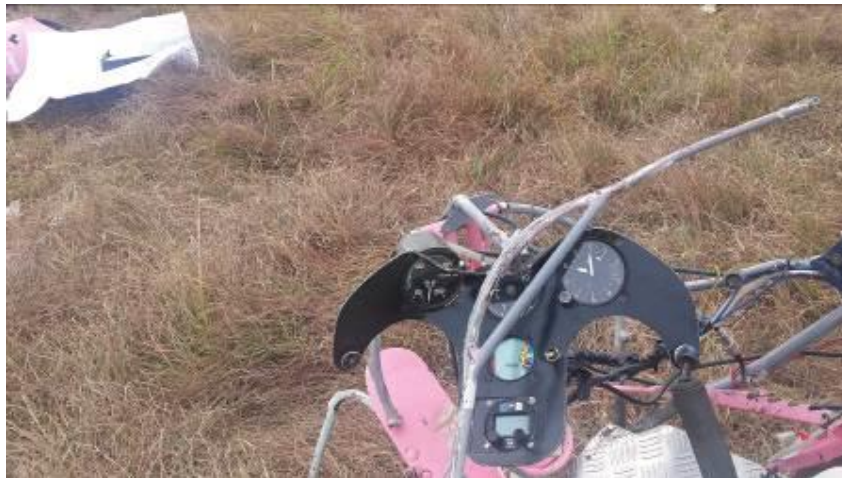
Figure 2: Damaged instrument panel and broken cockpit tubing.

1.12.3 The nose skid and main wheel were damaged. The instrument panel and seats were partially removed from their mountings. The rudder was dislodged from its mountings.

1.15.1 The accident was not survivable. The cockpit collapsed, exposing broken tubing, and both occupants sustained serious injuries from impact. Their four-point safety harnesses did not break on impact, but their seats were partially ripped from the fuselage floor.

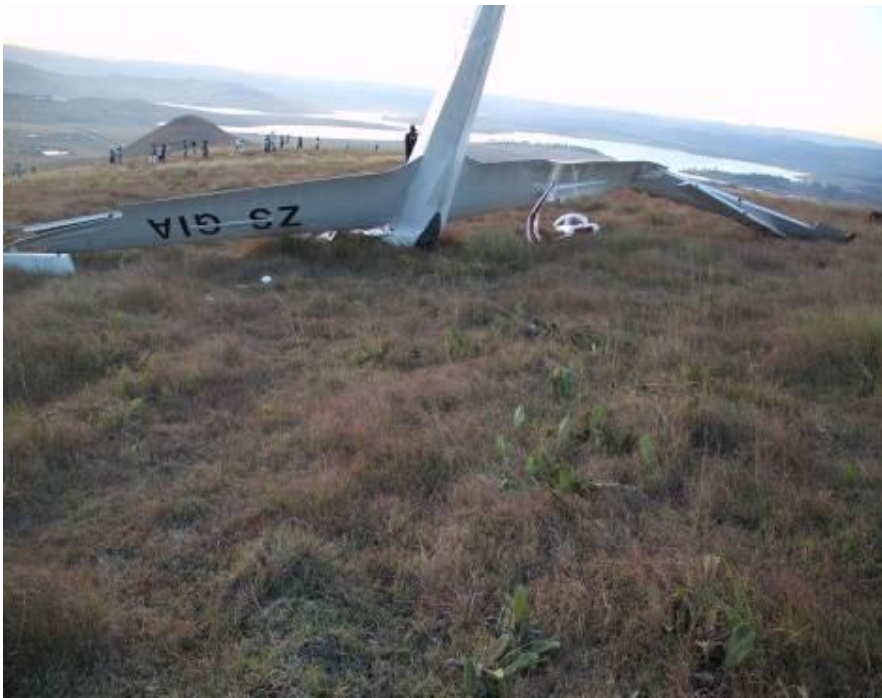
1.12.1 The accident site was on a hill 1.45km from the runway and at an elevation of 4 427ft. The investigation found that the right wing had dropped and struck the ground first, causing its main spar to break in half. The cockpit was completely destroyed as the aircraft struck the ground in a nose-down attitude. The debris was found in a radius of approximately 10m from the aircraft. No major components had broken off the glider.

Figure 3: The right wing hit the ground first, as can be seen here..

- 2.5 The investigation found that the glider had encountered a thermal sink on top of the ridge. This had caused the right wing to drop and strike the ground. The glider then pivoted around that point, spinning in a clockwise direction, and struck the ground in a nosedive attitude. The right wing and its main spar broke in the middle. The impact broke the fuselage and its tubing. The passenger was killed instantly
