AIRCRAFT INCIDENT REPORT AND EXECUTIVE SUMMARY

Reference:	CA18/3/2/1058	
Aircraft registration	ZU-FTC	Date of incident	6 June 2014		Time of incident	0720Z
Type of aircraft	Jabiru SP (aeroplane)		Type of operation		Training (Part 141)	
Pilot-in-command licence type		Private	Age	29	Licence valid	Yes
Pilot-in-command flying experience		Total flying hours	104.4		Hours on type	9.2
Last point of departure		George Aerodrome (FAGG), Western Cape Province				
Next point of intended landing		George Aerodrome (FAGG), Western Cape Province				
Location of the accident site with reference to easily defined geographical points (GPS position)						
Keurboomstrand, 3nm east of Plettenberg Bay (GPS position: 34°01'35.51" South 023°24'04.57" East)						
Meteorological information		Surface wind: 330°5kt; Temperature: 12°C; Visibility: +10km				
Number of people on board	1 + 0	No. of people injured	0	No. of people killed	0	
Synopsis						
<p>The pilot, who was the sole occupant on board, was engaged in a cross-country navigational flight from George aerodrome to Tsitsikamma and back to George. As he passed abeam Beacon Island at Plettenberg Bay, he initiated a climb from 1 500ft to 3 500ft above mean

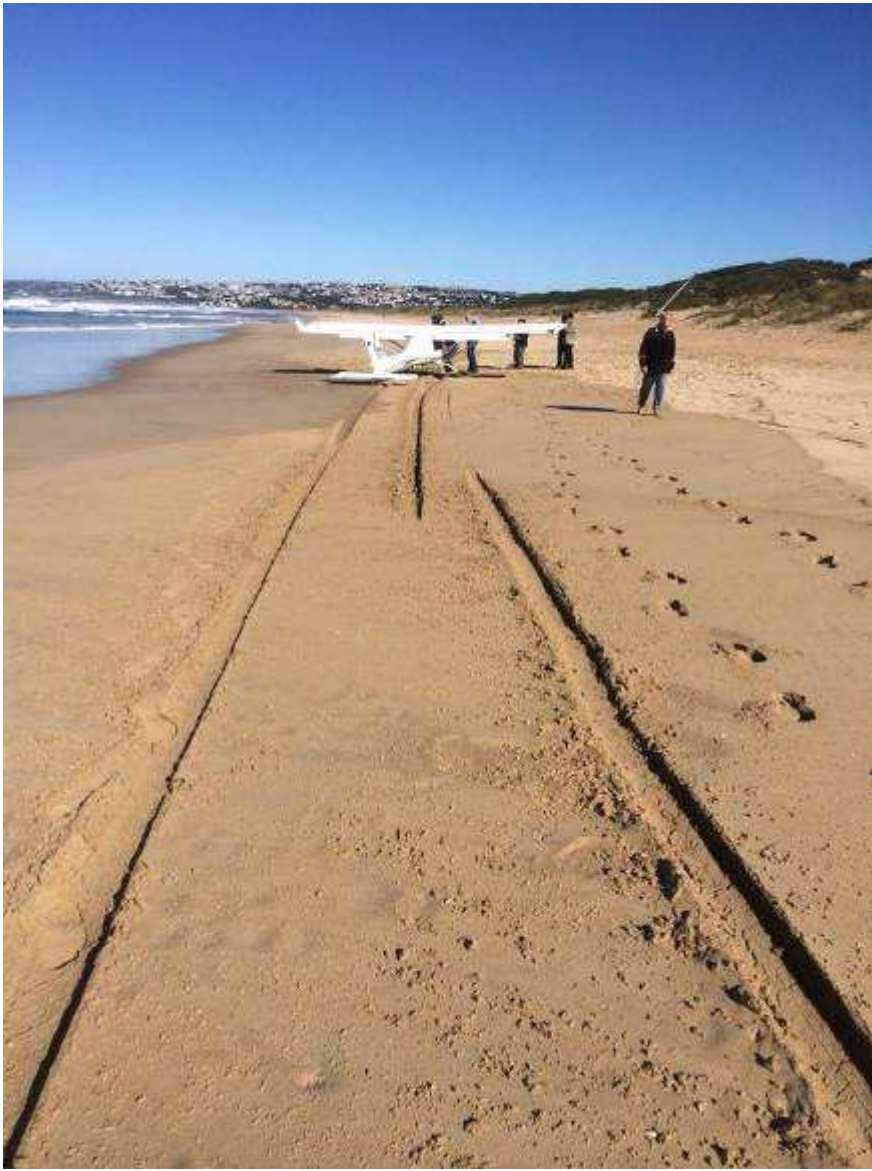
1.12.2 The pilot landed in a westerly direction on an open section of beach. He touched down above the shoreline. The aircraft came to a halt approximately 60m after touchdown. Just before it stopped, the nose wheel dug into the soft sand and the aircraft tipped forward, momentarily digging its nose section into the sand before falling back onto its main wheels, as shown in Figure 3. The propeller was recovered by members of the National Sea Rescue Institute (NSRI) on a rocky section of the shoreline to the east of the landing area, where it had washed up.

Figure 2. The tyre marks of ZU-FTC on the beach.

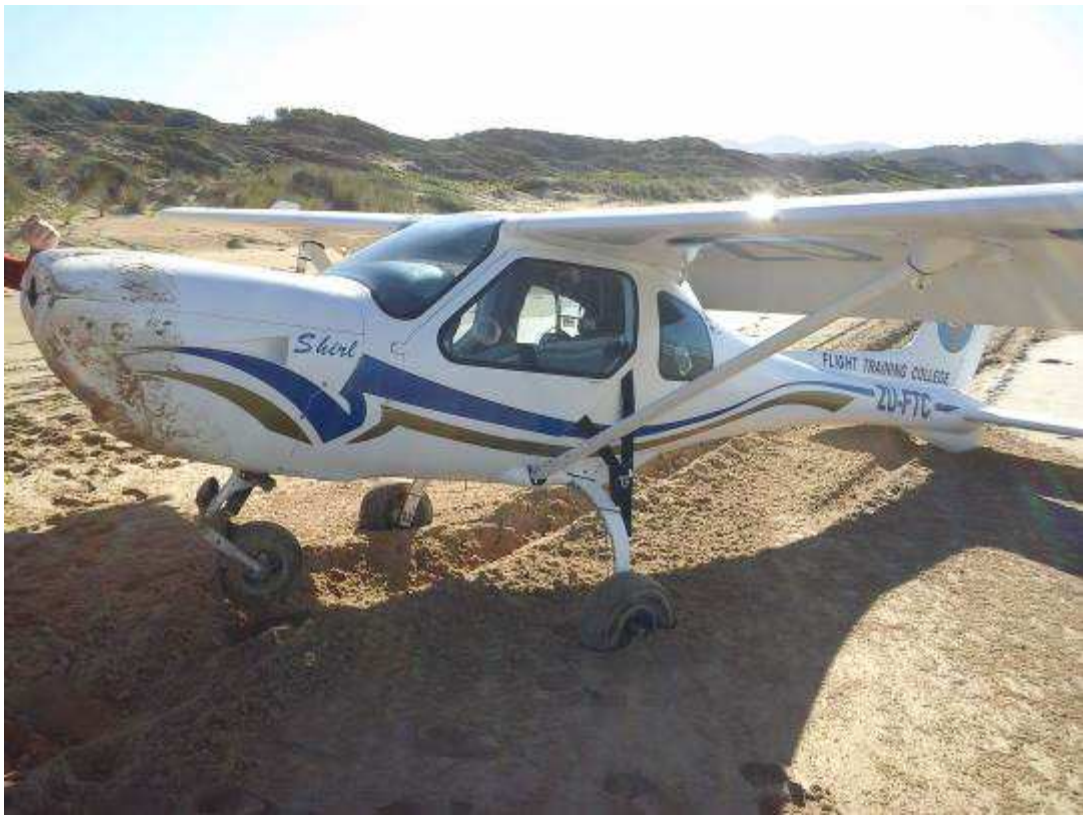
Figure 3. The aircraft after it came to rest.

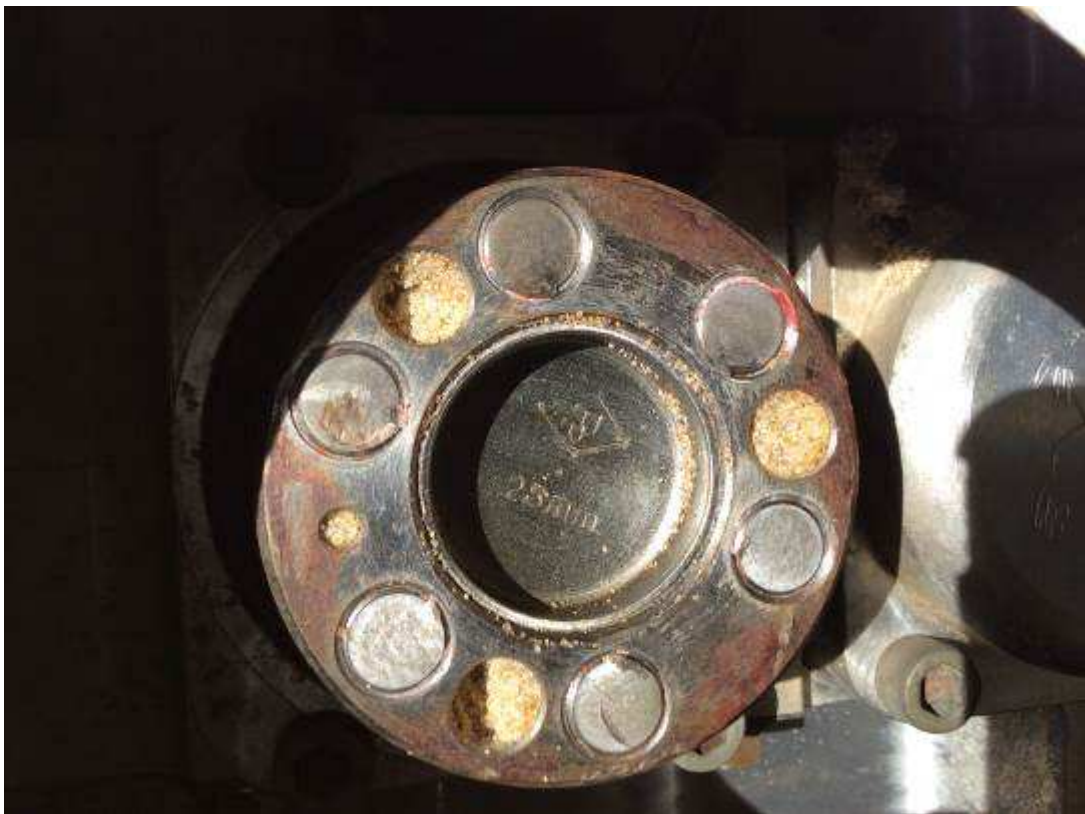
Figure 4. The sheared propeller attachment bolts (engine side).

According to the aircraft logbooks, Service Bulletin JSB-022-1 was incorporated and the aircraft flew a further 265 hours after this. The failure of the propeller attachment bolts was a secondary event caused by the sudden reverse load applied to the still-rotating propeller. This sheared the bolts and the propeller separated in flight.

- 4.3 It is recommended to the Director of Civil Aviation that the Jabiru Service Bulletin JSB-022-1 (attached to this report) be amended and reissued following review by the authority. JSB-022-1, page 2, paragraph (e) states that the flange bolts can be re-used providing they are of the correct length and there is no visible damage to the bolt. Considering the forces to which these bolts are exposed, it is recommended that this practice be removed from the bulletin and the re-use of any bolts be disallowed in the interest of aviation safety.

It is further recommended that all aircraft on which the Jabiru Service Bulletin JSB 022-1 was carried out be subjected to an inspection to ensure that none of the bolts securing the propeller flange to the crankshaft have fractured in operation. Any such bolts, or any suspect bolts, should immediately be replaced by new bolt(s).

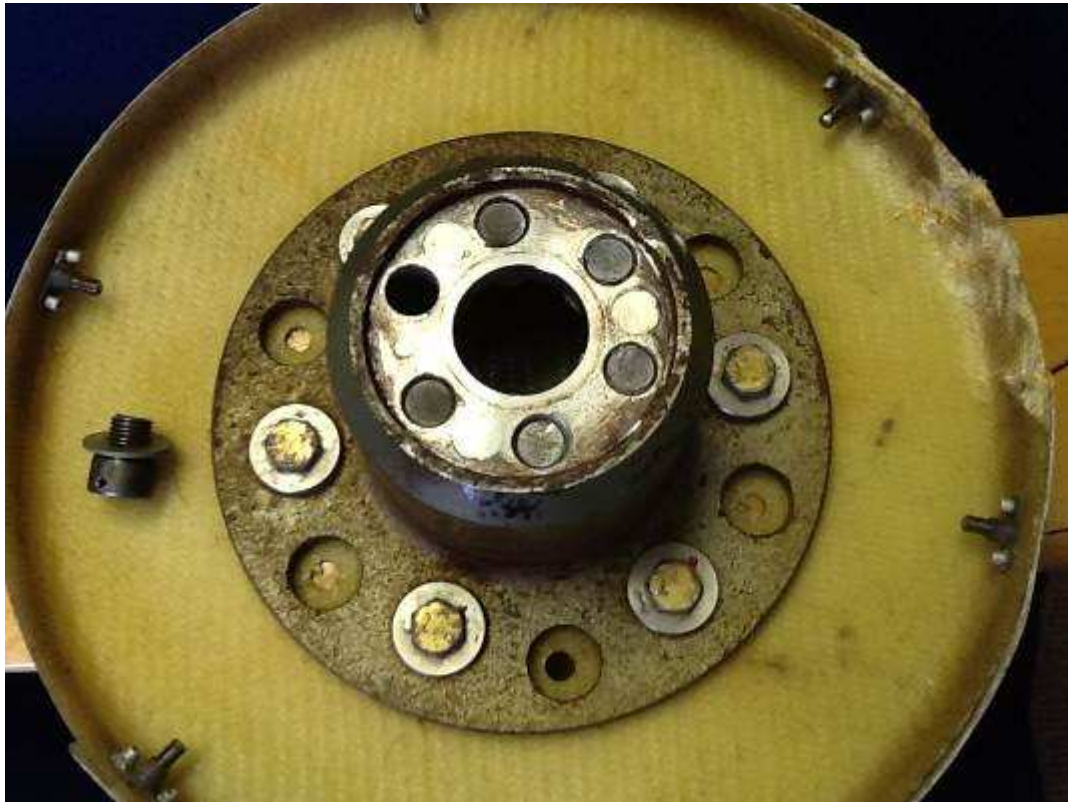
Figure 5. The sheared propeller attachment bolts (rear of the propeller)

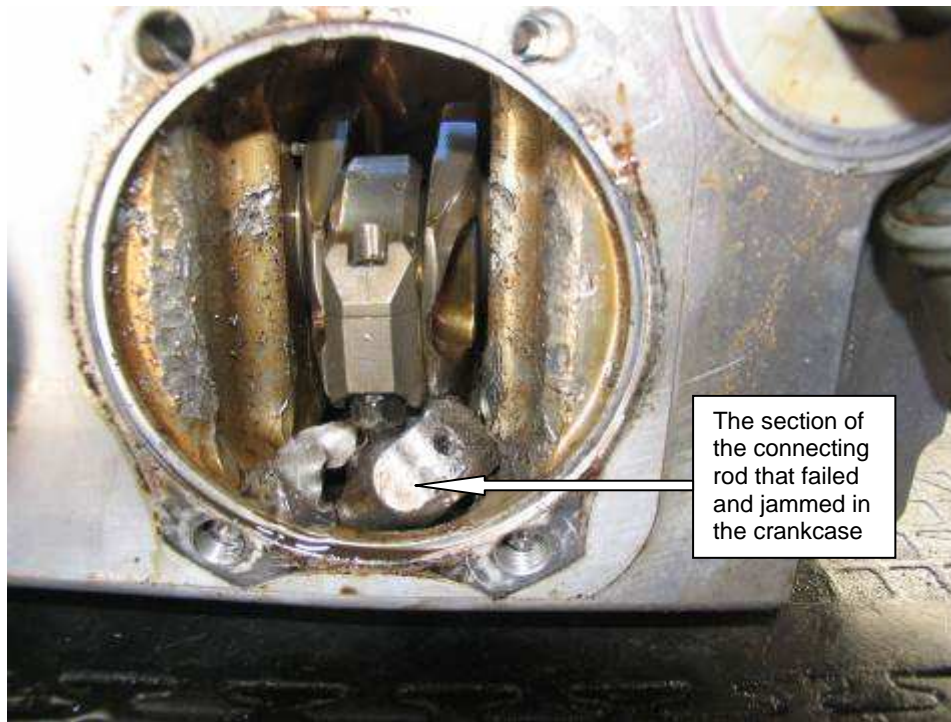
The engine could not be rotated after the incident. During further examination, it was evident that the lower crank case was deformed. An engine teardown inspection was conducted, during which it was found that a catastrophic failure had occurred: the number two piston was completely destroyed and the connecting rod had failed and deformed to such an extent that it had jammed in the crankcase (Figure 6).

Figure 6. The No. 2 connecting rod that failed.

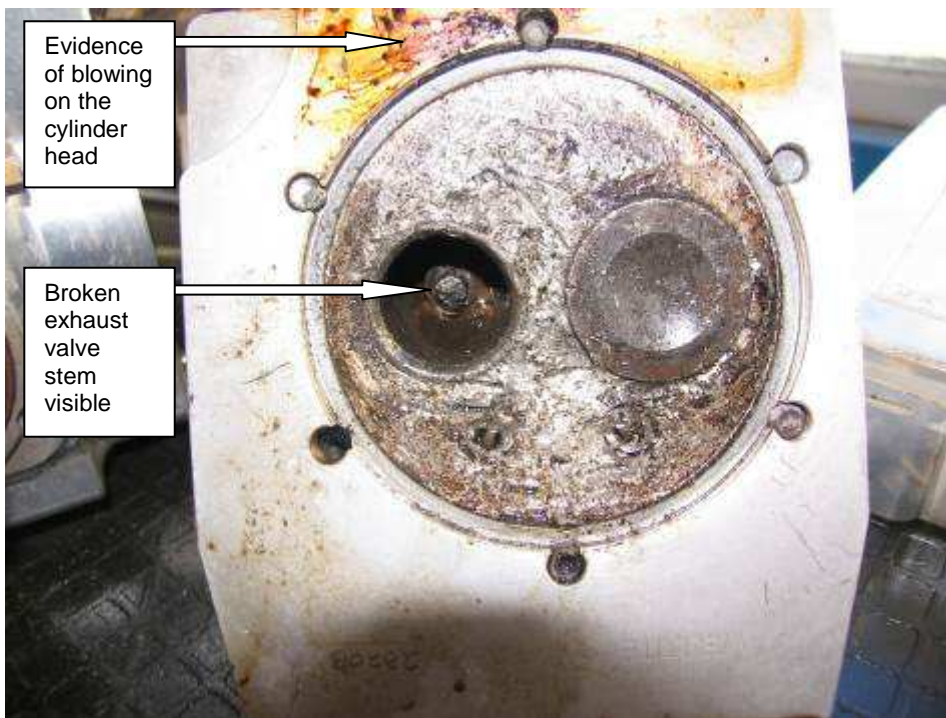
The head of the number two cylinder exhaust valve was retrieved from the oil sump. The valve stem from the exhaust valve was stuck in its valve guide (Figure 7). Further inspection showed that the valve guides were worn out of tolerance and a substantial amount of carbon had built up on the valve stems. All four cylinder heads were removed from the cylinders and three out of the four displayed signs of 'blowing'.

Figure 7. The damage caused to the No. 2 cylinder head.

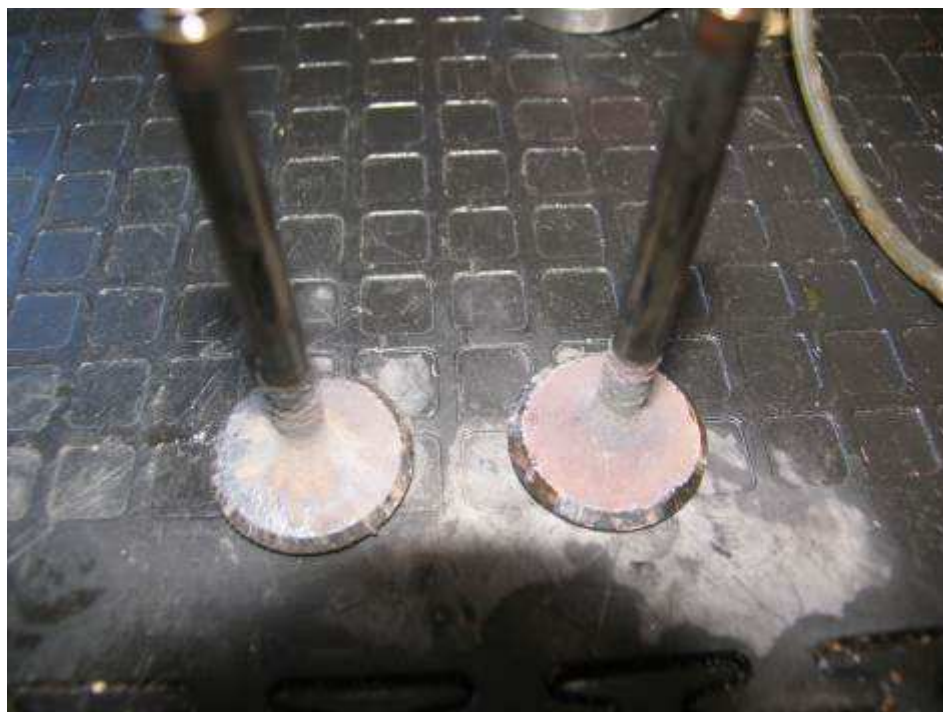
Figure 8 shows two exhaust valves that were removed from the engine during the tear-down inspection. Substantial carbon build-up can be seen on the lower valve stem area.

Figure 8. Carbon build-up on two of the valves removed from the engine.

Service Bulletin SL8 was issued on 14 December 2010. It was introduced to allow for better oil scavenging around the cylinder heads, as excessive oil in the rocker chamber flows down the valve guides and burns onto the valves, causing carbon

build-up on the stems. If enough carbon is allowed to build up, it could cause the valve to become stuck in the open position, causing the piston to collide with the valve. The latter would then break, damaging the piston and connecting rod. However, the service bulletin was not incorporated on this engine as it was not mandatory. A copy of the service bulletin is attached to this report as Annexure C.

- 4.2 In the interest of aviation safety, it is recommended that all owners of aircraft fitted with Jabiru engines comply with Service Bulletin SL8. This was issued to prevent carbon build-up in the engine and ensure that the valves seal more positively. This bulletin is not mandatory. However, it is recommended that the Civil Aviation Authority elevate the status of the bulletin to ensure that compliance is met by all aircraft owners.

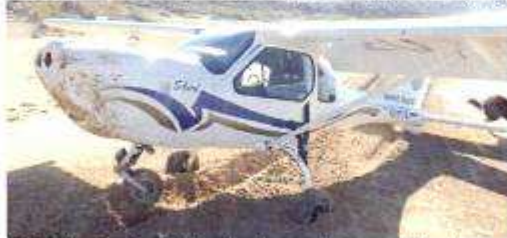
Photo 2: Accident aircraft, on site (courtesy SACAA)

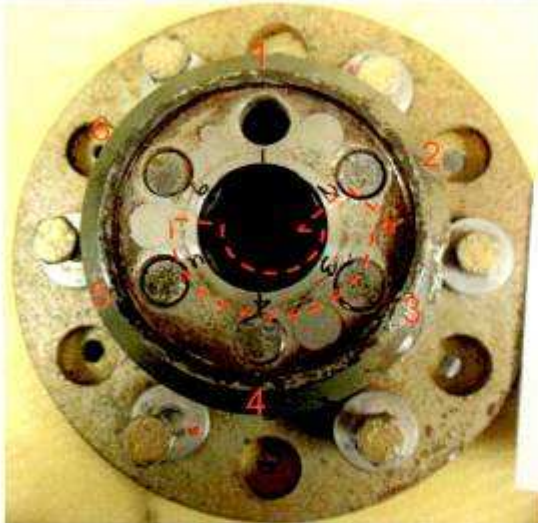
- 6.1.1. Propeller Flange Assembly: All 6 propeller flange attachment bolts (Photo 3) fractured at the engine drive flange position. The no 1 bolt was found removed from its position. At low magnification all 6 bolts revealed a similar macro fracture surface geometry with no clear indications of fatigue. At higher magnifications the fractographs from selected bolts (No's 3, 4 and 5) revealed no clear indications of fatigue or other pre-existing fractures prior to final failure. The fracture surfaces revealed a clear directional orientation in geometry (Photo's 7, 8 and 9) pointing towards a shear rather than a pure tensile type failure mode.

Photo 3: Engine propeller flange (digital)

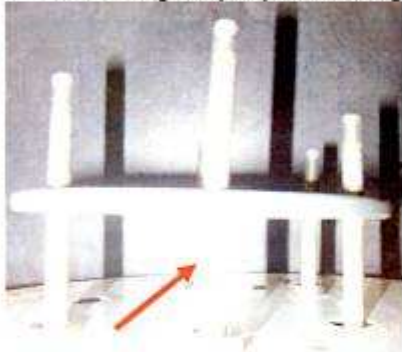
The propeller attachment bolts revealed severe bending damages (Photo 4, red arrow). The propeller bolt guides showed impact damages similar in shape and relative position (Photo's 5 and 6, blue arrows). Considering the applied force during operation (red dashed arrows), the unidirectional bending of the propeller attachment bolts and the fact that no inflight propeller strike was reported, it can be derived that the propeller attachment bolts impacted the guides due to a reverse directional force imposed from the engine end.

Photo 4: Propeller attachment bolts (digital)

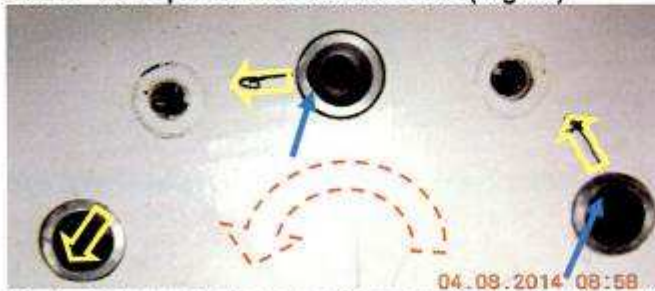
Photo 5: Impact damages to propeller bolt guides (digital)

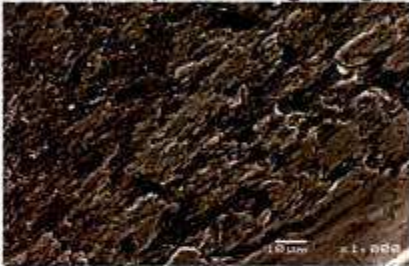
Photo 7: Fractograph - Bolt 3 (x1000, SEM)

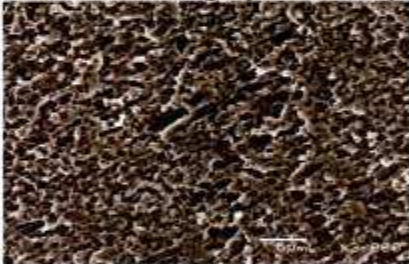
Photo 8: Fractograph - Bolt 4 (x3000, SEM)

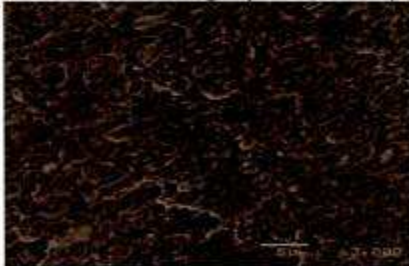
Photo 9: Fractograph - Bolt 5 (x3000, SEM)

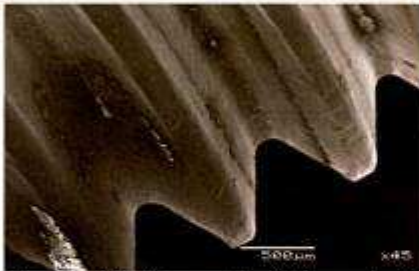
The threaded sections revealed no clear indications of sub-fracture initiation (Photo's 10 and 11) as expected under a pure tensile load condition.

Photo 10: Flange bolt threaded section (x45, SEM)

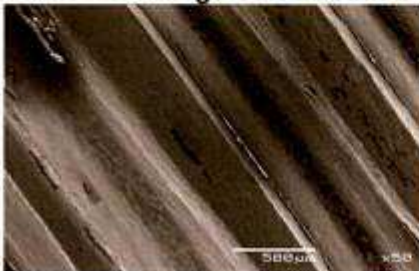
Photo 11: Flange bolt threaded section (x50, SEM)

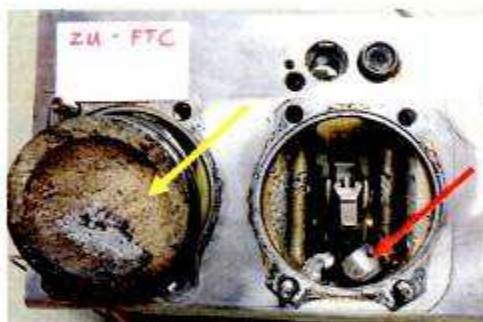
6.1.2. Engine Block Assembly: The inspection revealed the no 2 connecting rod (Photo's 12 and 13, red arrows) still attached to the crankshaft at the big end with no clear fracture/s. Damages inflicted to the inner sections of the crankcase (Photo 13, blue arrow) can be attributed to the connecting rod impacting following the failure of the no 2 piston.

Extensive carbon deposits were noted on all the piston surfaces (Photo 12, yellow arrow) as well as in the exhaust exit duct and valve stem guide areas (Photo 18, red arrows). Similar deposits were noted on the exhaust valve stem (Photo's 20 and 23, red arrows) adjacent to the valve stem guide entrance position. The exhaust valve stem revealed extensive scraping marks (Photo 22, red arrow) induced by the valve stem guide as well as copper based deposits (yellow arrow) originating from the guide.

Photo 12: Engine block - No 2 piston damages (digital)

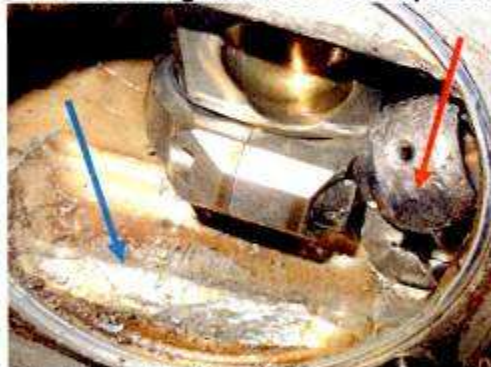
Photo 13: Position of No 2 connecting rod (digital)

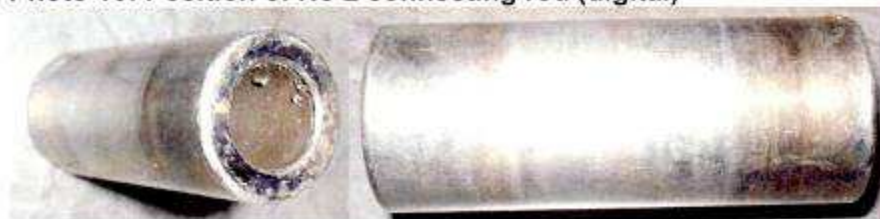
The (small end) piston gudgeon/wrist pin revealed no clear evidence of possible contact with the sleeve during operation (Photo 14) suggesting that the 'circlips' was intact and in position at the time of piston failure (*refer Jabiru SB 033-1*).

Photo 14: Gudgeon pin – small end No 2 (digital)

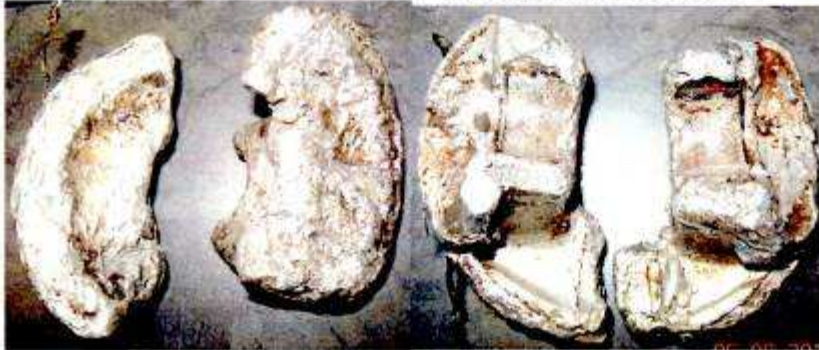
The no 2 piston revealed severe impact damages (Photo 15). Inspection of the resultant, and relatively undamaged, fracture surfaces (Photo 16) exposed no clear indications of pre-existing fractures.

Photo 15: No 2 piston damages (digital)

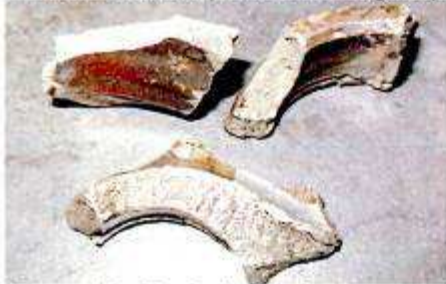
Photo 16: No 2 piston fracture surfaces (digital)

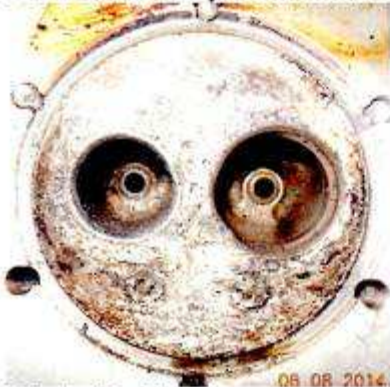
The no 2 cylinder head (Photo 17) showed severe damages that can be attributed to multiple impacts by the remains of the fractured exhaust valve during operation. It can therefore be derived that the exhaust valve most probably failed first in the sequence of events allowing the parts thereof to be forced into the cylinder head by the still oscillating piston. These impact forces ultimately would have caused the failure of the piston itself. Small, hard object impact marks in close proximity to the top end of the cylinder sleeve (Photo 19, red arrow) also confirms that the exhaust valve most probably failed first and allowed to be contained in the combustion area for a short period of operational time. Both the exhaust and inlet valve seats were found in position.

Photo 17: No 2 head damages (digital)

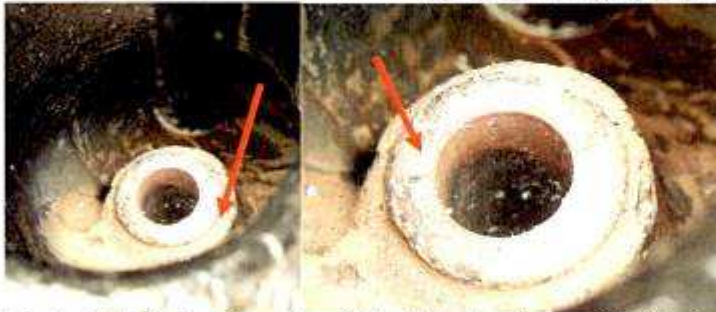
Photo 18: No 2 exhaust exit duct and valve guide (digital)

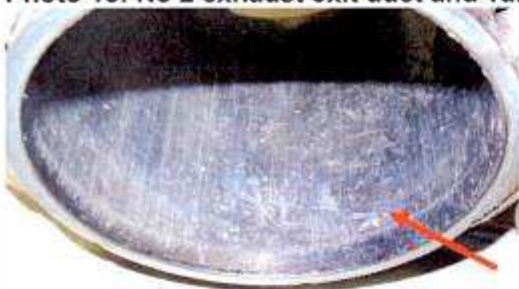
Photo 19: No 2 pod damages (digital)

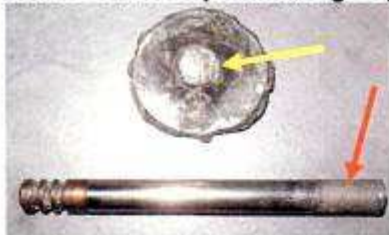
The no 2 exhaust valve head fractured from the stem at the radius (Photo 20) with extensive damages to both fracture surfaces ends (Photo's 20 and 21, yellow arrows). At higher magnification, fractographs from the stem end (Photo 24) confirmed the extensive impact and other damages inflicted post-failure while no clear evidence of pre-existing fracture initiation was noted.

Photo 20: No 2 exhaust valve damages (digital)

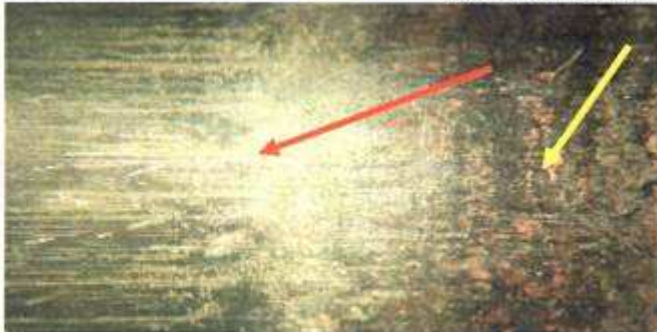
Photo 22: Scraping marks on exhaust valve stem (stereo)

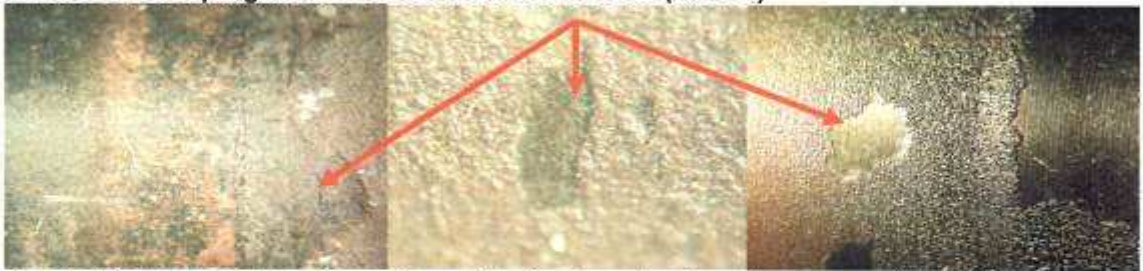
Photo 23: Hard carbon deposits on No 2 exhaust valve stem areas (stereo)

- 7.2. The buildup of surface carbon deposits proved to be a contributing factor to accidents and incidents in the past involving similar aircraft (*refer AAIB Bulletin No: 10/2002 and Investigation Report: Exhaust Valve Failure Jabiru 3300 engine, MET 003-3-07, dated 2007-03-14 - By the same investigator*). In this case, again, the clear buildup of hard carbon deposits on the exhaust valve seat as well as on the vulnerable stem area, in close proximity to the valve stem guide point of entry, proved to be the most probable contributor. In the majority of the cases the resultant effect of these flaking carbon deposits (Photo 26 – *from historic case*) proved to be a 'sticky' valve inside the valve stem guide leading to catastrophic consequences.

- 8.1. Inflight engine failures are severely detrimental to Flight Safety. It is therefore strongly recommended that the OEM, owners and relevant AMO's sensitise operators regarding the dangers of carbon deposits and the correct inspection methodology to detect out of limit accumulation.

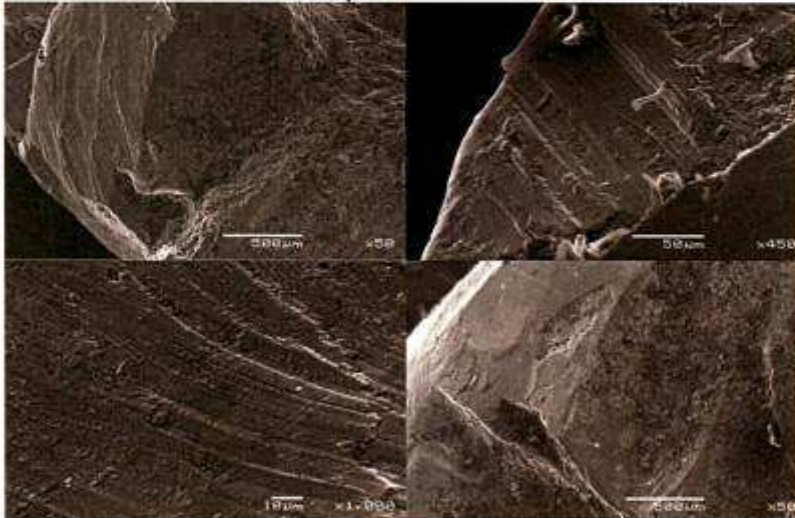
Photo 24: Fractographs - No 2 exhaust valve, stem end (x50 – x1000, SEM)

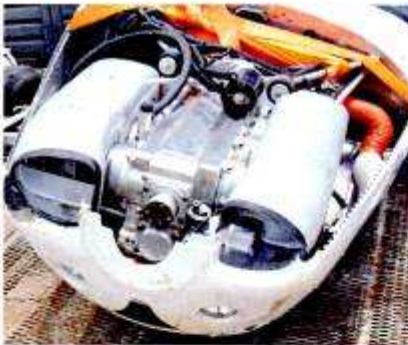
A comparable failure was noted on a similar aircraft in Kwa-Zulu Natal, South Africa (Photo 25).

Photo 25: Similar failure of the propeller flange bolts following an engine failure (courtesy SACAA)
