FINAL INVESTIGATION REPORT OF SERIOUS INCIDENT TO M/S JET AIRWAYS
ATR 72-212A AIRCRAFT VT-JCS AT BENGALURU ON 13/06/2014

On 13.06.2014, M/s Jet Airways Ltd. ATR 72 -212A aircraft VT-JCS while operating flight 9W-2731 (Bengaluru to Cochin) was involved in a serious incident during pushback at Bengaluru.

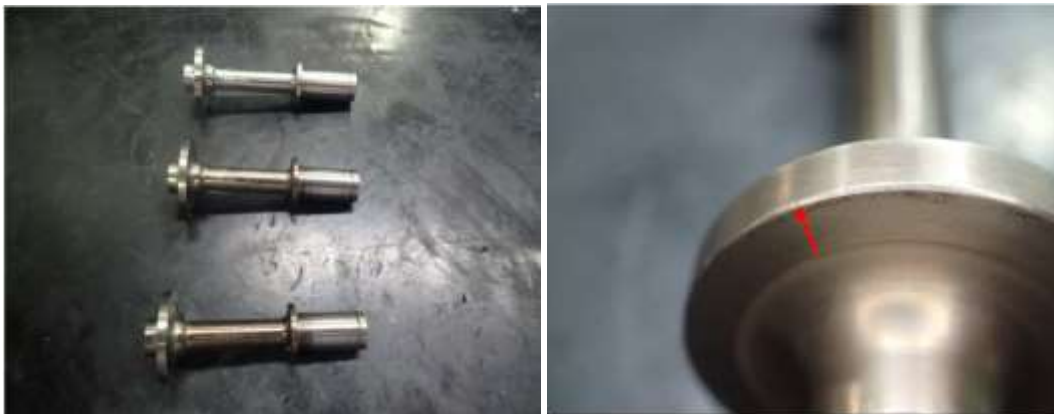
Burr at outer Diameter on all the three P 2.5/3 Air Switching Valve

On 19.06.2014, an evaluation flight was carried out and no smoke or oil smell was observed in cockpit and cabin. Thereafter, the aircraft was released and the snag has not reoccurred. The removed inner valve of P2.5/3 Air Switching Valves was sent to P&W for investigation. As per the report received from P&W "During inspection of the valves, outer diameter was observed with Burr and inner diameter of bushing was observed with wear beyond serviceable limits.

It is opined that the burr found on outer diameter could cause restriction to the valve movement due wear of the valve diameter that slide along the guide pin. As a result, the valve may not be able to move smoothly within the inner housing and could disturb the balance of the secondary sealing layer to the bearing compartment. Functionally, any parts within the Air Switching Valves could also affect the operation of P2.5/3 Air Switching Valve.

16. As per Aircraft Maintenance Manual, Inner valve of P2.5/3 Air Switching Valves on both the engines were replaced.
17. An evaluation flight was carried out and no smoke or oil smell was observed in cockpit and cabin.

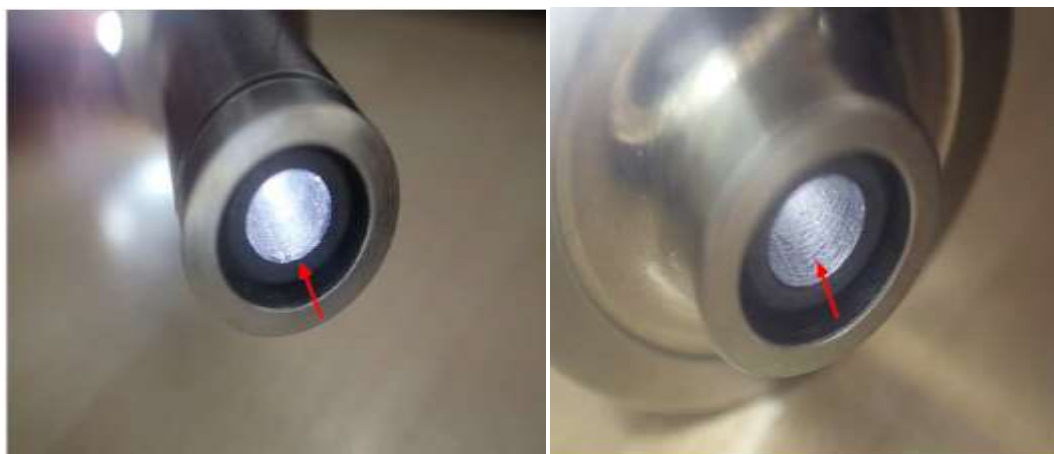
Wear in bushing inner diameter in two of the P 2.5/3 Air Switching Valve

valves, outer diameter was observed with Burr and inner diameter of bushing was observed with wear beyond serviceable limits, which could disturb the balance of the secondary sealing air to the bearing compartment.

During engine start up, the smoke/ oil smell in the cockpit and cabin was probably caused due to oil leak as a result of wear of inner diameter of the inner valve of the Air Switching Valve thereby imbalancing the secondary seal of bearing compartment.
