AIRCRAFT ACCIDENT REPORT AND EXECUTIVE SUMMARY

Reference:	CA18/2/3/9328	
Aircraft Registration	ZU-RRP	Date of Accident	13 June 2014		Time of Accident	1245Z
Type of Aircraft	Auto Gyro GMBH		Type of Operation		Private	
Pilot-in-command Licence Type		Private Pilot	Age	44	Licence Valid	Yes
Pilot-in-command Flying Experience		Total Flying Hours	491,8		Hours on Type	8,8
Last point of departure		Stellenbosch Airfield-Cape Town(Western Cape Province)				
Next point of intended landing		Stellenbosch Airfield-Cape Town (Western Cape Province)				
Location of the accident site with reference to easily defined geographical points (GPS readings if possible)						
Left-hand side of Runway 01 at Stellenbosch Airfield, during take-off roll, GPS coordinates S33° 58'50.0" E 018° 49' 22 .0"; elevation: 321 feet above mean sea level.						
Meteorological Information		Wind direction: (NNE) 23°; Wind speed: 20 knots; temperature: 22,4°C; cloud and visibility ok (CAVOK); cloud cover: minimal; cloud base 4739 (as reported by the pilot)

AIRCRAFT ACCIDENT REPORT

Name of Owner/Operator : P. Roux
Manufacturer : Auto Gyro (GMBH)
Model : Calidus
Nationality : South African
Registration Marks : ZU-RRP
Place :

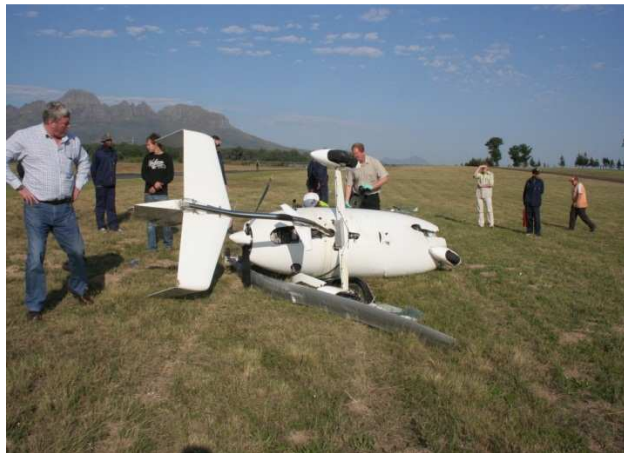
- 1.3.1 The aircraft was extensively damaged during the accident.

Figure 1 Wreck at the crash site

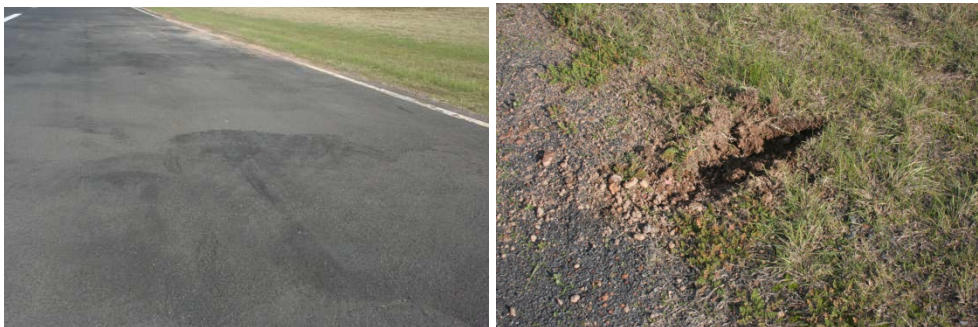
- 1.4.1 There were scratch marks on the runway and damage to the grass where the propeller blades struck the ground after the aircraft veered off the runway.

Figure 2 Scratch marks on the runway and the damage caused by propeller strike

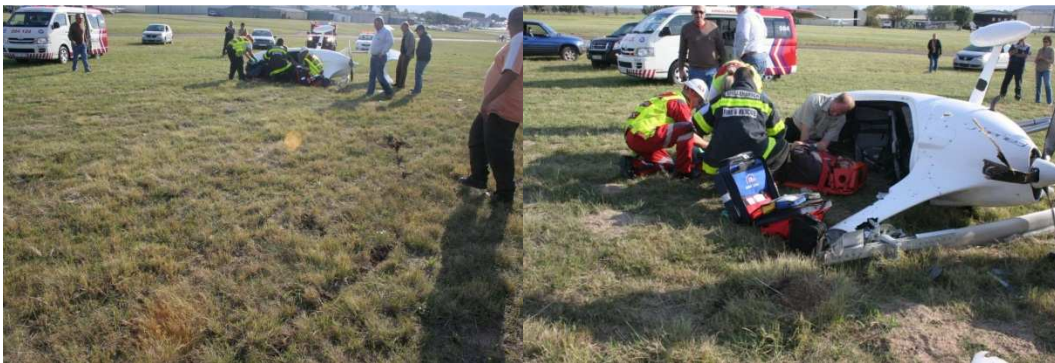
- 1.12.1 The aircraft tail section hit the runway and the aircraft veered off to the left of Runway 01. The main rotor made contact with the runway surface and one rotor blade separated, while the other blade remained on the mast. The aircraft rolled three times before coming to rest on its left side. The nose of the aircraft contacted the ground first, then the main undercarriage and then the aircraft flipped over. All damage to the aircraft was caused during the accident sequence. The left hand side vertical stabiliser was damaged when the aircraft rolled to the left before coming to a halt. The cockpit instrumentation panel was also damaged during the accident sequence. One of the main rotor blades separated from the aircraft and one of the propeller blades was damaged.

- 1.12.2 The nose wheel was bent rearwards and the front right-hand side fuselage was damaged, possibly when the aircraft was rolling.

Figure 3 Marks caused when the gyrocopter veered off the runway and position of the wreck after the accident

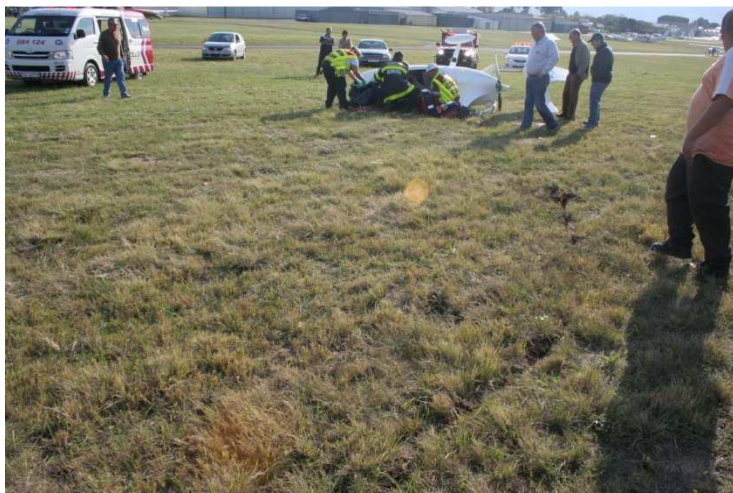
- 1.15.1 The accident was considered survivable due to the low impact loads and damage to the cockpit. The pilot made use of the safety harness installed in the gyrocopter and the safety harness did not fail. It was unlatched by the medical services when they were freeing the pilot from the aircraft.

Figure 4 Emergency services assisting the pilot after the accident.
